ASPECTS REGARDING THE DEGRADATION OF A RETAINING WALL WITH THE DESTINATION TO REINFORCE THE STABILITY OF THE SITE ARRANGEMENT OF RESIDENTIAL BUILDINGS

I. TUNS and FLORIN-L. TAMAȘ

The paper presents situation generated by the execution of a section of domestic sewage, near and under the implantation foundation of a retaining wall having the role of maintaining stability of the arrangement site of residential buildings.

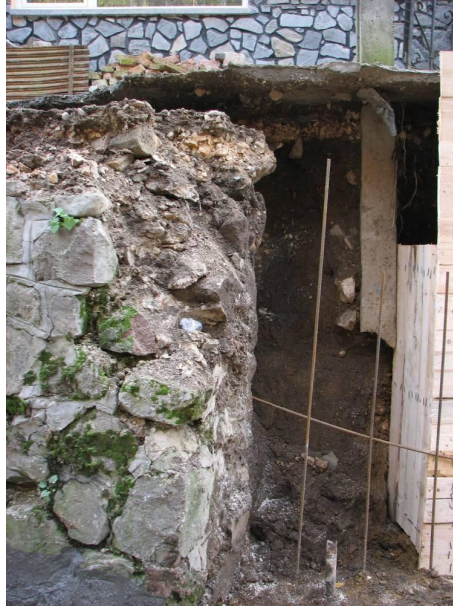
The analysed area is part of Cretaceous age, characterized by polymictic conglomerates that form the petrographic structure of the Mountains Poiana Brașov. The Morphology of the land plot shows that real estates are located on a platform artificially arranged, dug in a cenomanian conglomerate towards the Southern slope, a gritty powder diluvium to the North and behind the retaining wall an inhomogeneous stuffing layer made of scratchy rocks, sand and dust (Fig. 1).

Fig. 1. – Appearance of earth filling behind the retaining wall.

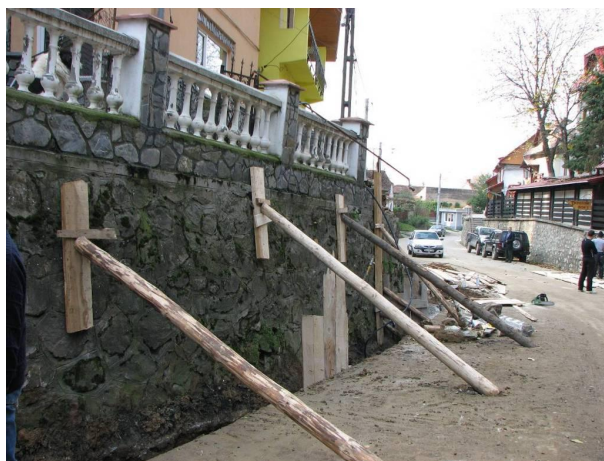
Fig. 2. – The digging carried out on long sections near and under the foundation quota of the retaining wall.

The lack of passive resistance of the earth located downstream of the retaining wall [3], as a result of the digging carried out near and under the foundation quota, on long sections, (Fig. 2), led to linear and angular shifts of the wall, highlighted

by cracks whose opening reaches to 10 cm.

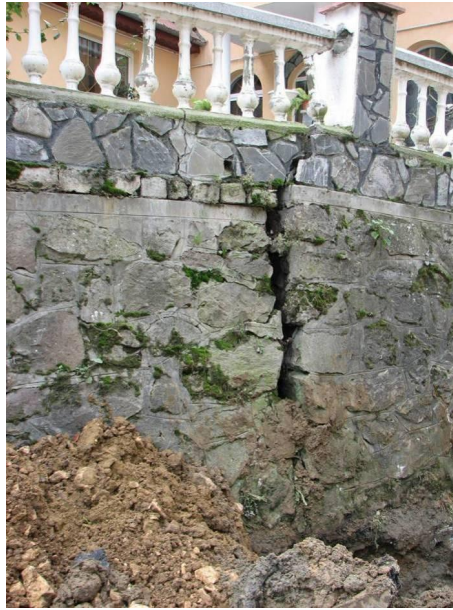
The opening of cracks formed in the area is accentuated in the area of the compression joint on the wall height, but cross also the support area of the protection bulwark achieved subsequently, (Figs. 3 and 4).

Fig. 3. – The large opening of the compression joint.

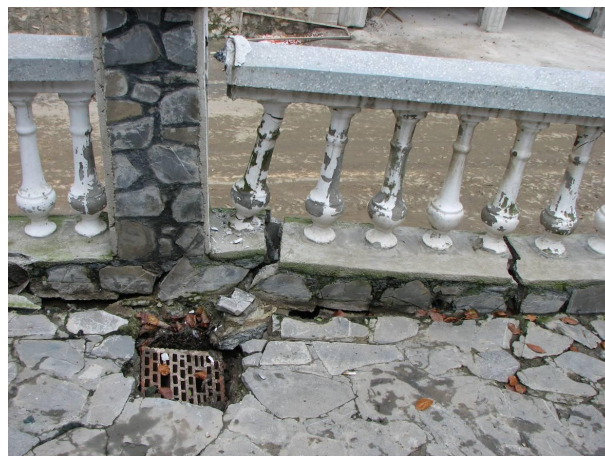
Fig. 4. – Cracks in the protection bulwark area.

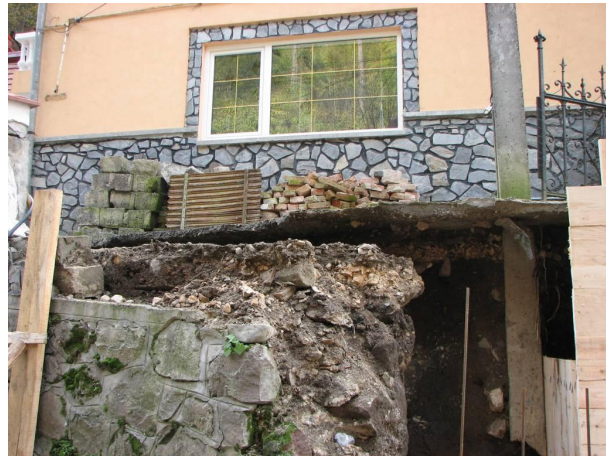
The linear and angular movements of the portion of the wall bounded by serious cracks have generated their separation from the wall and trigger of land portions expanding to the existing buildings (Figs. 5 and 6).

Fig. 5. – Portion of the wall detached from the wall.

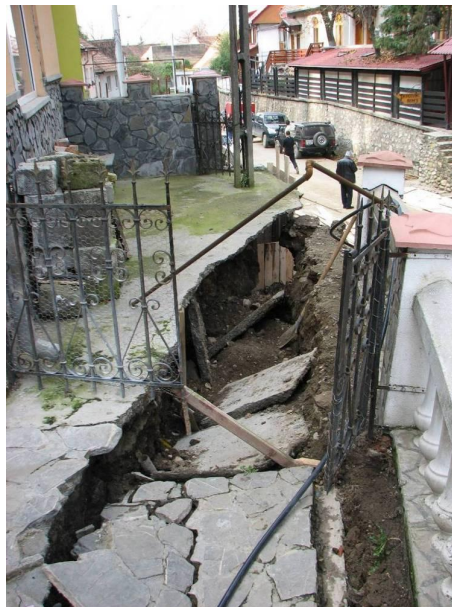
Fig. 6. – Crashing of portions of land behind the retaining wall.

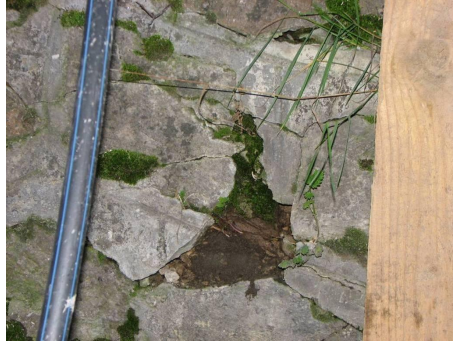
The long action of environmental factors have contributed fully to enhance the

state of degradation, evidenced by cracks, exfoliations of material, by separation of the mortar from the joints and stones of the wall, enabling the development of vegetation (Fig. 7).

Fig. 7. – Portions of the wall with extended cracks, detachments of stone and abundant vegetation.

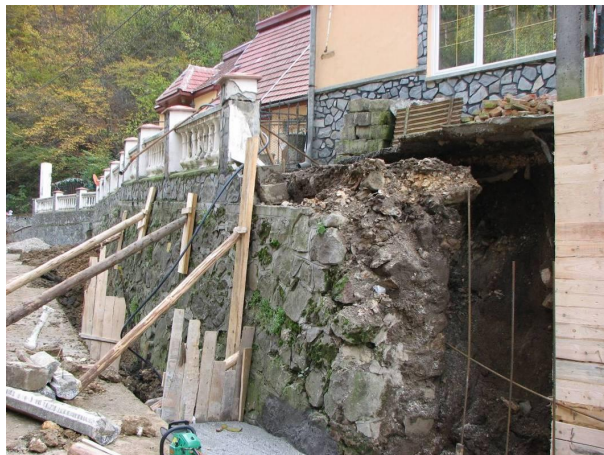
Fig. 8. – Blocking the movement of the retaining wall (using concrete works) and sustaining its wall parament.

a) blocking the movements of the wall base by casting of a stuffing concrete (C5/7.5) in the trenches made at its basis, while ensuring a support for the wall parament [2] (Fig. 8);
