BULETINUL INSTITUTULUI POLITEHNIC DIN IAȘI
Publicat de
Universitatea Tehnică „Gheorghe Asachi” din Iași
Tomul LIX (LXIII), Fasc. 3, 2013
Secția
CONSTRUCȚII. ARHITECTURĂ

ASSESSMENT AND CONSOLIDATION OF A BUILDINGS FRAMING ELEMENTS

SIMONA STANCA*, **DANIELA-ROXANA TAMAȘ-GAVREA** and
CONSTANTIN MUNTEANU

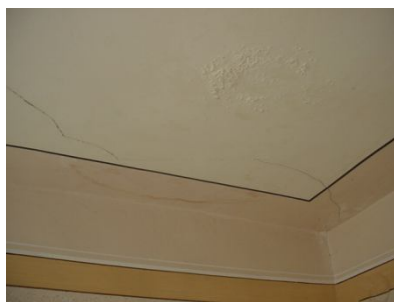
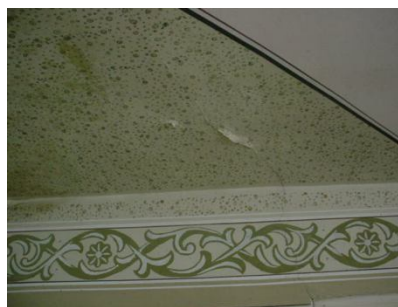
Fig. 2

The degradation suffered by the components of the roof structure are extended almost on the entire surface of the roof. These failures are probably due to the damages suffered in time by the roof structure and roof elements, which greatly reduced the tightness of the roof, while allowing infiltration of rain water through it and through the floor above the first level (Figs. 2 and 3).

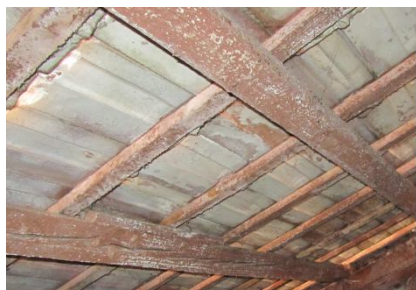
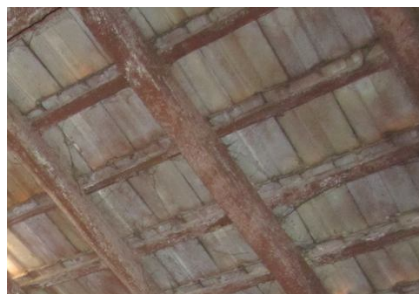
Fig. 4

Most of the timber slats that support the tiles are in an advanced state of aging and deterioration (Figs. 4 and 5), so it was decided to replace them, which is an acceptable and cheaper solution than to remediate them (Fig. 6).

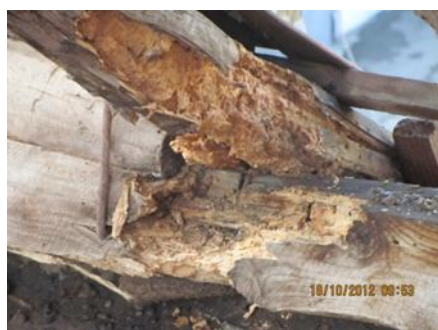
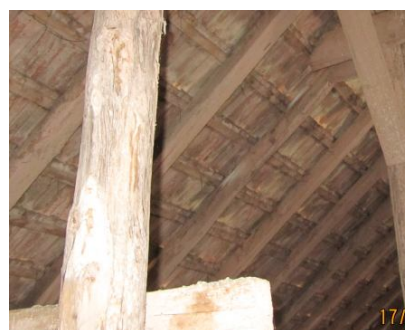
Fig. 7

Due to the lack of a sealed roof, some elements of the roof structure are in an advanced state of deterioration, even rotting (Figs. 7 and 8), which also involved their replacement (Figs. 9 and 10).

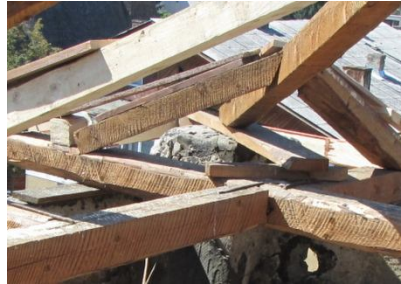
Fig. 11

It also requires the replacement of some structural elements because in the new planned modernizations the scheme or static load, changes, so that the original structure no longer meets the new circumstances (Fig. 11).

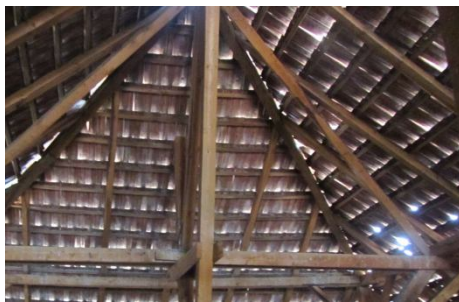
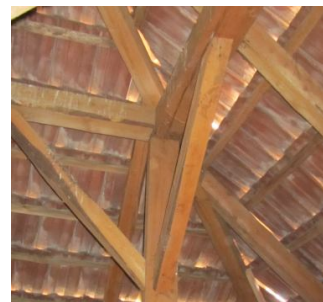
Fig. 12

Also to create a more stable roof structure elements additional bracings were executed. It is necessary the replacement of some props due to the presence of a bending effect (Figs. 12 and 13).

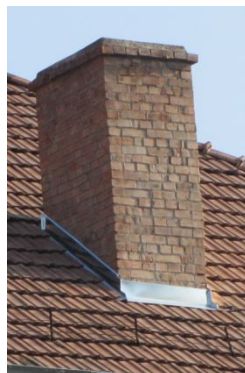
Fig. 14

Tin collars around chimneys were originally incorrectly executed, being damaged due to water infiltration; there was required replacement of them (Fig. 14).

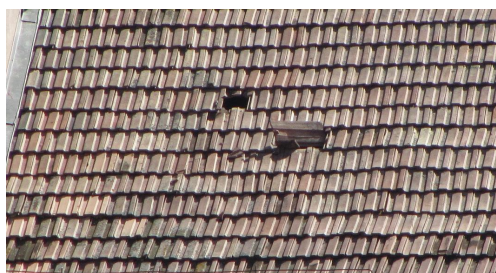
Fig. 15

The upper portion of the roof has some areas where the tiles were torn by the wind (Fig. 15). Others have some damages due to the passage of time; they were broken, deformed or displaced and following the assessment it was imposed the replacement of them (Fig. 16).

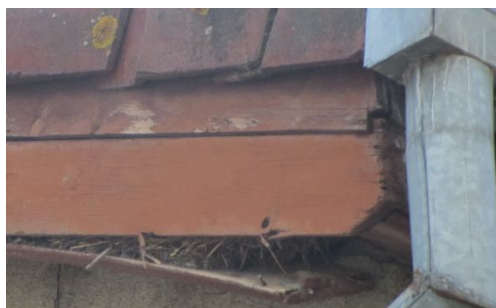
Fig. 17

The gutters and vertical pipes that presented insufficient sections that could not take all of the water, especially in heavy rains, but also for other reasons such as clogging of the gutters with pieces of tile ripped by wind and the lack of the exhaust system accessories (boilers at the end of the gutters) (Fig. 17) were replaced by providing a system as in Fig. 18.
