BULETINUL INSTITUTULUI POLITEHNIC DIN IAȘI
Publicat de
Universitatea Tehnică „Gheorghe Asachi” din Iași
Tomul LIX (LXIII), Fasc. 4, 2013
Secția
CONSTRUCȚII. ARHITECTURĂ

THE STRUCTURAL REHABILITATION OF A MASONRY BUILDING

IOAN POP and NICOLETA COBÎRZAN*

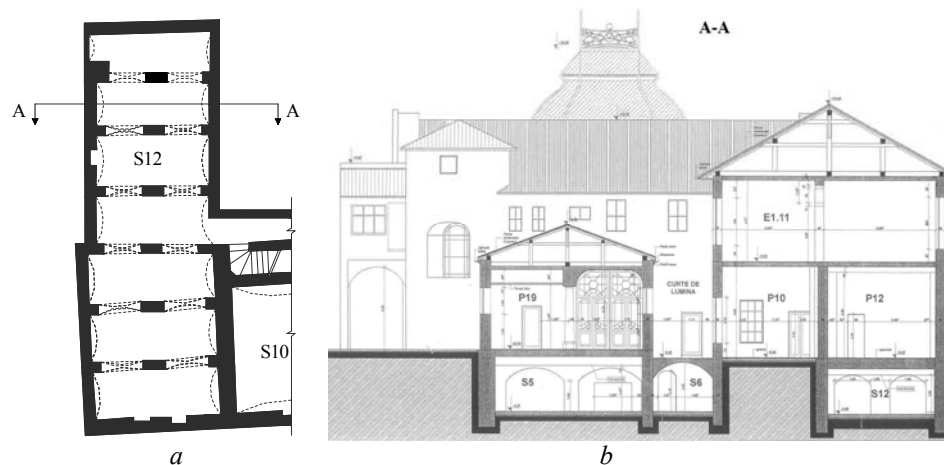
Fig. 1 – Basement floor plan (a) and cross section (b).

The area of the building under investigation in this paper regards the basement plan and the cross section presented in Fig. 1.

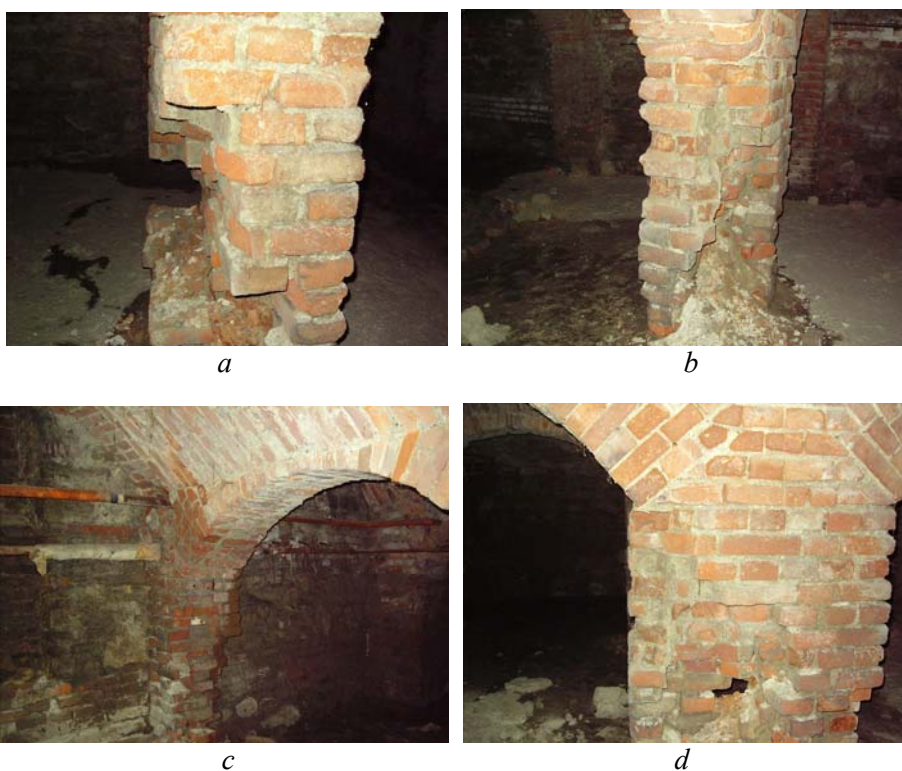
Fig. 2 – Structural damages to columns.

Structural damage stops at the level of the basement and is mainly caused by the action of the water originating from rainwater and from the damaged pipes as water can be permanently found in the basement of the building.

The deterioration of the brick predominantly in the columns led to the reduction of their section to about 25...30% of the initial section, making the balance be weak and poor (Fig. 2).
