VERIFYING THE OPERATIONAL SAFETY OF SOME EARTH DAMS USING OWN CODED COMPUTER PROGRAMS

DORIN COTIUȘCĂ ZAUCĂ*, **RALUCA-CATRINEL GIURMA-HANDLEY**,
AMEDEO MITROI and **PAULA COJOCARU**

An analysis of this type has been carried out on the Varsolt Hydrotechnical System, located on the Crasna River in Romania. The results of the test have contributed to the rehabilitation and modernization of the earthen dam (Expertiza tehnică..., 1997).

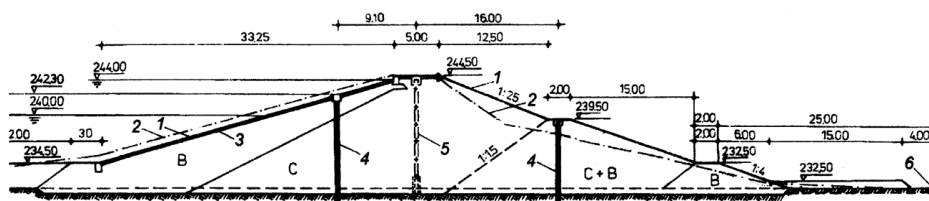
Fig. 1 – The transversal profile of the Varsolt dam: 1 – the initial shape; 2 – the present-day shape; 3 – pitching of the concrete slab; 4 – piezometer tubes; 5 – mark of depression; 6 – channel.

b) The dam presents a less slender cross section than in the project's design.

c) The upstream face of the dam is protected by a layer of riprap instead of concrete slabs. As a result there is an active process of infiltration through the dam with significant water loss from the storage basin. The infiltration current initiates and intensifies the internal erosion phenomenon.

2. The execution of the initial transversal section of the dam through embankment and molding the present shape. The upstream face of the dam as well as the downstream face must stick to the slopes shown in the execution project (1:2.0-1:3.50).

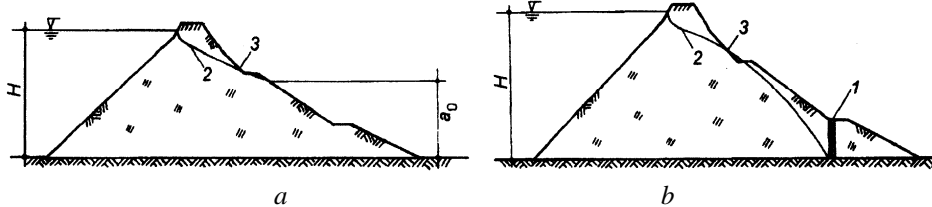
specific seepage flow is $q_{\max} = 15 \times 10^{-8} \text{ m}^3/\text{sm}$, with the spring of trickling on downstream face of the dam at $a_0 = 3.82 \text{ m}$ (Fig. 2).

Fig. 2 – The position of the seepage curve at the maximum level hypothesis ($p = 1\%$):
a – blocked drainage; *b* – functional drainage; 1 – drain; 2 – seepage curve; 3 – spring point.

For the level with the exceedance probability = 0.1%, calculus section 3 becomes the most strained; here the elevation point of trickling on downstream face of the dam $a_0 = 6.03 \text{ m}$ has the highest value and the depression curve intersects first berm. In the hypothesis of the blocked drainage, the maximum specific infiltrated debit results in cross section 2, having the value of $q_{\max} = 24 \times 10^{-8} \text{ m}^3/\text{s}$. This means that a possible try to over increase of the operating level of the lake can trigger the loss of the dam's stability, due to the appearance of the springing phenomenon on the downstream slope at very high elevations (higher than 6.0 m).

3. Decreasing the depression curve and ensuring the stability of the dam, by executing a drain beneath the downstream face of the dam.
