BULETINUL INSTITUTULUI POLITEHNIC DIN IAȘI
Publicat de
Universitatea Tehnică „Gheorghe Asachi” din Iași
Tomul LXI (LXV), Fasc. 1, 2015
Secția
CONSTRUCȚII. ARHITECTURĂ

STRUCTURAL AND DAMAGE ASSESSMENT OF AN HISTORICAL MASONRY CHURCH

LUCIAN SOVEJA* and MIHAI BUDESCU

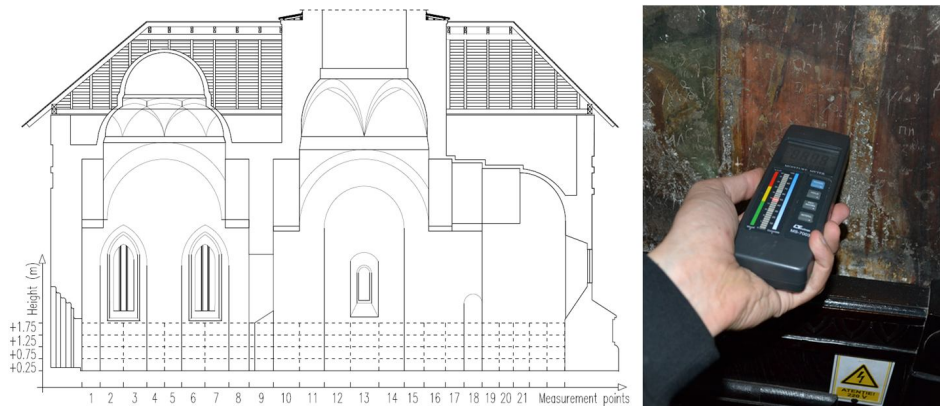
Fig. 2 – The division of the study area with a grid and humidity measurements.

After visual investigation of the walls affected by humidity, as a study area, the interior of the north longitudinal wall was chosen. The examined surface was divided by a grid so that the measurements are carried out in points at approximately equal distances of 1.0 m, at four different heights (+0.25 m, +0.75m, +1.25 m, +1.75 m).

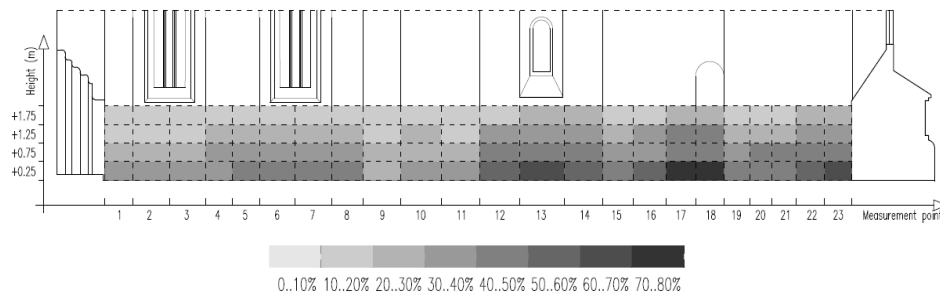
Fig. 3 – Humidity chromatic map at the interior of the northern longitudinal wall.

For an easy visual identification of the humidity level, on the grid initial establish, a cromatic map corresponding with the humidity values is plotted in Fig. 3. Also, the variation of the humidity at the test points, different for each height indicated, where plotted in a graph of the longitudinal moisture profile (Fig. 4).

a) the highest values of moisture at the masonry surface was identified at the altar niche, where the water needed at specific rituals was not carefully drained; the accentuation of the moisture values had been read at all four heights;

e) the maximum values of moisture, of 76.8% were recorded at +0.25 m height near the altar veil.

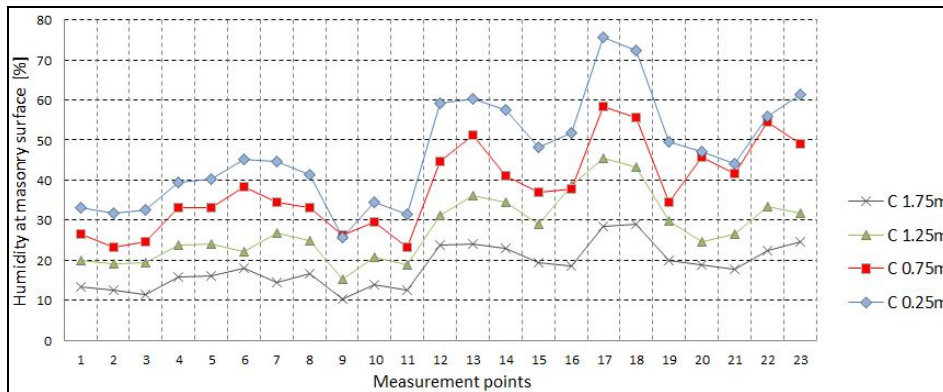
Fig. 4 – Longitudinal moisture profile at four indicated heights.

b) high values were revealed in the walls of the nave and altar apse, which increased with the curvature of the apse, probably due to greater exposure to weathering action;

c) the lowest humidity values have been reported at the intersection with the transversal wall (10.3% at the measuring point 9);

d) in the current areas of the longitudinal walls, the average humidity values were mediated at 39.5% at +0.25 m height decreasing to 17.5% at 1.75 m height;

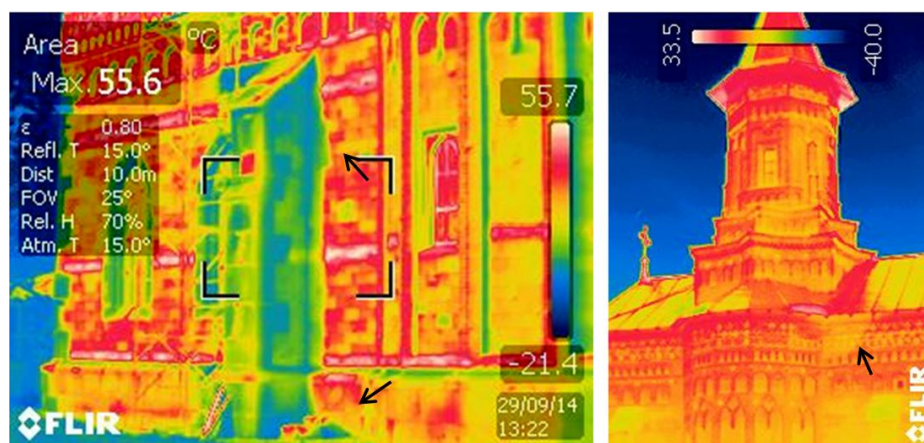
Fig. 5 – Infrared thermography at the north wall of the nave.

Fig. 8. At the intersection between the longitudinal north wall and the nave buttress, the variation of the surface temperature could indicate a vertical crack (Fig. 5).

Areas with damaged masonry were identified at the upper part of the north apse (Fig. 5), at the base of the north altar buttress (Fig. 6) and at the south nave buttress (Fig. 7).

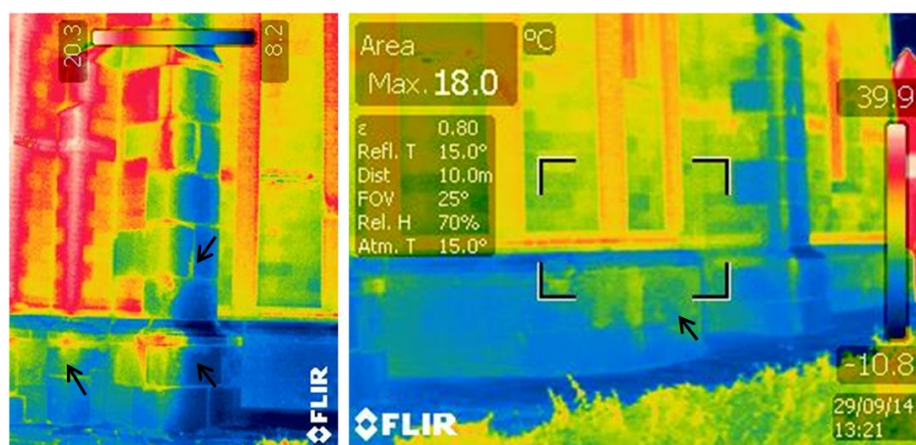
Fig. 6 – Infrared thermography at the base of the longitudinal north wall.

Analyzing the thermographic maps it can be observed that the changing of the colour proportional with the drop of the surface temperature indicates the presence of high humidity in the masonry walls. Areas where this phenomenon is generally visible were identified at the base of the walls (Fig. 7), at the altar niche (Fig. 6) and at the narthex (Fig. 8). This was also confirmed by measurements with a portable hygrometer.

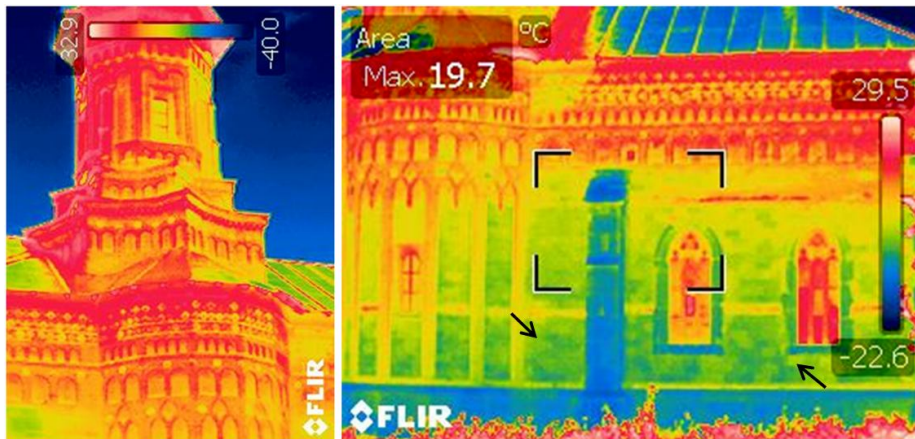
Fig. 8 – Infrared thermography at the tower and north wall.

The capillary rise of water on the height of the walls, until the upper part of the nave windows, can be observed on the thermographic map plotted in

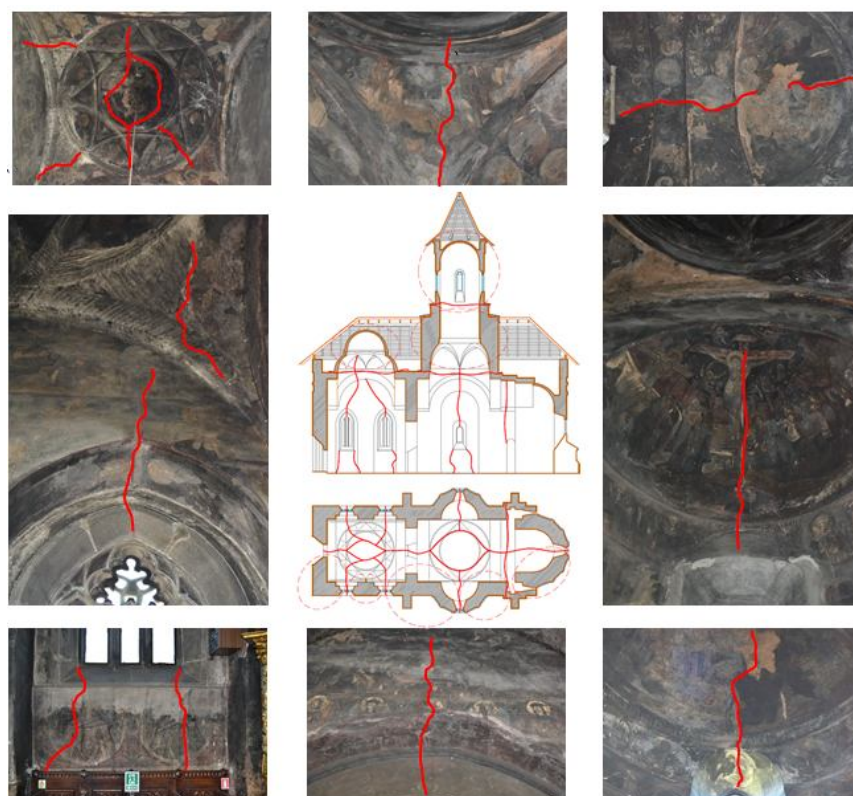
Fig. 9 – Damage mechanism for “Sf. Gheorghe” Church based on in situ investigations (Soveja & Budescu, 2014).

The structure of “Sf. Gheorghe” Church in Hârlău is affected in longitudinal direction by a fracture, which, at the towers level, follows the boundary of their plan. This fracture is accompanied by vertical cracks in the wall between the narthex and nave, in the transversal arcs and in the altar apse (Fig. 9). In transversal direction, from all the windows parapets and arcs, vertical fractures in walls and in the domes pendants have been observed (Soveja & Budescu, 2014).

Two main processes were highlighted: a longitudinal fracture that separates the main body in two symmetrical halves and transversal fractures systematically arranged in vulnerable areas.

These two types of processes, graphically exemplified in Fig. 9, lead to the separation of the church structure into 13 independent quasi-rigid blocks, each being in its own static equilibrium.

The number of the separation blocks reflects the vulnerability of the church structures.

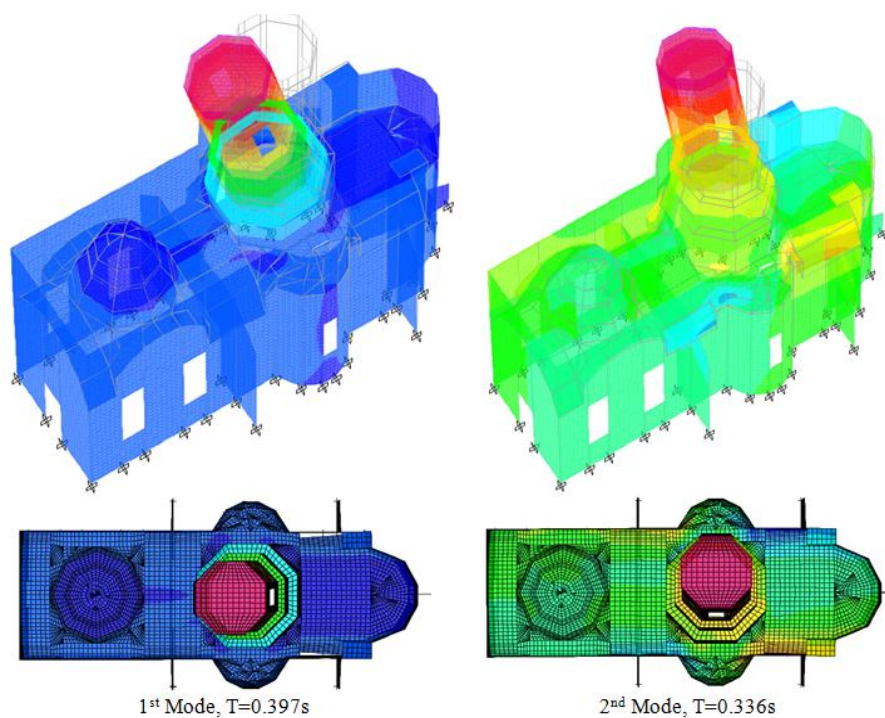
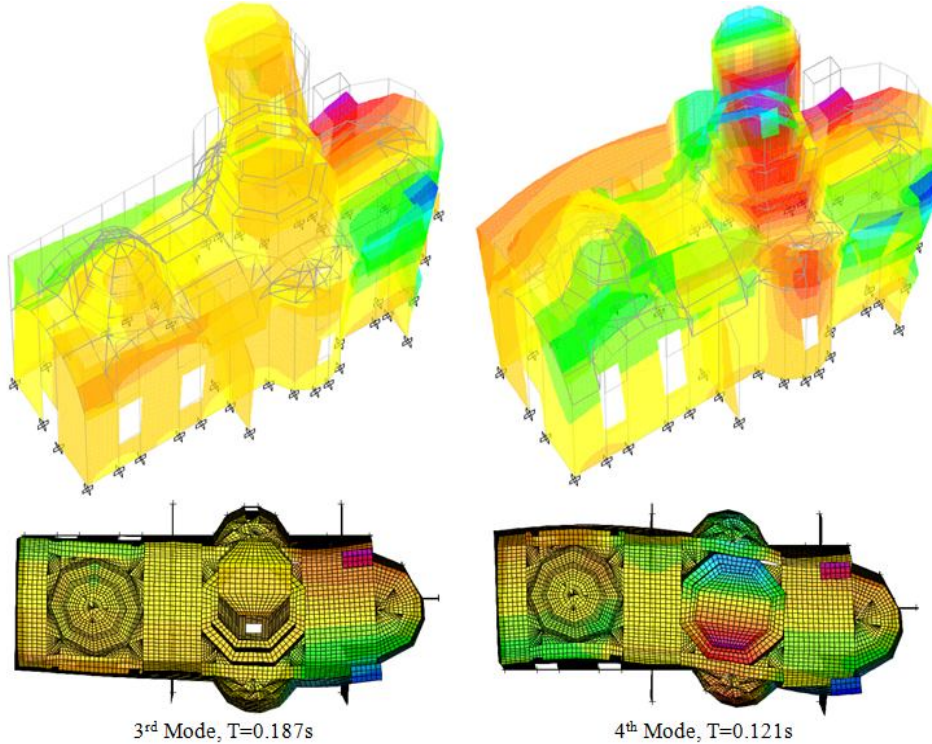
Analysing the structural behavior of the church towers in case of response oscillations during seismic actions (Figs. 11 and 12), it results that this appendix tends to produce distortions of the response parameters due to high dynamic amplifications. Under this circumstances, the church towers are prone to severe damages and even collapse.

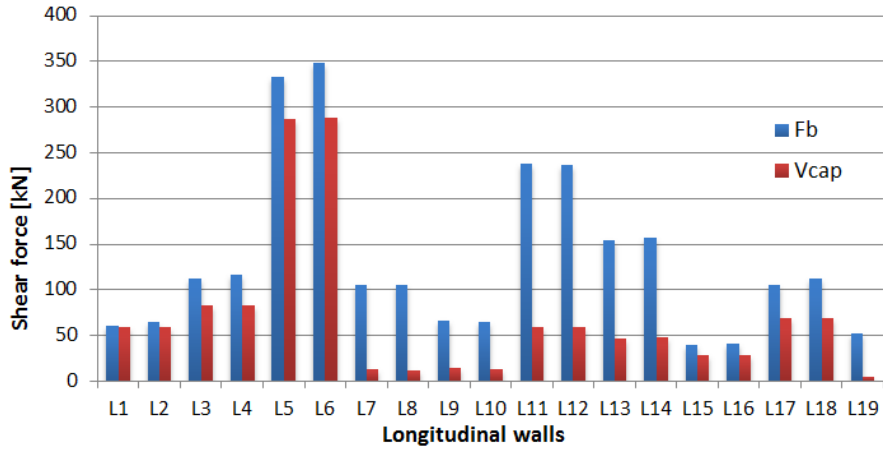
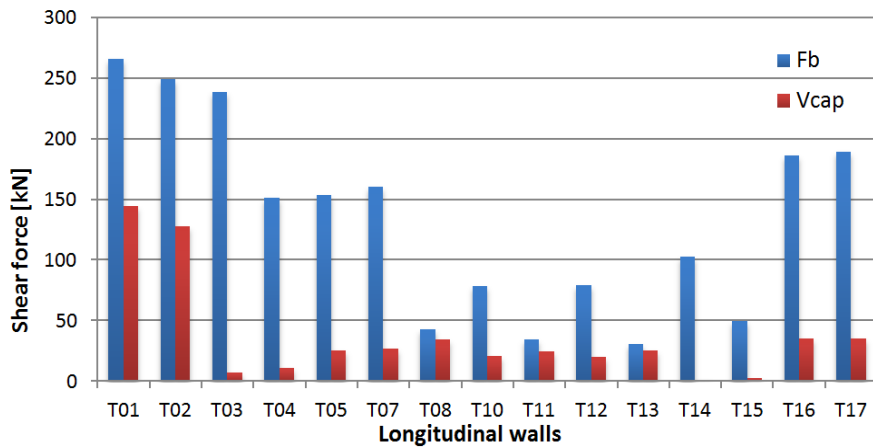
Comparing the shear strength with the shear force demand for each wall due to seismic action, in both longitudinal and transversal direction, it can be observed in Figs.12 and 13 that the most vulnerable points of the structure in case of seismic action are: the longitudinal walls of the nave apses ($L7, \dots, L10$), the transversal walls (with niches) of the altar ($T14, T15$), the narthex butresess ($T3, T4$) and the altar apse walls ($T16, T17$).
