BULETINUL INSTITUTULUI POLITEHNIC DIN IAȘI  
Publicat de  
Universitatea Tehnică „Gheorghe Asachi” din Iași  
Volumul 65 (69), Numărul 1, 2019  
Secția  
CONSTRUCȚII. ARHITECTURĂ

## **SPECIAL MONITORING OF THE SERVICE BEHAVIOUR OF A HERITAGE BUILDING IN ORDER TO REHABILITATE AND URBAN REINTEGRATION**

**DANIEL COVATARIU<sup>1,\*</sup> and VALERIA ENACHE (COSTEA)<sup>2</sup>**

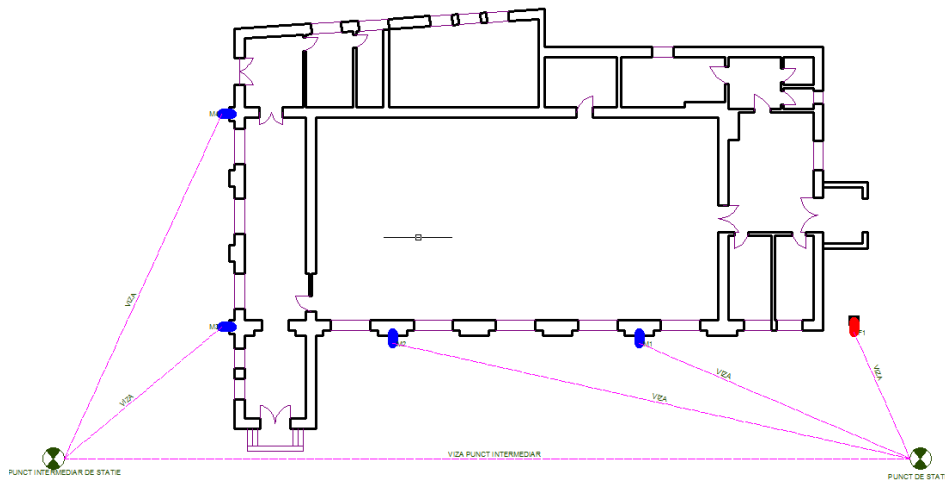
Fig. 7 – Mobile and fixed landmarks placement draft

The M2 landmark, mounted on the same façade, was intended to demonstrate whether the identification of the settlements in the right of the masonry column in which M1 was mounted, are local or general. The M3 and M4 landmarks were mounted on the corners of the western façade, areas prone to settlements (Fig. 7).

Vertical displacements ( $2 \div 9$  mm) of the landmarks on the left side façade – the inner courtyard (M1 and M2), as well as  $7 \div 8$  mm of those on the posterior façade (exposed to car traffic vibrations) M3 and M4, was found.

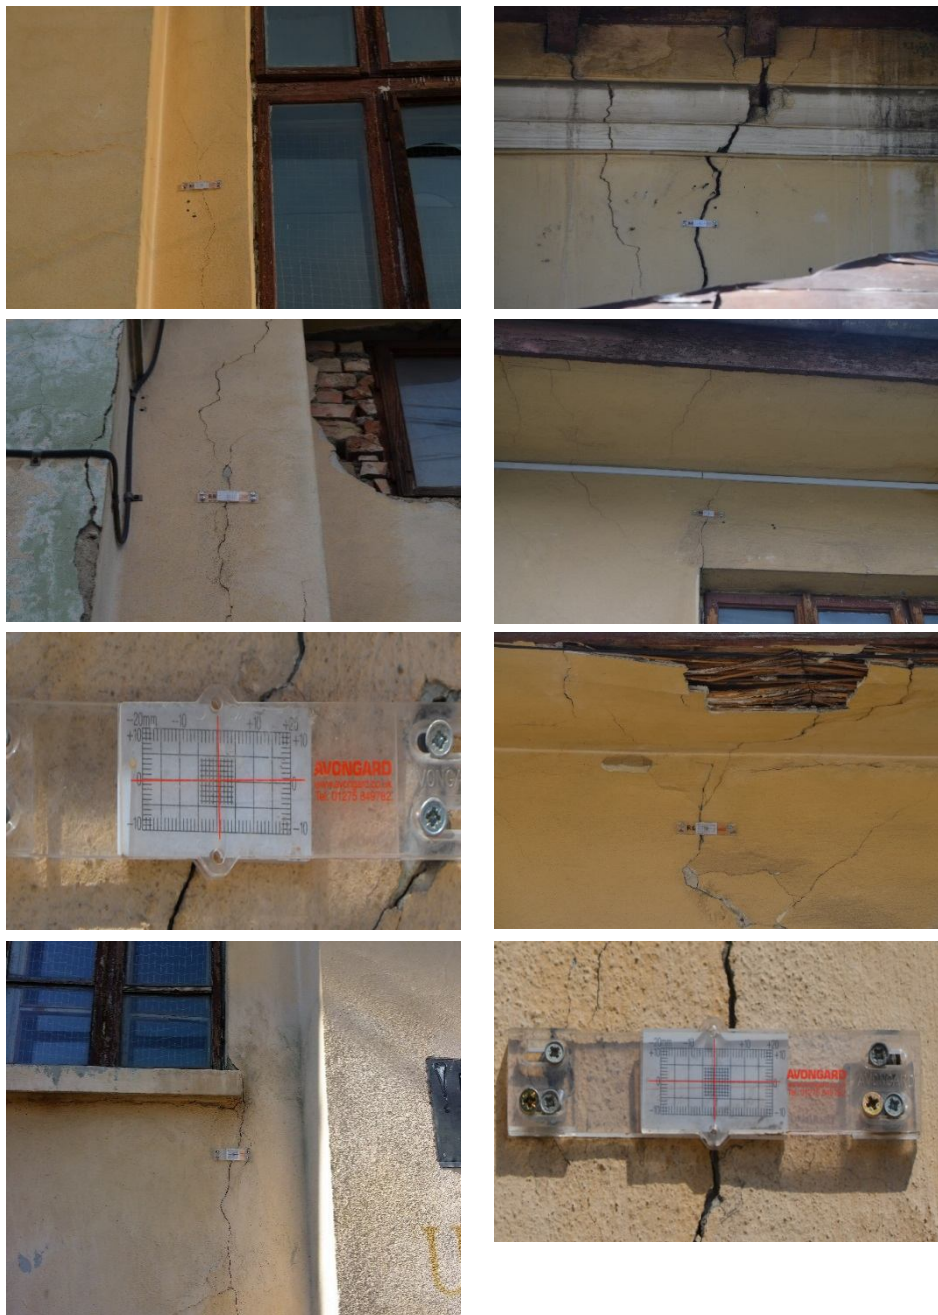
Fig. 9 – Rulers placement to cracks evolution's monitoring.

- On the main façade were mounted two devices (rulers), one on the vertical fissure-inclined from the top of the window gap and a device on the vertical crack that starts from the base of the roof beam;
- On the left side façade, a device was mounted on the vertical fissure in the masonry column adjacent to the window gap;
- On the posterior façade, were mounted to the masonry column adjacent to the window gap and on the crack at the top of the window gap;

By interpretation of the variations recorded by the mounted devices, it can be concluded that the cracks were of an evolutionary nature (from 3 to 11 mm), this being possible due to the advanced state of degradation, the vibration induced on infrastructure and, obviously, onto the walls of the structure due to road traffic from proximity and the decrease in the characteristics of the foundation ground (water infiltrations).

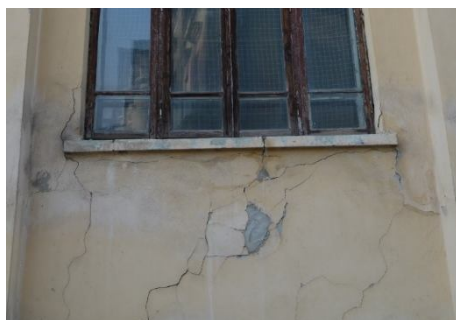
- Vertical, inclined and horizontal fissures and cracks on the masonry walls at all four facades, depending on the bearing capacity due to seismic actions (Fig. 10);
- Cracks around the gaps of doors and windows, due to the fact that these areas are concentrated areas of tension in the building's strength structure (Fig. 11);

Fig. 10 – Inclined cracks on the masonry wall.

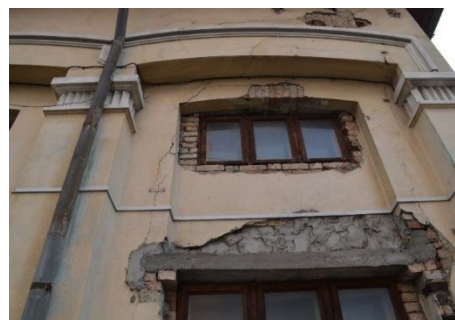
Fig. 11 – Fissures over the lintels (where are present).

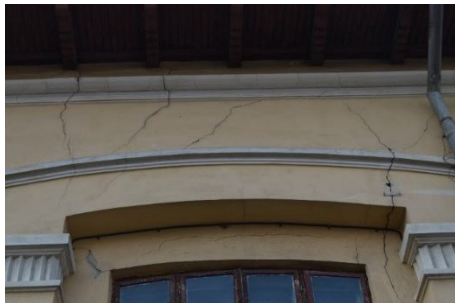
- Vertical cracks in the walls of the building to the openings due to lintels absence (Fig. 12);
- Detachments of exterior plasters (local and extended areas); the lack of thermal insulation determines the formation of dew point at the level of plasters, and in the presence of low temperatures, by increasing the volume of water due to frost, expels plaster (Fig. 13);

Fig. 12 – Vertical cracks in masonry parament.

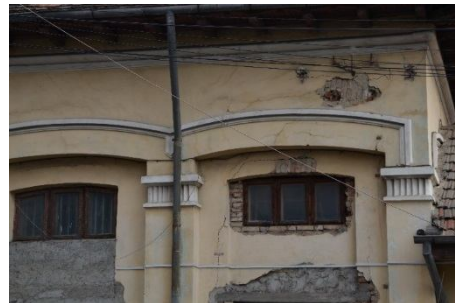
Fig. 13 – Plaster detachments.

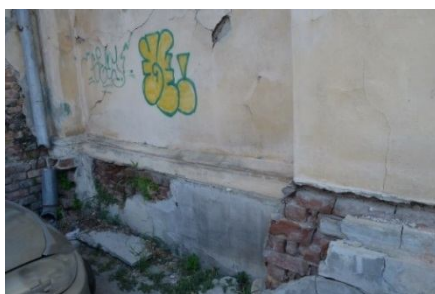
- Detachments of the socle due to wetting by raising the level of groundwater and the penetration of surface water, but also of frost-thaw cycles (Fig. 14); The lack of waterproofing caused the occurrence of the gelivity phenomenon. The upward migration of water led to the expulsion of plaster from the socle and the walls;
- Crushes and breakdowns of the socle bricks due to faulty evacuation of rainwater. Under the self-weight of the brick masonry pillar, the bending phenomenon in the socket is observed (Fig. 15);

Fig. 14 – Detachments of the socle.

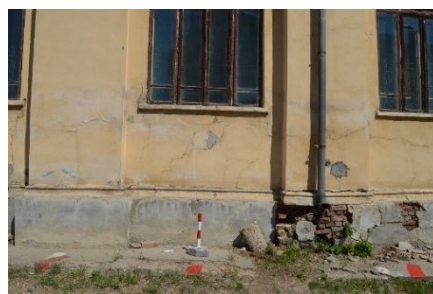
Fig. 15 – Crushes and breakdowns of the socle bricks.

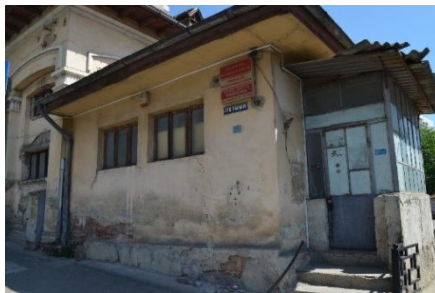
- The annex building (without seismic joints) and in the event of an earthquake the two structures would not independently oscillate, the annex would induce adjacent horizontal forces on the walls of brick masonry (Fig. 16);
- On the western façade, non-compliant attempts can be observed to embed the lintels, which already shows the displacements (probably due to the lack of the reinforcement), and the supporting area is too small (Fig. 17);

Fig. 16 – The annex building (without seismic joints).

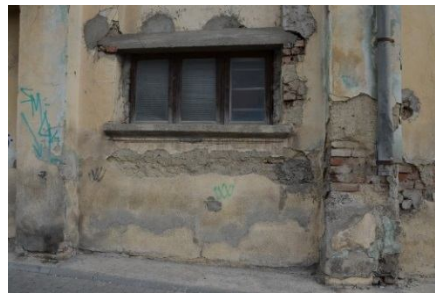
Fig. 17 – Non-compliant attempts to embed the lintels.

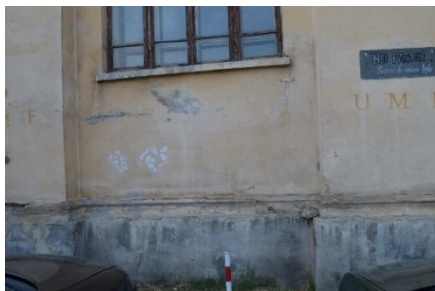
- Infiltrations of water to the socle and cornice due to snow thawing and non-compliant drainage of rainwater (Fig. 20);
- Settlement of the foundation ground, demonstrated by local fractures and failures identified at the façade socle (Fig. 21);

Fig. 20 – Infiltrations of water to the socle.

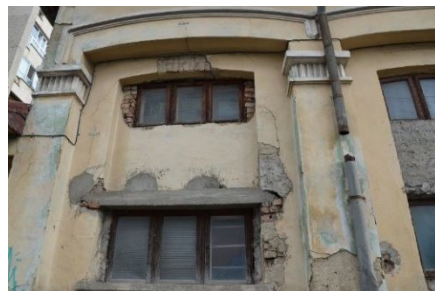
Fig. 21 – Rainwater infiltration.

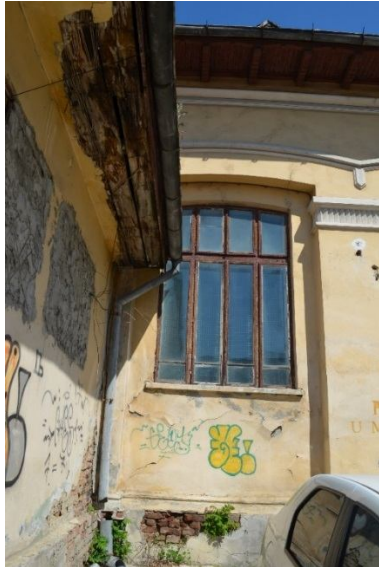
- Water infiltrations at the level of the straw floor (clay-knit reed) due to the degraded roof and gutter (Fig. 18);
- Vertical cracks present inside the building at the level of non-bordered gaps (Fig. 19);

Fig. 18 – Water infiltrations in the straw.

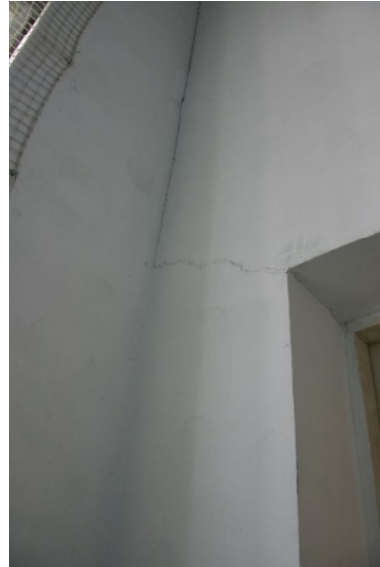
Fig. 19 – Non-bordered gaps.

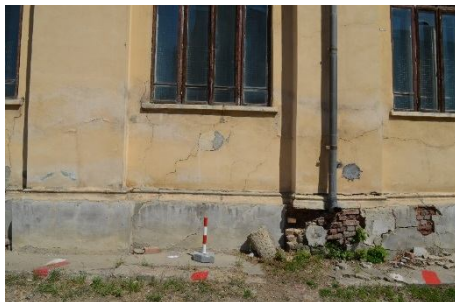
- Settled and non-waterproof sideboards that allow rainwaters to access the infrastructure (Fig. 22);
- Cracks in the walls due to the lack of uneven belts and unequal soil's settlements (Fig. 23);

Fig. 22 – Settled and non-waterproof sideboards.

- Injection of large cracks with cement solution;
- Thermo-insulation and waterproofing at the foundation level;
- Total replacement of the perimeter sidewalk around the building (Protection of the foundation against meteoric water. The newly realized sidewalk will have a length greater than the cornice to ensure the waters removal);

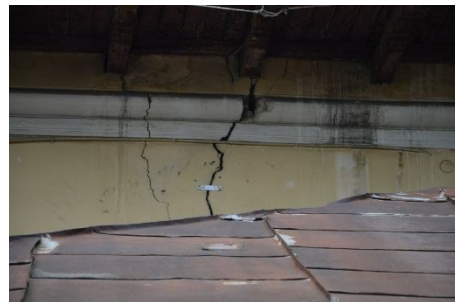
Fig. 23 – Major cracks under the roof.
