## REHABILITATION OF EXISTING STRUCTURES SUBJECTED TO EXTREME EVENTS

CORNELIU BOB, SORIN DAN, CĂTĂLIN BADEA,  
AURELIAN GRUIN and LILIANA IUREŞ

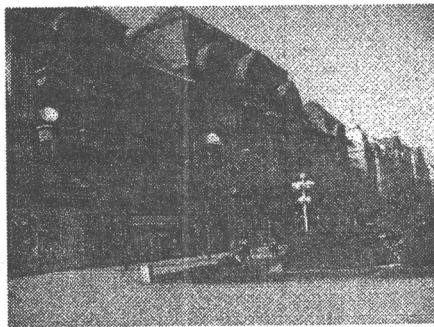
The “Palace” structure (Fig. 1) is a huge building (underground floor, ground floor–restaurant, three storeys-apartments, timber roof), built before 1900’s with a composite structure: masonry and RC framed structure (Fig. 2). Initially it was an entire masonry structure, but later the ground floor was changed: some resistance brick walls were cut and two longitudinal RC frames were erected to sustain all the vertical loads. Due to this architectural operation the structure became more vulnerable at seismic actions: by the transversal direction main part of the ground floor became unstable at horizontal actions because of some erected columns with hinge connection at both ends (masonry wall supports from the underground floor and first storey). Other vulnerabilities of the building consist of: overall lateral stiffness values along the two main axis are different; lack of seismic joints to divide building parts have different dynamic characteristics; lack of straps at each floor.

Fig. 1.– The “Palace” building.

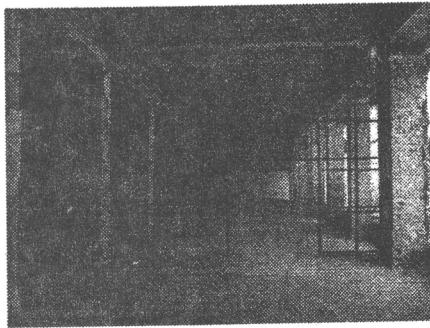
Fig. 2.– Longitudinal RC frames.

The building assessment emphasized some aspects: concrete quality is very variable in structural elements, having different classes (C8/10...C16/20); some cracks in longitudinal beams; corrosion of the slab reinforcement; etc.

From data presented in Table 1 a very important conclusion could be drawn: the ratios,  $R$ , between the actual values of ultimate bending moment ( $M_{cap}$ ) and the necessary bending moment ( $M_{nec}$ ), given by the present-day seismic action level, were very low for columns, *i.e.* 0.27. That meant that the building was characterized by a high risk of collapse at seismic actions. It results the necessity of structural rehabilitation.

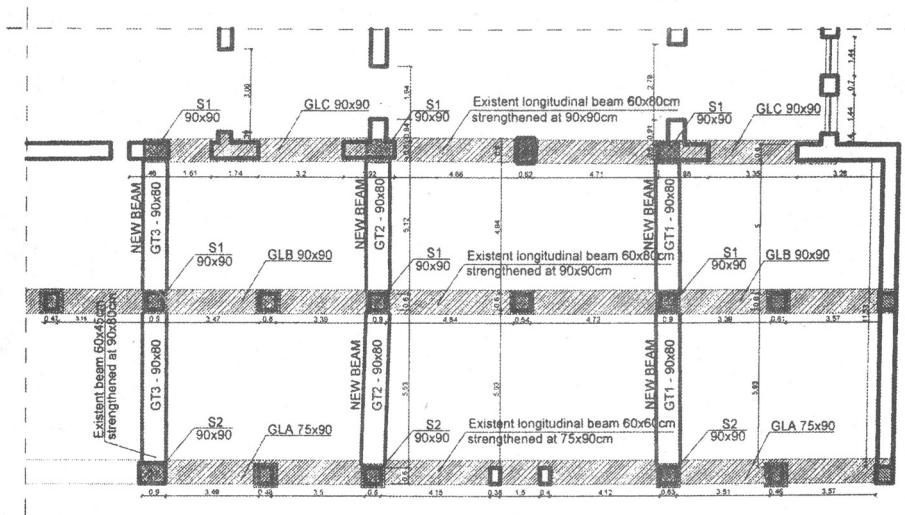
Fig. 4.- Ground floor rehabilitation.

c) strengthening of half from the existing columns (60×60 cm coated by RC to become 90×90 cm – Fig. 3) and erecting of new transversal RC beams in order to create new transversal frames (Fig. 4);

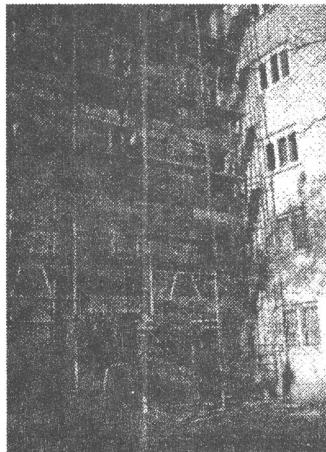
At the beginning of December 2002 an explosion was reported into a block of flats in the town of Timișoara, Romania (Fig. 5).

Fig. 5.- Block of flats.

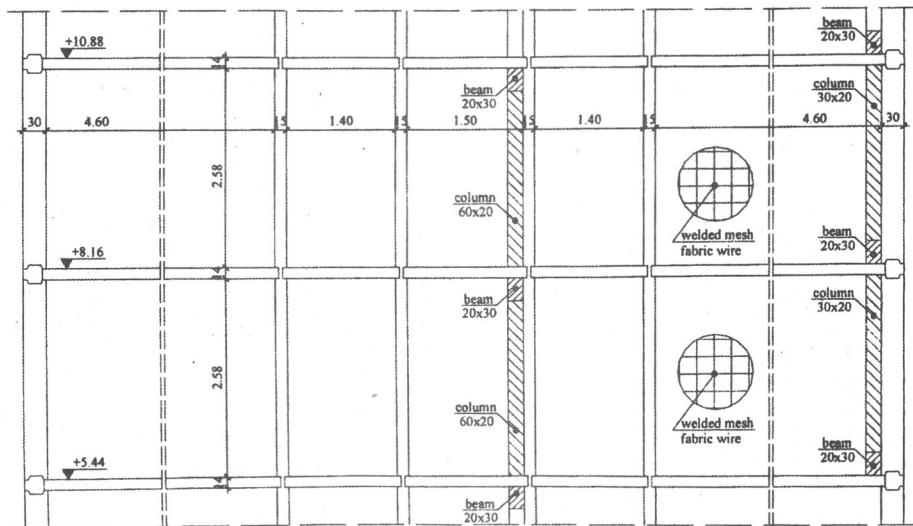
Fig. 7.- RC vertical rehabilitation solutions.

- a) new RC floors, with the same geometry and reinforcement characteristics as for the existing members, at levels 3, 4 and 5, total five elements;
- b) new RC walls at levels 4 and 5 which represent four transversal walls (with the same width as of the corresponding walls with new shirts) and four longitudinal-lateral walls;
- c) local strengthening with RC shirt (5 cm on each side), columns ( $60 \times 20$  cm in the gangway and  $30 \times 20$  cm at façade) and longitudinal beams at all levels ( $20 \times 30$  cm), vertical elements from ground floor to the roof, incorporating the new walls, on the one part of the gangway (Fig. 7);

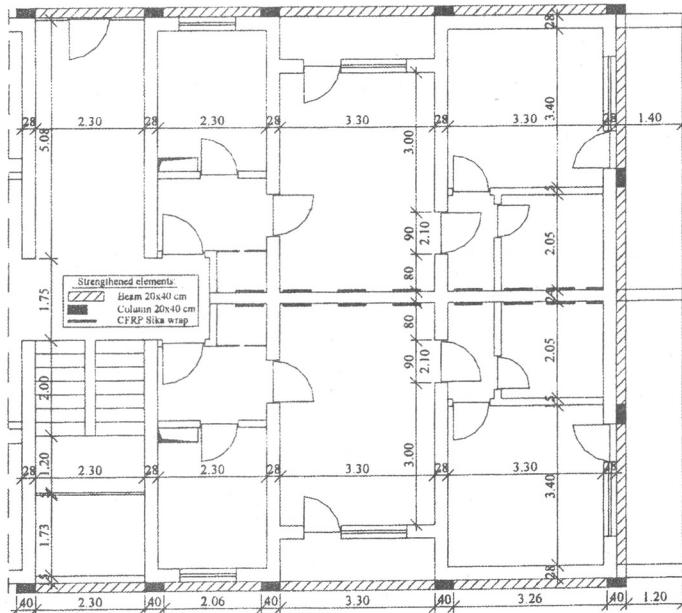
The main damages due to earthquake are: fracture of some precast strips of the floor over the sub-base; important damages of the longitudinal walls at the first floor; a lot of cracks on the longitudinal walls at 2<sup>nd</sup> to 5<sup>th</sup> floors; inclined cracks on the interior longitudinal wall; vertical cracks on the transversal walls near the joint with longitudinal walls; horizontal cracks on the transversal walls, at the first level, under the floor.

Fig. 9.- Vertical rehabilitation solutions for masonry building affected by earthquake.

In accordance to the building damage assessment and structural analysis the strengthening has been made as follows (Fig. 9):

a) general strengthening of the perimeter walls with RC framed structures consisting of columns ( $20 \times 40$  cm) and beams ( $20 \times 40$  cm), which were connected with the existing structure by steel anchors;

- b) new reinforced concrete slab (monolith, 6 cm thickness) over the existing precast strip at the first floor;
- c) rehabilitation of the interior longitudinal wall using CFRP (Sika wrap).
