BULETINUL INSTITUTULUI POLITEHNIC DIN IAȘI Publicat de Universitatea Tehnică "Gheorghe Asachi" din Iași Tomul LIX (LXIII), Fasc. 2, 2013 Secția CONSTRUCȚII. ARHITECTURĂ

## RETROFIT OF STONE MASONRY BUILDINGS IN GREECE I. DAMAGE PATTERNS AND PREVENTIVE RETROFIT/REPAIR MEASURES

## MARIA BOŞTENARU-DAN<sup>1,\*</sup>, GREGORY G. PENELIS<sup>2</sup> and GREGOR BOURLOTOS<sup>3</sup>

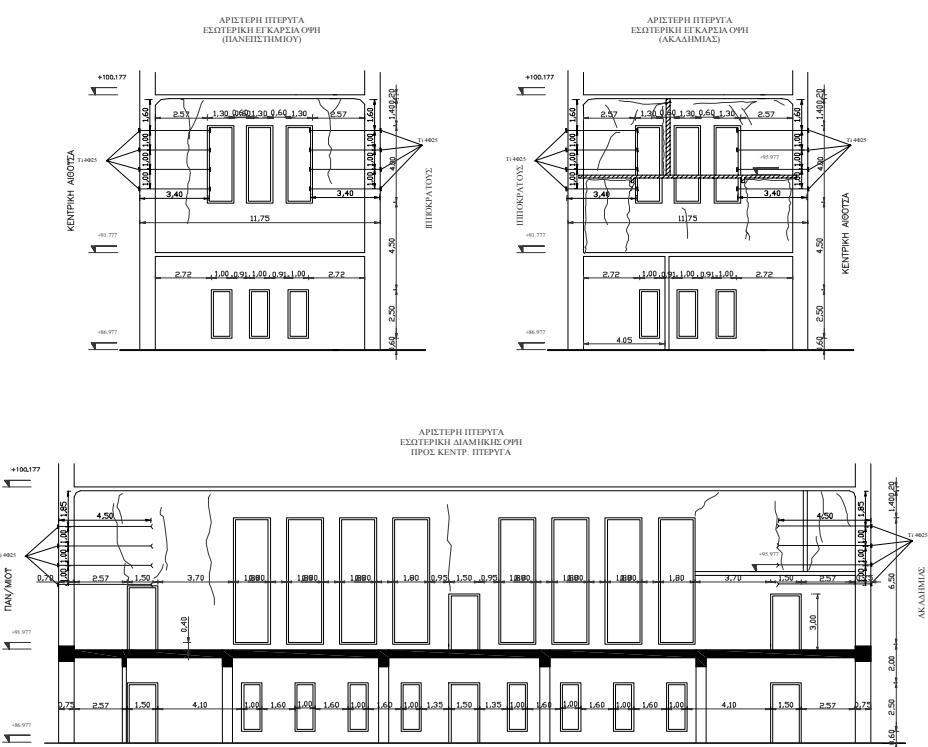
More specifically the two side wings presented inclined cracks at the edges of the transverse walls typical of independent out of plane behavior of these walls due to the lack of diaphragm constraint at the floor and roof levels. Furthermore horizontal cracks were presented at the foot of the piers of the longitudinal walls due to in plane flexure. The spandrels of the longitudinal walls suffered small vertical cracks indicative of tensile stresses. One of the side wings had an additional R/C mezzanine level, which during the 1999 earthquake pounded on the URM back transverse wall and caused significant damages. The main wing had significantly less damages that can mainly be

Fig. 6 - Titanium stitches of corners at the National Library of Greece.

As has been aforementioned the intervention mainly concentrated on the side wings except for type I damages (time dependent) which also existed in the main wing. Furthermore all the intervention has been directed towards being light and reversible. So, in that context, for the two side wings, the structural restoration consisted in the implementation of a perimetrical, internal zone consisting of beams on the roof level, in order to restore the diaphragm constraint, either using concrete with stainless steel as reinforcement or uniformly stainless steel profile in order to avoid future corrosion. Furthermore four titanium stitches per corner per wall were suggested in order to secure the uniform behaviour of the longitudinal and transverse walls (Fig. 6). The cracks on URM were filled with enema with specially selected composition in order to

conform chemically, mechanically and aesthetically with the existing mortar using the sophisticated laboratory tests that had been performed and the existing database at the Reinforced Concrete Lab of AUTH. Finally the mezzanine level was demolished and reconstructed with a composite steel-lightweight concrete structure providing a suitable seismic joint with the surrounding URM walls, to avoid pounding damage in the future.

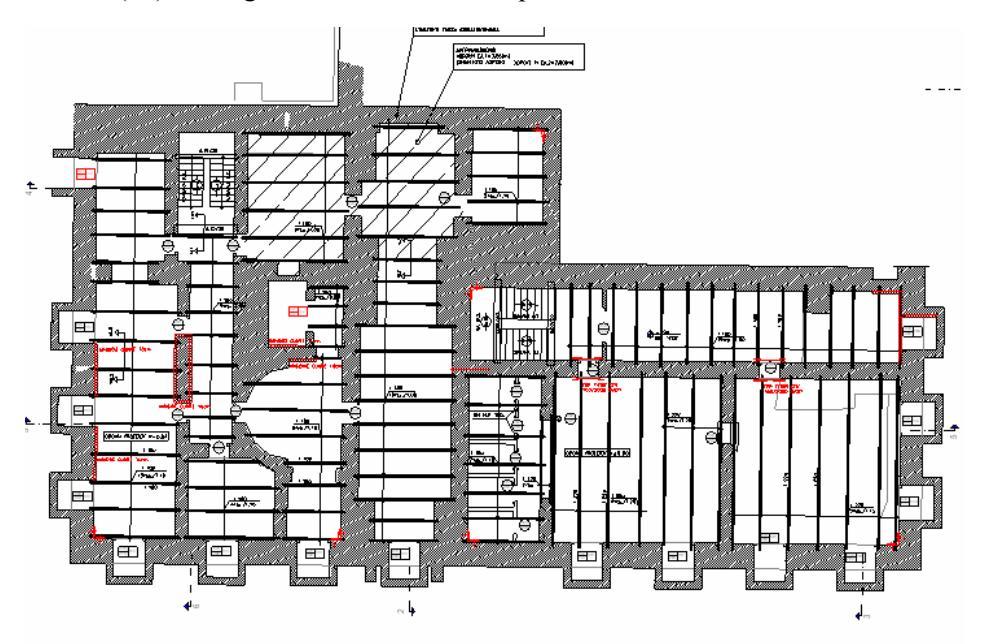
- The building had the following type of damage:
- (I) Time related.
- (II) Damage in the perimeter walls from the balcony cantilever.
- (III) Damage from the 1999 earthquake.

Fig.  $7 - 2^{nd}$  basement interventions, National Theatre of Greece.

performed aiming at the structural and seismic upgrading of the existing preserved part of the theatre. The interventions in general include two-side shotcrete jackets at selected interior piers, one side shotcrete jackets at exterior

piers, strengthening of spandrels – lintels with FRP laminates and stitching of selected corners with inox anchors to reduce the out-of-plane flexure of URM walls. Typical intervention plans are shown in Figs. 7 and 8. It should be noted

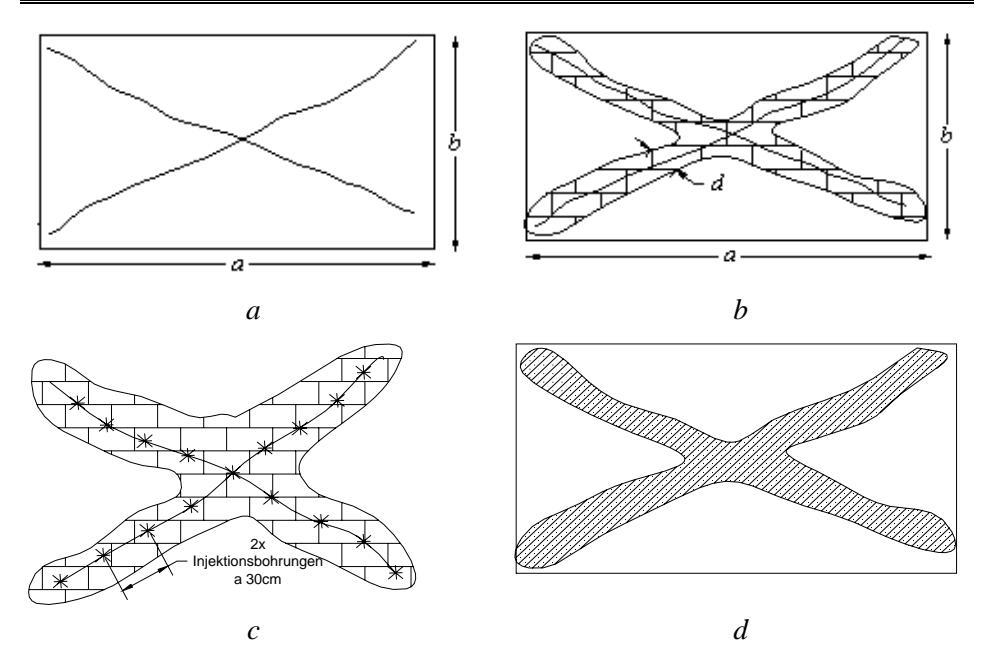
Fig. 9 – Rifts in not load bearing masonry walls. Step (c) is not necessary at small rifts (from Boştenaru & Bourlotos, 2008).

The extensive cracking considered occurs in X shape in the field of masonry walls (Fig. 9 *a*), for example between two openings. There are two kinds of cracks: deep cracks or small rifts. Fig. 9 summarizes the measures. In a first step the plaster is removed (Fig. 9 *b*), the crack is enlarged to several centimeters with hammer and chipper and cleaned with air under pressure, then the rubble rests are removed. If the cracks are large, there is an additional step (Fig. 9 *c*) with injections all 30 cm. The crack and, if necessary, the injections, are filled with cement or reparation mortar and the plaster is re-established (Fig. 9 *d*).

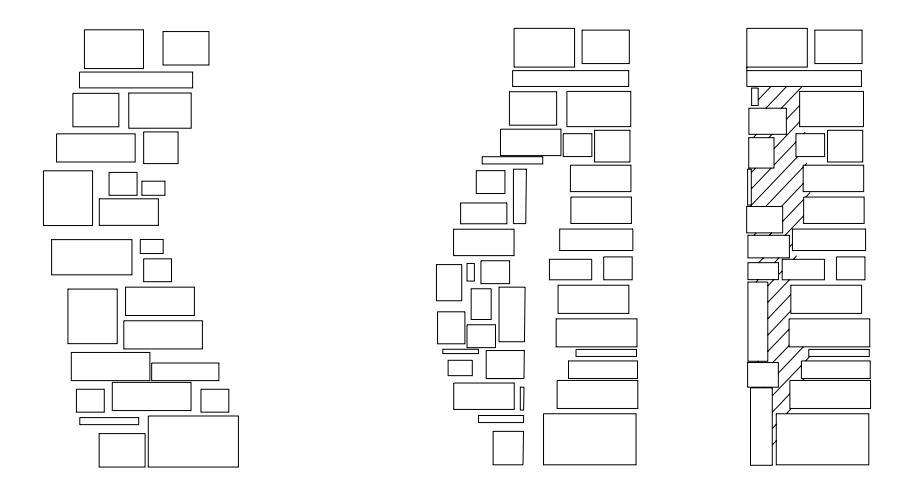
Fig. 10 – Rehabilitation of buckled masonry walls (in the second case one side of the wall acts as framework) (from Boştenaru & Bourlotos, 2008).

Masonry walls can be buckled on one side or on both (Fig. 10). If only one side is affected, the other side acts as framework for filling in with cement and repairing the wall.

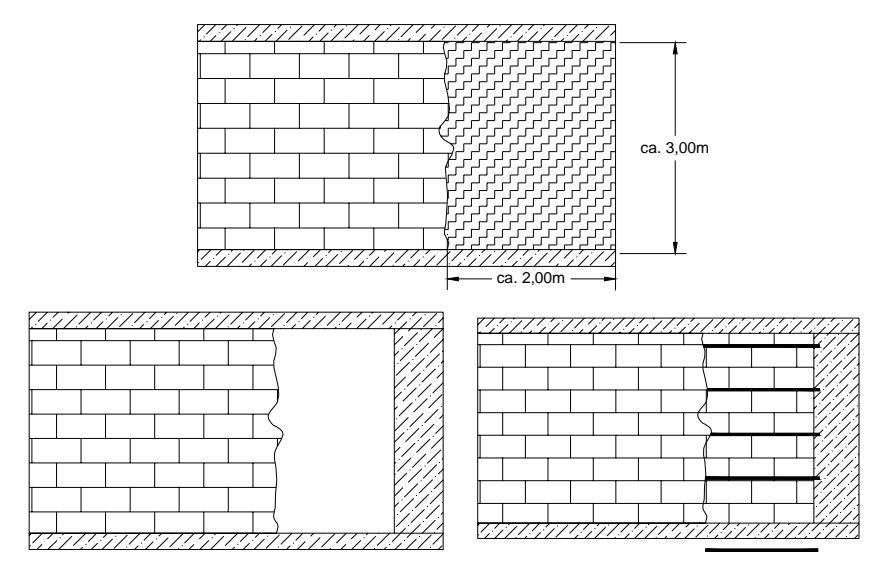
One of the frequent damages of stone masonry buildings in Greece affects corners (collapse of corners, separation of two walls converging at a corner). The first retrofit measure is envisaging the retrofit measures in case of lack of confinement of the corner. Intervention on corners can be also a reparation measure.

Fig. 12 – Confinement of masonry corners with a column (from Boştenaru & Bourlotos, 2008).

As in the previous case the loads from the roof and the floors are caught with a scaffold construction (Fig. 11). It is bolted in two directions on the inner side of the wall. The corner masonry is demolished on a length of ca. 2 m and disposed (Fig. 12 *a*). The corner is reinforced with a column: forming, concreting and stripping of the corner column (Fig. 12 *b*). In the zone of the column reinforced masonry is created (Fig. 12 *c*).

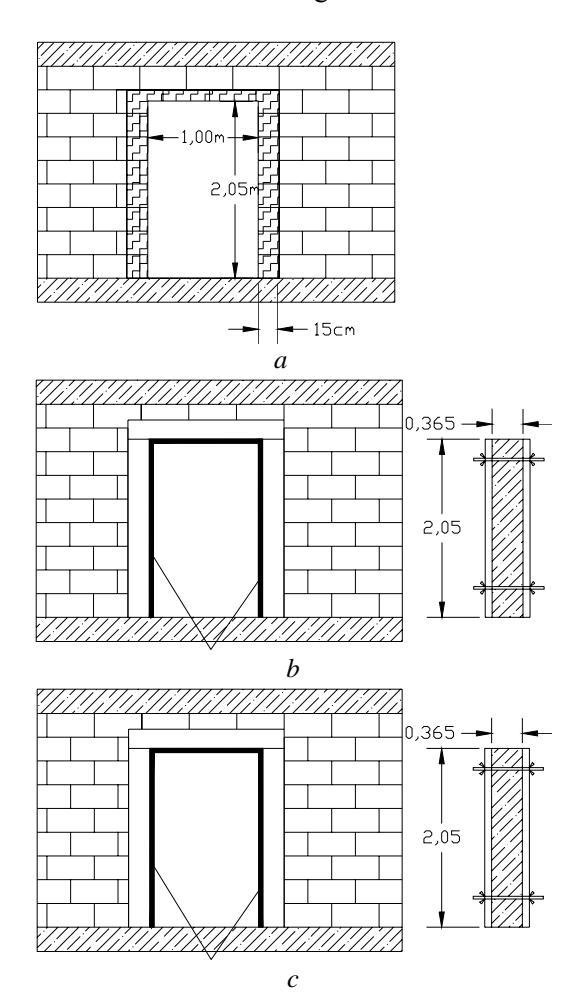
Fig. 13 - Confinement of door frames (from Boştenaru & Bourlotos, 2008).

Sometimes the lintels consist of stone arches, wood or metal joists. These do not always correspond to the sizes and surfaces of the wall openings. This is also a seismic deficiency. The steps in taking the measure are described on the example of a door opening (Fig. 13). First the old door and the door frame are demolished and disposed. If there is a lintel, this is also demolished and disposed. Then the masonry adjacent to the door opening is demolished and disposed on a 15 cm width (Fig. 13 a). The reinforcement of the reinforced concrete frame is anchored in the floor slab. Other reinforcement works are done, then the reinforced concrete door frame: formed, concreted, stripped (Fig. 13 b). Finally the new door is introduced (Fig. 13 c). The confinement of window frames is similar (Fig. 14).
