BULETINUL INSTITUTULUI POLITEHNIC DIN IAȘI Publicat de Universitatea Tehnică "Gheorghe Asachi" din Iași Tomul LXI (LXV), Fasc. 2, 2015 Secția CONSTRUCȚII. ARHITECTURĂ

STRUCTURAL REHABILITATION OF OLD MASONRY CHURCHES. A COST-ORIENTED CASE STUDY

RADU LUPĂȘTEANU, LUCIAN SOVEJA and VLAD LUPĂȘTEANU^{*}

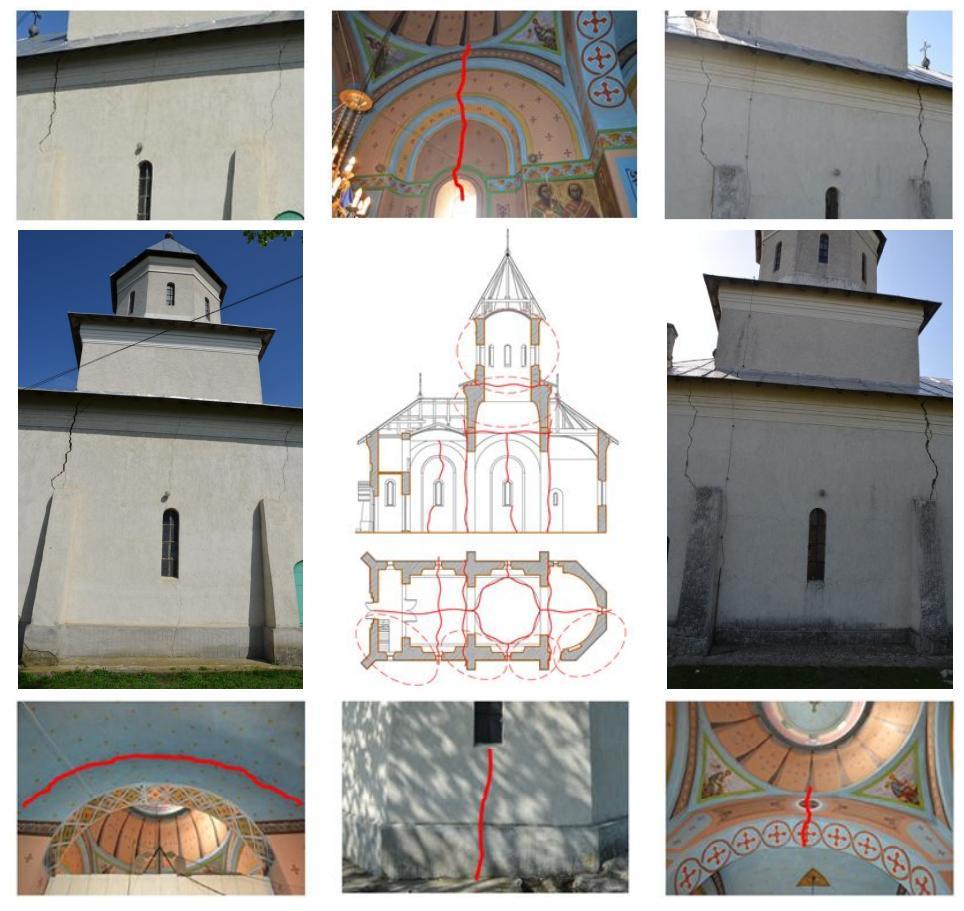
Fig. 4 – Cracks / fissures path and location (Soveja & Budescu, 2014).

The first phase of the qualitative diagnosis of the church structure consisted in direct observation of the damage extent by investigations carried out on site. After a careful evaluation of the cracks pattern and location it has been conclude that, due to consecutive earthquake actions and because of the soil settlements, the structure of the church is divided in distinct quasi-rigid blocks, confirming the damage mechanism proposed by Prof. Al. Cişmigiu. The mechanism, having a three-dimensional distribution is characterized by two main processes (Cişmigiu A., 1996):

The most important damages that were identified during the site investigations were the two pairs of cracks (opened up to 15 mm) in the northern and southern walls, starting at the square base of the tower and, we assume, ending at the foot of the foundations (Fig. 4). The cracks have a vertical direction, on the exterior sides of the buttresses, and were caused due to great variation of the loading state (high concentrations of the vertical loads under the tower) combined with the low tensile strength of the masonry and low bearing capacity of the foundation soil. The cracks are also visible from the inside, their path following the exterior boundary of the transversal arches that carry the tower. Also, other vertical cracks and fissures were identified above and under the embrasures of the windows or doors and in the key stones of the interior arches. After evaluating the damage mechanism, a total of 10 distinct quasirigid blocks have resulted (Fig. 4). The number of the separation blocks illustrates the vulnerability of the church structure.

Taking into account that the seismic risk class of the church is the 1st one, for which structural interventions are mandatory, four rehabilitation solution are proposed. The impact and the complexity of the rehabilitation solutions are increased consecutively, aiming to obtain higher values of the seismic safety factors from one solution to another. The first solution consists in strengthening the existing foundations by an adjacent continuous R.C. beam and of a R.C. girdle executed on the top side of the masonry walls. The second and the third solutions supplements the previous one with vertical R.C. elements executed at the inner side of the masonry walls, that connect the foundation beam to the girdle executed on top of the walls. Also, the high load concentrations in the masonry walls near the transversal arches that carry the tower are eliminated by executing a R.C. frame. The fourth solution introduces R.C. strengthening elements to the tower, consisting in two girdles, at the bottom and at the top side of the masonry, connected with vertical elements. The works implied by all solutions are briefly presented in Table 6 and Fig. 8.

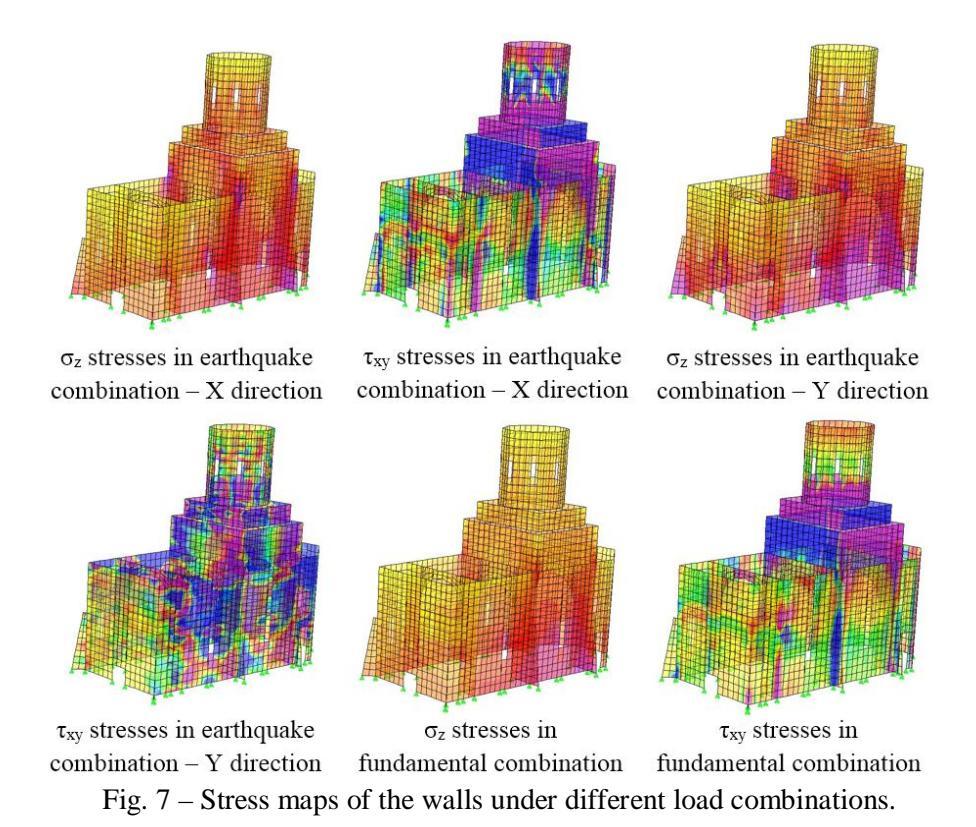
The structural walls have been modeled as shell elements and the loads in each of the latter are calculated by integrating the stresses obtained by means of linear elastic analysis. Fig. 7 presents the stress maps of the masonry walls under different loads combinations.
