BULETINUL INSTITUTULUI POLITEHNIC DIN IAȘI

Tomul LV (LIX), Fasc. 1, 2009

## SEISMIC BEHAVIOUR OF AN EXPERIMENTAL MODEL MADE OF THIN-WALLED COLD FORMED STEEL PROFILES – HARDELL STRUCTURES

IONUȚ-OVIDIU TOMA, M. BUDESCU and GH. ALBU

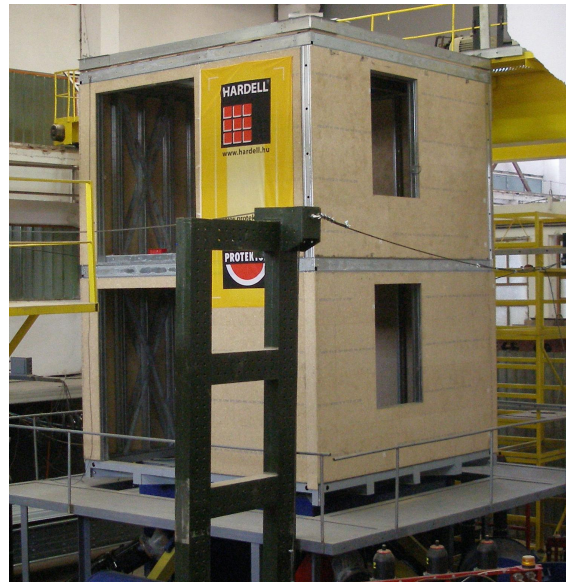
**Fig. 1.** – Hardell structure on the shaking table.

The present paper presents the experimental results of a shaking table test of a Hardell type of structure made of thin-walled cold formed steel profiles, (Fig. 1). The structure has the in-plane dimensions of  $4 \times 4$  metres and the height of 6 metres, being of the type P+1E.

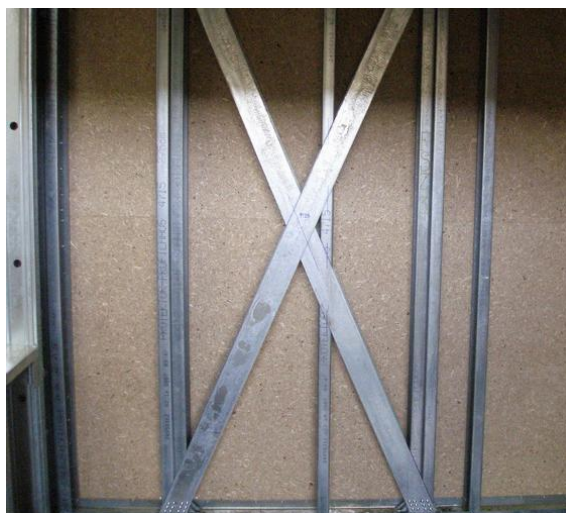
**Fig. 2.** – CW 147/52/1.5 and MP 275 profiles used for wall and floor frames.

The structure is made out of CW 147/52/1.5 steel profiles (channel shape profile with the height of 147 mm, the width of 53 mm and the thickness of 1.5 mm) both for the vertical elements of the wall frame and for the beams in the floors, (Fig. 2). The steel profiles located on the rim of both the wall frame and the floor frame, (Fig. 3), are of the type UW 150/40/1.5 (channel shape profile with the height of 150 mm, the width of 40 mm and the thickness of 1.5 mm). MP 275 steel elements were used for the braces, (Fig. 2). The claddings consisted of wood panels.

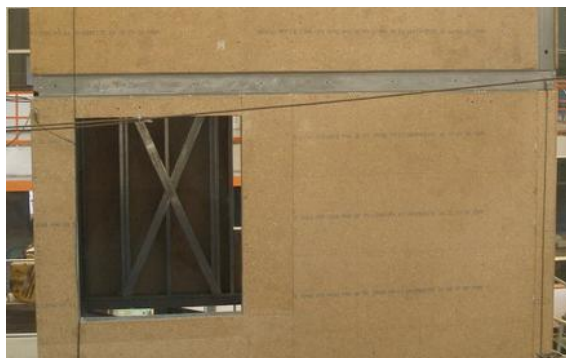
**Fig. 3.** – UW 150/40/1.5 profiles for the rims of the wall and floor frames.

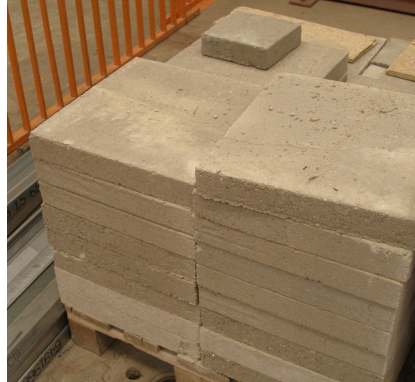
**Fig. 4.** – Additional weights for loading the structure.

In order to ensure a gravitational load corresponding to the live load of a real structure, the model was equipped with additional weights up to  $1 \text{ kN/m}^2$ , (Fig. 4).

The weights were uniformly distributed on the first and second floor, respectively.

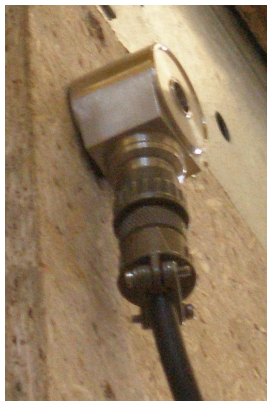
**Fig. 5.** – Dytran 3202A1 accelerometer.

The acquisition of the primary data (the data that controls the shaking parameters of the table) and the data that describes the seismic behaviour of the tested specimen is performed by a digital acquisition system. The Hardell structure was equipped with Dytran 3202A1 LIVM high accuracy accelerometers (which can record data in the range of  $\pm 10g$ , Fig. 5) and PT5AV displacement transducers able to measure displacements up to  $\pm 0.5$  m, (Fig. 6).

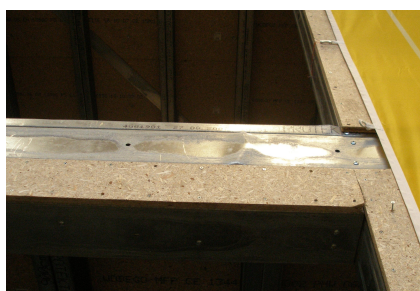
**Fig. 13.** – Local buckling of the frame girder at the level of the first floor.

During the visual inspection of the structure at the end of the seismic tests, there could be observed several areas where the damage was located. Most of the damages consisted of local buckling such as the main frame girder at the level of the first floor, (Fig. 13), the vertical steel profiles located at the corners of the structure, (Fig. 14) and at the left lower part of the door frame, (Fig. 15). More severe damage was observed at the interface between the structure and the shaking table: ruptured bolts and cracked corner steel pieces, (Fig. 16).

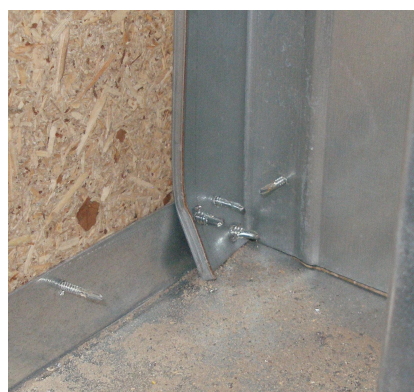
**Fig. 14.** – Deformation of the vertical steel profile at the corner of the structure.

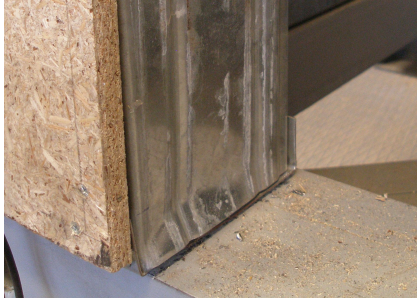
**Fig. 15.** – Local deformation of the lower left steel profile of the door frame.

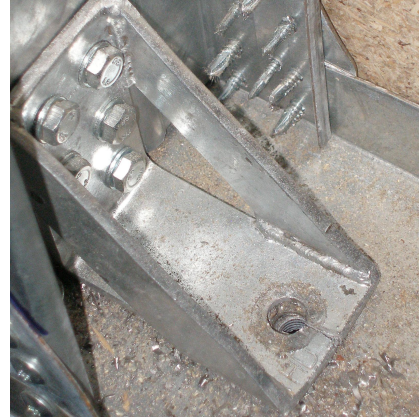
**Fig. 16.** – Breaking of the anchorage bolt and of the corner steel piece.
