BULETINUL INSTITUTULUI POLITEHNIC DIN IAŞI
Publicat de
Universitatea Tehnică „Gheorghe Asachi” din Iaşi
Tomul LVI (LX), Fasc. 1, 2010
Sectia
CONSTRUCȚII. ARHITECTURĂ

THE PRESERVATION OF ADOBE BUILDINGS

DAN BABOR and DIANA PLIAN

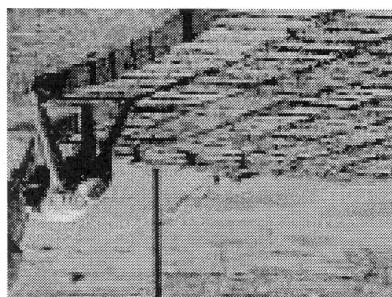
Fig. 1 – Sun-dried brick molding.
in a kiln as are clay bricks, they do not permanently harden, but remain unstable

Traditional adobe construction techniques in Romania have not varied widely for over 3 1/2 centuries (Fig. 2). Adobe building methods employed in the 16th century are still used today (Fig 1). Because adobe bricks are not fired

A mixture of mud and straw is pressed into a mold to form an adobe brick. After the adobe brick is removed from the mold, it must dry in the open air for a month or more before it can be used.

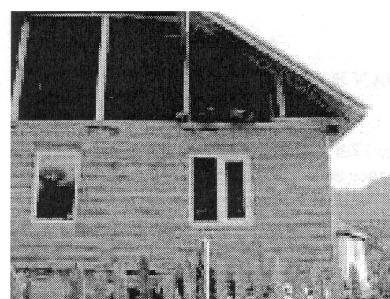
Fig. 2 – Adobe house.

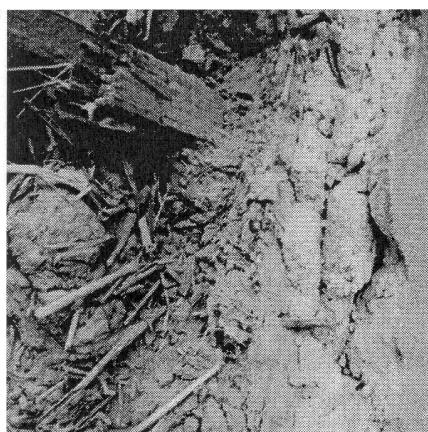
Fig. 3 – Adobe cond with wood.

Adobe will not permanently bond with metal, wood, or stone because it exhibits much greater movement than these other materials, either separating, cracking, or twisting where they interface (Fig. 3). Yet, many of these more stable building materials such as fired brick, wood, and lime and cement mortars are nonetheless used in adobe construction.

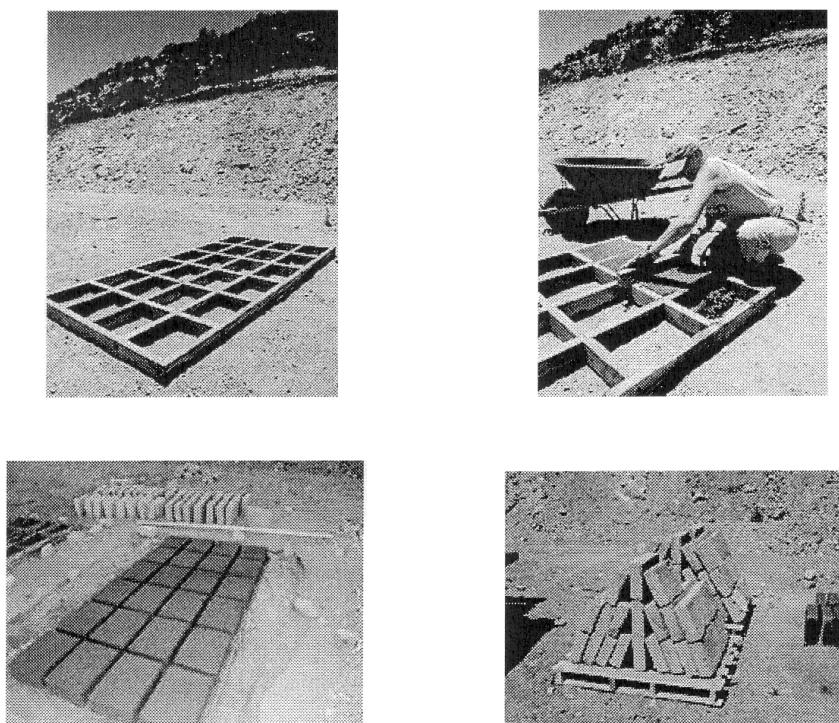
Fig. 4 – Adobe cycle.

dry. More important for durability, however, is the inherent clay-to-sand ratio found in native soil. The prepared mud is placed in wooden forms, tamped, and leveled by hand. The bricks are then "turned-out" of the mold to dry on a level surface covered with straw or grass so that the bricks will not stick. After several days of drying, the adobe bricks are ready for air-curing. This consists of standing the bricks on end for a period of four weeks or longer (Fig. 4).

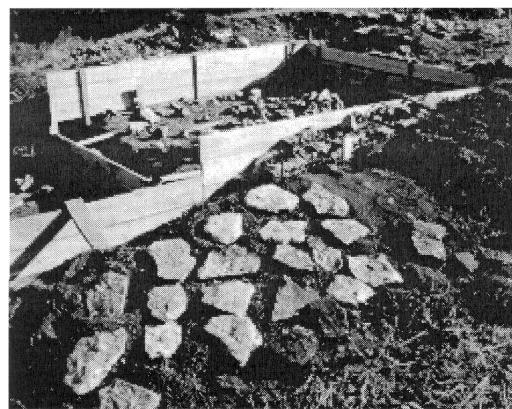
Fig. 5 – Stone foundation.

Early adobe building foundations varied because of the difference in local building practices and availability of materials. Many foundations were large and substantially constructed, but others were almost nonexistent. Most often, adobe building foundations were constructed of bricks, fieldstones (Fig. 5), or cavity walls (double) filled with rubble stone, tile fragments, or seashells. Adobe buildings were rarely constructed over basements or crawlspaces.

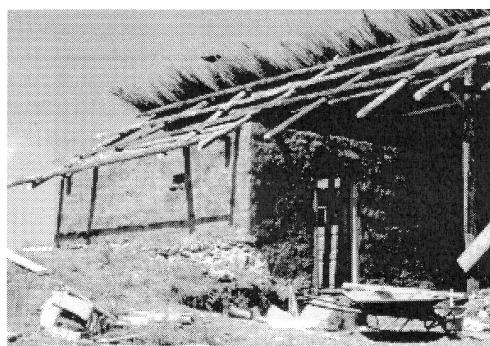
Fig. 6 – Adobe walls.

Since adobe construction was load-bearing with low structural strength, adobe walls tended to be massive. In some parts of the Romania, it was common to place a long wooden timber within the last courses of adobe bricks. This timber provided a long horizontal bearing plate for the roof thereby distributing the weight of the roof along the wall (Fig. 6).

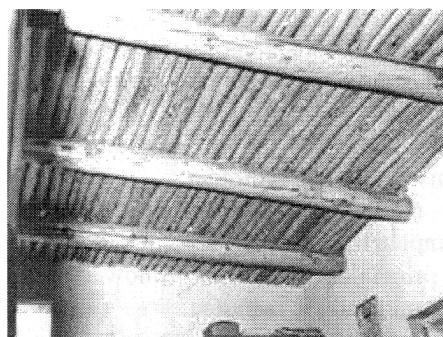
Fig. 7 – The wooden materials that comprise the traditional flat adobe roof create interesting and pleasing patterns on the ceilings of interior rooms.

Adobe roofs tended to be flat with low parapet walls. These roofs consisted of logs which supported wooden poles (Fig. 7), and which in turn supported wooden lathing or layers of twigs covered with packed adobe earth. The wood was fir, oak, lime, elm, or whatever was available.

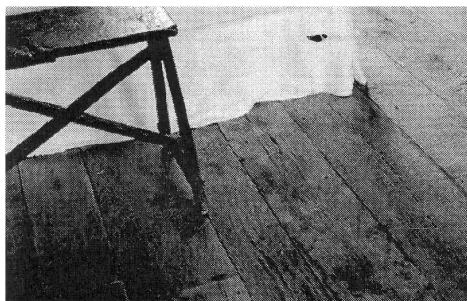
Fig. 8 – Ancient oak wood floor.

Historically, flooring materials were placed directly on the ground with little or no subflooring preparation. Flooring materials in adobe buildings have varied from earth to adobe brick, fired brick, tile, or flagstone, to conventional wooden floors (Fig. 8).

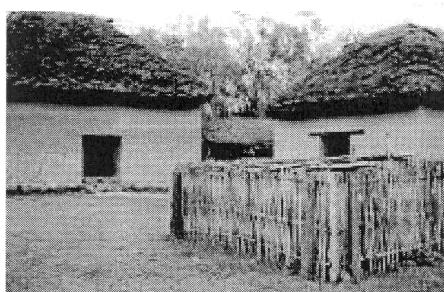
Fig. 9 – A traditional mixture of mud and straw plaster should be applied to stabilize the exterior of this house.

Once the adobe deterioration and any resulting structural damage is repaired, the restoration of the adobe building can proceed. Careful attention should be given to replace, repair, and/or reproduce all damaged materials with traditional or original materials (Fig. 9).

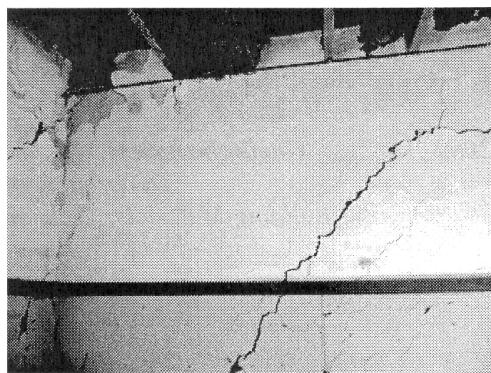
Fig. 10 – Adobe wall cracks.

In repairing adobe cracks (Fig. 10), a procedure similar to repointing masonry joints may be used. It is necessary to rake out the cracks to a depth of 2 or 3 times the width of a mortar joint to obtain a good "key" (mechanical bond) of the mortar to the adobe bricks. The bricks should be sprayed lightly with water to increase the cohesive bond. A trowel or a large grout gun with new adobe mud mortar may then be used to fill the cracks.
