BULETINUL INSTITUTULUI POLITEHNIC DIN IAȘI
Publicat de
Universitatea Tehnică „Gheorghe Asachi” din Iași
Tomul LIV (LVIII), Fasc. 3, 2011
Secția
CONSTRUCȚII. ARHITECTURĂ

THE BRIDGES OF IAȘI AESTHETIC ASPECTS

ANDREI JANTEA*

Abstract. This paper highlights some aesthetic aspects of bridges from Iasi, with the presentation of technical data and photos.

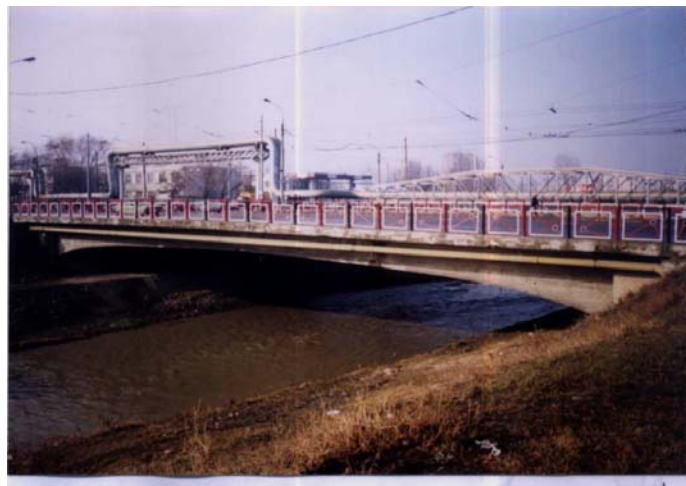
Fig. 1

Tudor Vladimirescu Bridge of Tudor Vladimirescu Avenue, provides the link between the headquarters and the industrial area (Fig. 1).

Tudor Vladimirescu Bridge was built between 1964 and 1965. The superstructure is made of frames with columns in the "V" system (Morandi) cast prestressed concrete monolith, with a length of 46 m and the normal direction to cross the river Bahlui.

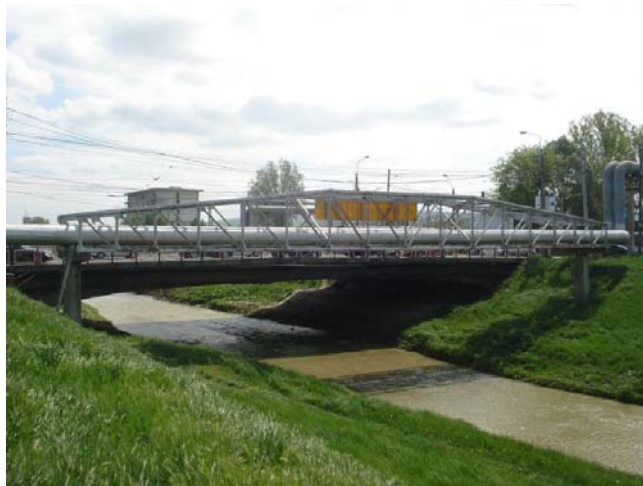
Fig. 2

From an aesthetic point of view, this bridge can not be rendered valuable sufficiently due to adjacent buildings. Upstream and downstream, the river is crossed by two pipes for utilities, supported by lattice beams, and they obstruct the bridge as shown in Fig. 2. Fig. 3 shows the closeness between the upstream construction and bridge.

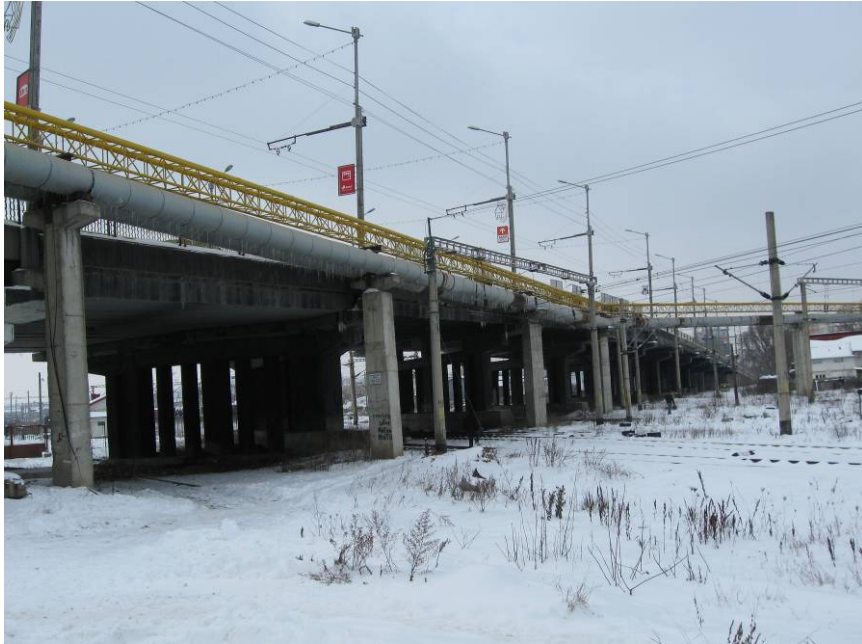
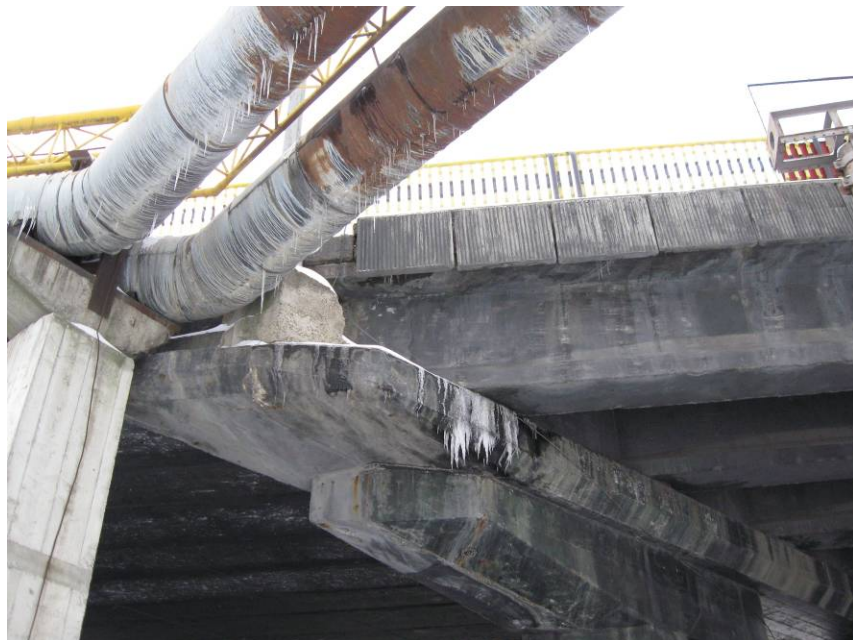
There are many such situations aesthetically undesirable. Another example is the overpass Socola (Figs. 4 and 5), over the railway Iași – Ungheni, Socola Station area. This passage was built in 1958 and was rehabilitated in 1985. The superstructure is made of 11 openings of beams (strips) with prestressed concrete, and an opening of prestressed concrete beams, simply supported.

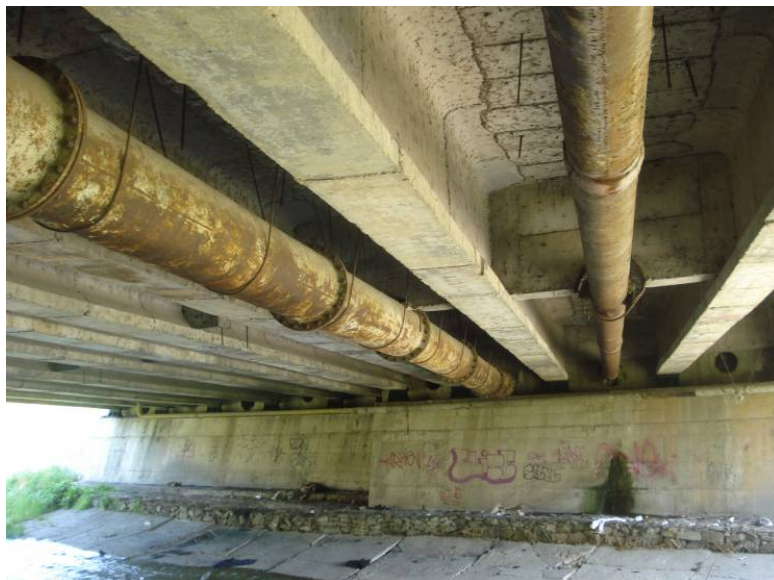
Fig. 6

Hiding such a pipeline between bridge beams represents sometimes the used solution (Fig. 6); pipelines pass through spaces in abutment, under the bridge design (Fig. 7). In contrast, interventions for pipe failure are probably much more difficult. Thus, there are quite complicated situations, but for which solutions must be found. A relatively simple solution is to avoid locating other structures near the bridges, so they do not obstruct them. These distances could be determined through studies and surveying calculations.

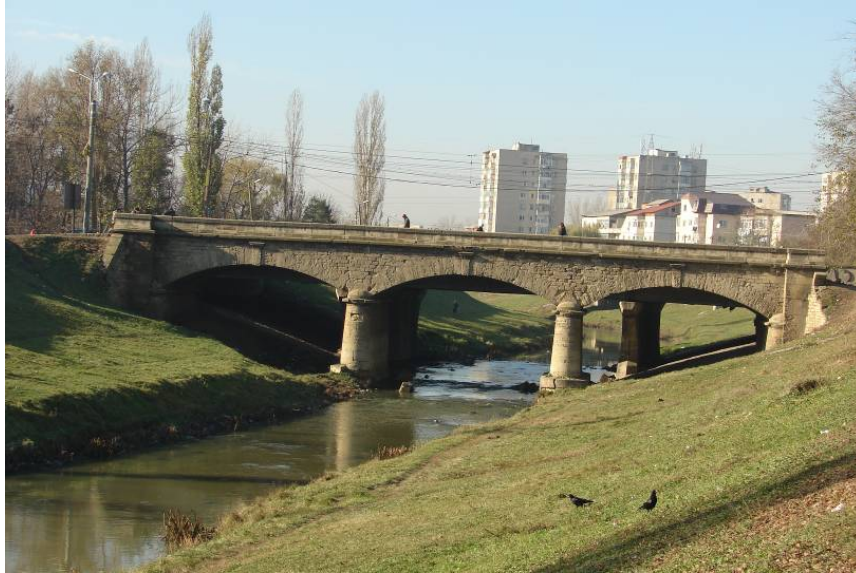
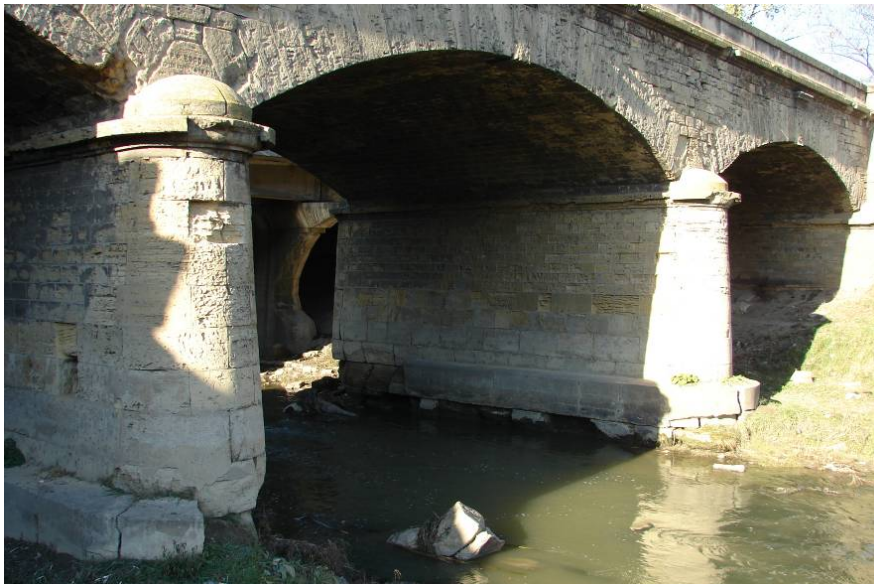
A similar situation occurs sometimes between the close bridges. This happens frequently when a bridge with historical and aesthetic value can not be used in the same request and another is made next to it, for the continued along the road route. An exemple is the “The Stone Bridge” (Figs. 8 and 9), built between 1836 and 1838, and which can be used only as a pedestrian bridge.

The superstructure was made of double arches built of stone with openings of 3×11 , 50 m. The infrastructure is composed of stone masonry elevations and direct stone masonry foundations.

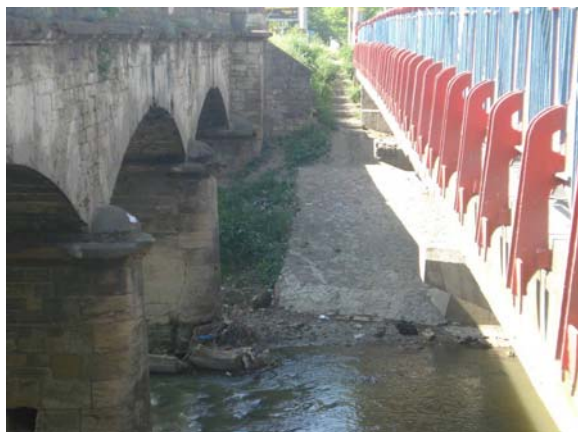
Fig. 10

Parallel to this road has made a new bridge but this one obstructs the upstream side of the old bridge (Fig. 10). Avoiding this would have been very difficult, meaning actually rerouting the road. It is noted, however, that should be avoided wherever possible these situations, even incurring great investment.

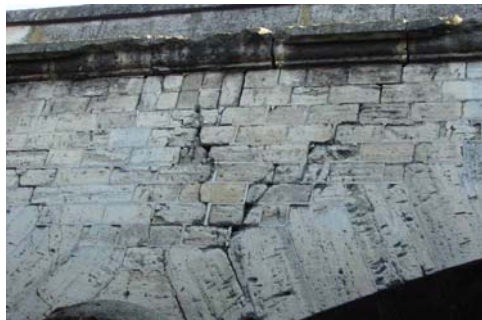
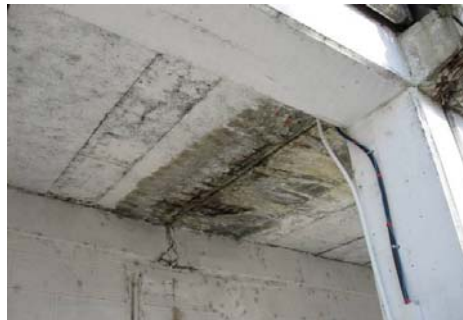
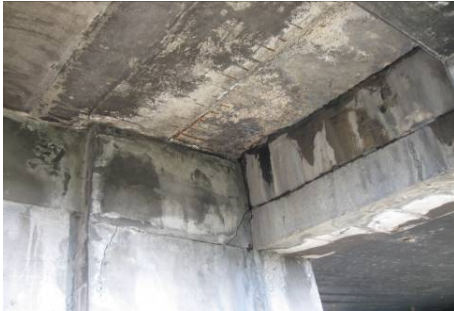
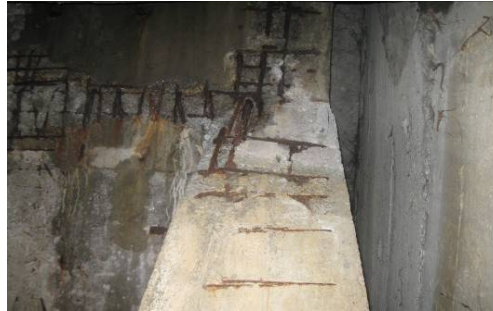
At all bridges and passages presented above may find the following main defects and degradation (Figs. 11,...,14):

- a) segregation, cracking, corrosion;
- b) discovered corroded steel reinforcement;
- c) dirty, smoky concrete surfaces, black spots, etc.
- d) surface alteration by the appearance of stone blocks cracks and crevices;

- a) to avoid spatial agglomeration of constructions so as not to cause obstruction of mutual visibility;
- b) a proper maintenance of the technical condition of bridges;
- c) a good management by adopting policies that would take precedence as far as possible the appearance of bridges, before the economic benefits.
