BULETINUL INSTITUTULUI POLITEHNIC DIN IAȘI
Publicat de
Universitatea Tehnică „Gheorghe Asachi” din Iași
Tomul LIV (LVIII), Fasc. 4, 2011
Secția
CONSTRUCȚII. ARHITECTURĂ

OLD MASONRIES' REHABILITATION. DAMAGED AND COATED STRUCTURES MADE WITH WEAK MORTARS

Abstract. The present paper realizes a synthesis of some experimental data regarding the vertical load behavior of wall elements made of pressed bricks and weak mortars (lime-sand, clay-sand and clay) tested for a damage degree at plastic limit and after retrofitting with different reinforced coating solutions (polymeris grids, welded soft steel nets having small grids).

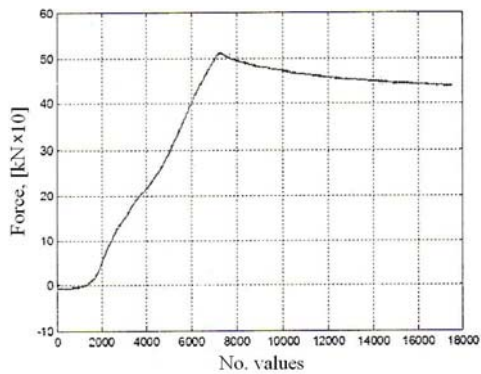
Fig. 1 – Load; average values – 10:1 sand clay initial stage.

The analysis of acquired data performed using MATLAB, an average of the three main types of models using identical mortars, was realized, and results in the domain load/values number are presented in Figs. 1,...,3.

As can be noticed, the load's value increasing mode is different, depending on the deformation capacity, implicitly on the energy absorption, of each type of mortar, determining a different behavior of the retrofitting solutions chosen for rehabilitation.

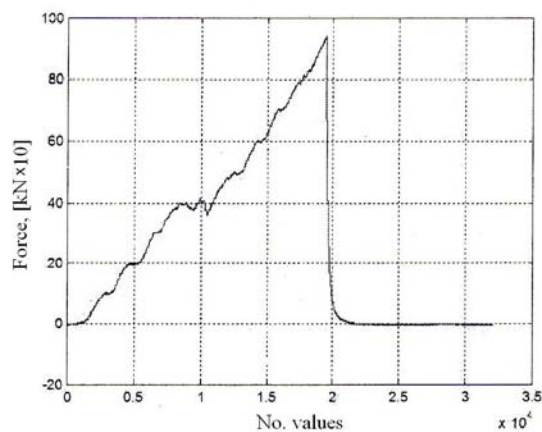
Fig. 10 – Force values – 10:1 sand clay reinforced.

As regards the loading force in time evolution, several experimental data are presented in Figs. 7,...,11.

e) The use of polymeric grids in coatings' reinforcing tend to uniform the masonry models as can be observed from Figs. 7,...,11. It is to be noticed that the used and tested polymeric grids in this program bring a substantial increase in capacity to take over the horizontal force both for their use in new buildings, in the form of reinforcement in horizontal joints and confinement, or for damaged and polymeric grids coating retrofitted masonry buildings.

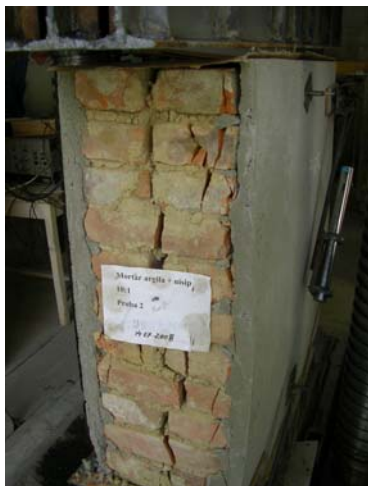
Fig. 12 – Fracture in steel grid reinforced coating.

Fractures in steel grid reinforced coating and in polymer grid reinforced coating are represented, respectively, in Figs. 12 and 13.

f) The obtained data relieve clearly the failure mode of masonry structures and the difference between grid reinforcement polymer (which have a great deformation capacity of masonry and is totally leading it) and the one which uses welded meshes that work together only limited with the masonry.

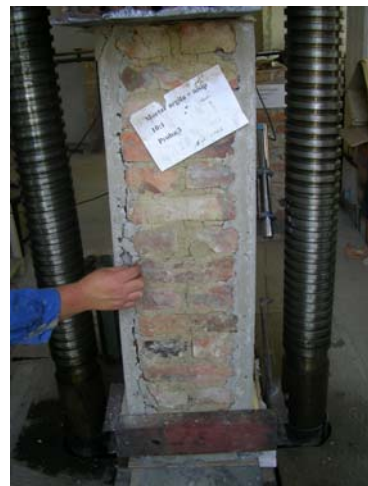
Fig. 13 – Fracture in polymer grid reinforced coating.
