BULETINUL INSTITUTULUI POLITEHNIC DIN IAȘI  
Publicat de  
Universitatea Tehnică „Gheorghe Asachi” din Iași  
Tomul LVIII (LXII), Fasc. 2, 2012  
Secția  
CONSTRUCȚII. ARHITECTURĂ

## STATE OF THE ART FOR STRENGTHENING MASONRY WITH FIBRE REINFORCED POLYMERS

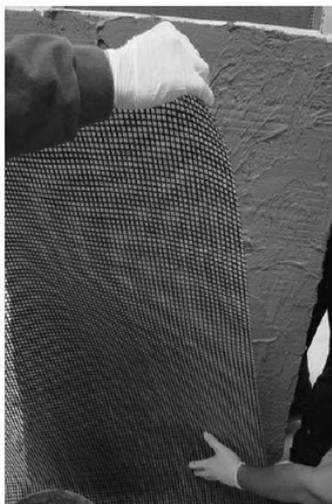
cover the entire surface by using a bonding agent. For specimens receiving mortars, the wall surface is previously dampened. Then, the bonding of the textile is made by hand and roller pressure. The bonding agent is applied in 2 mm thick layers with a smooth metal trowel and the textile is pressed slightly into the mortar which protrude through all the perforations between fiber rovings (Fig. 1).

Fig. 1 – Reinforcing masonry by textile embedded in cementitious mortar (Papanicolaou *et al.*, 2008).

a) *Using mortar as binder*

For the wallets tested in out-of-plane bending, with plane of failure parallel to the bed joints, the displacement amplitudes increased and debonding of brick bed joint interfaces close to the mid-span was detected. Until the onset of 10th displacement cycle the panel showed no other signs of severe damage. The cementitious matrix allowed the formation of almost evenly distributed fine cracks on the coated surface, parallel to the bed joints. The low tensile capacity of the cementitious matrix and the resulting distributed cracking led to a more compliant response, enabling the wall to develop higher deflections at failure and to fail at a higher load. Failure occurred in the 11th cycle, through the formation of diagonal cracks. At larger displacements, reversals the brick adjacent to the crack crushed and the crack propagated through the masonry-

textile reinforced mortar (TRM), interface, causing controlled debonding of the textile reinforcement. The maximum load obtained was of 12.22 kN, with a corresponding displacement of 10.7 mm. With a doubled number of textile sheets, the maximum load attained was of 15.15 kN and the displacement of 44%, lower than the one obtained with only one sheet of textile.

For the wallets tested in out-of-plane bending with failure perpendicular to the bed joints, during the early cycles of the response, diagonal cracking occurred. This cracking pattern became critical and marked the failure mechanism for the doubled number of textile layers. For a single layer of textile, the failure occurred due to tensile fracture of the textile at midspan. A gradual tensile fracture of the TRM jacket in the pull direction was observed. The maximum load undertaken by the system was of 14.42 kN and a corresponding displacement of 9.45 mm.

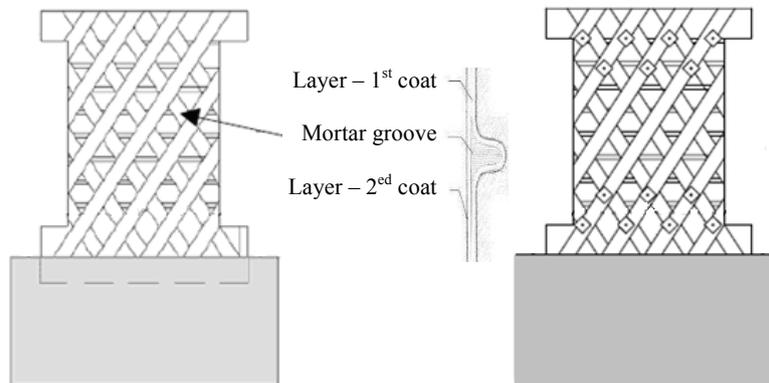
The system consists of using strips of composite material, glass fibers and epoxy resin matrix, with/without connectors to stick together the strips from both sides of the wall (Candeias *et al.*, 2005), applied in two layers with the composite strips oriented after the principal directions of tensile stresses (Fig. 2).

Fig. 2 – Reinforcing masonry by FRP strips with/without connectors (Candeias *et al.*, 2005).

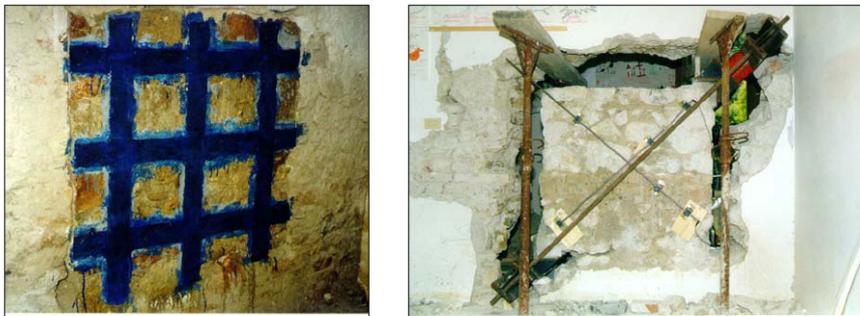
Another system used to strengthen masonry consists of using sheets of unidirectional carbon fiber or glass fiber (Borri *et al.*, 2003) placed on both sides of the panel, following the scheme presented in Fig. 3.

Fig. 3 – Reinforcing masonry with unidirectional carbon/glass fibers sheets and layout of diagonal compression tests (Borri *et al.*, 2003).

Due to the great irregularity in the masonry texture, the strengthening of the panels was carried out only after spreading a layer of cement based mortar to create a sufficiently plane, uniform surface on which the composite was then applied. The mortar used was placed directly on the masonry once the original rendering had been removed.

The results of shear-compression tests showed an increase in the strength,  $\tau_k$ , of the strengthened panels, relative to those non-strengthened, of approximately 55%, independent of the type of fibers used. This essentially depends on the particular modality of failure, which did not involve the crisis of the composite, except at a limited area on some of the panels. In fact, the fibers remained attached to the cement-based mortar, used to create a uniform surface on which the FRP was applied, which in turn had detached from the masonry. Therefore, since the state of fiber stress was well below its failure level, it was only marginally engaged. For this reason, no difference resulted from the use of carbon fibers or fiber glass. However, in the successive diagonal compression tests the layer of mortar was replaced by a thinner layer of epoxy putty which bonded more efficiently with the masonry substrate and determined a better utilization of the fibers, which did not detach until the masonry-composite system failure was reached.

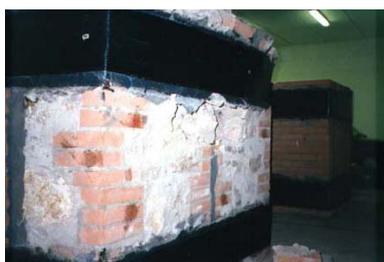
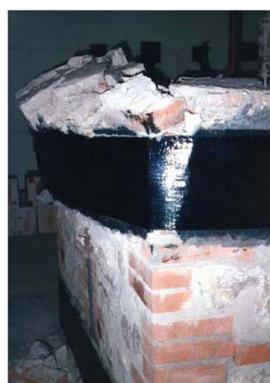
Fiber wrapping or encasement of masonry buildings in FRP shells (Borri *et al.*, 2003) (Fig. 4), may significantly enhance the strength and ductility of masonry structures. Most masonry walls are not correctly connected to each other, and this makes these structures particularly vulnerable to seismic action.

Fig. 4 – Fiber wrapping/encasement of masonry buildings in FRP shells (Borri *et al.*, 2003).

Preparation of the wall surface for the strengthening operation is a quick procedure, consisting of the use of a grinder to remove the external blaster. The application of carbon fiber reinforced polymers (CFRP), reinforcement is

carried out after having spread an epoxy-primer and an epoxy-mortar on the surface of panels. Two bands of CFRP are applied along the external perimeter in order to wrap the masonry cell with one band near the base and with another near the upper border.

The solid brick and the stone masonry cells failed at a load of 70 kN and, respectively, of 90 kN. The low flexural stiffness of the CFRP sheet caused large lateral deformations at the maximum load. The experiment showed that the FRP reinforcement maintains its effectiveness until the crushing strain of masonry is attained.

Several strain gauges were fixed along the FRP sheets in order to measure the stress tensile status of the composite (Fig. 4). This allowed us to confirm that the FRP reinforcing technique carried out its strengthening action, as well as to measure the degree of utilization of the FRP.

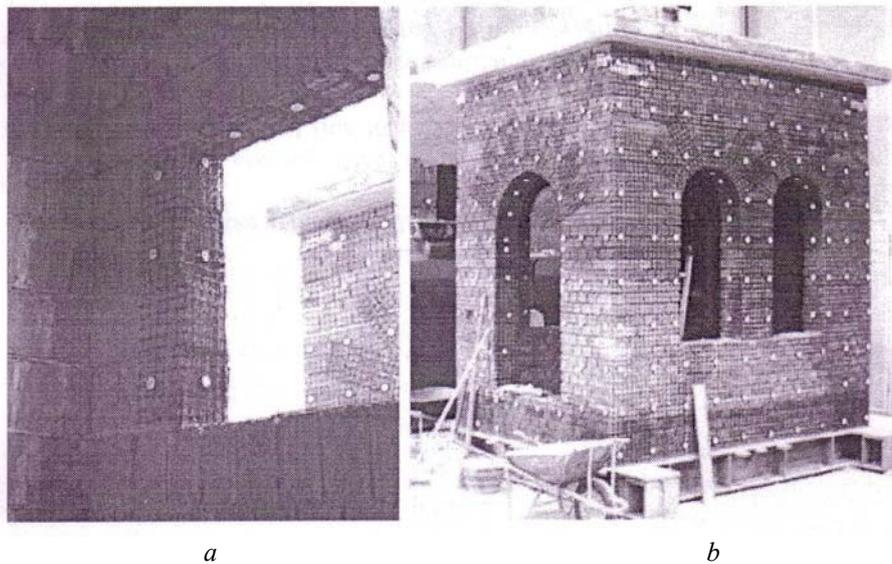
The applications of these grids may differ, from embedding them in bed joints, confining the masonry by wrapping around with polymer grids and then by rendering either building bodies as such or only some of their structural members (Fig. 6).

Fig. 6 – Polymer grids used to: *a* – confine masonry, *b* – wrapping around the masonry building, as presented by Sofronie (2004).

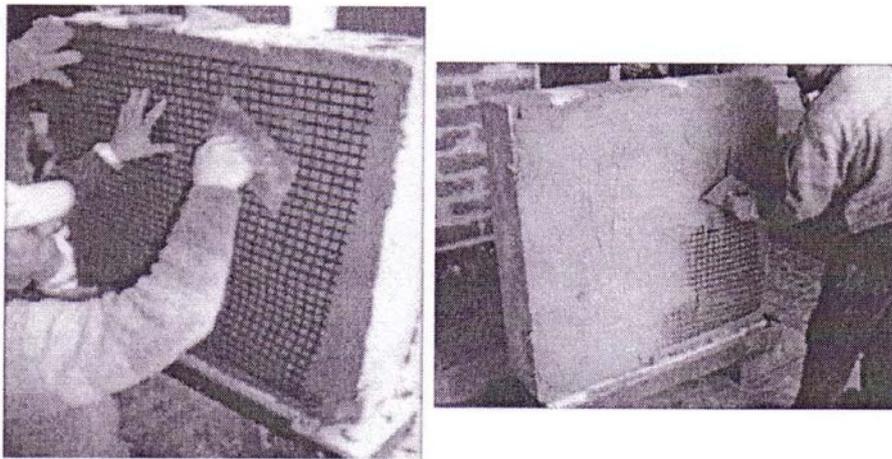
The strengthening system was installed as follows: the wall was properly prewetted and the mortar, previously mixed with water and an acrylic fortifier, was then troweled onto the wall with a 5 mm thick layer. The first 900 mm<sup>2</sup> fabric sheet was firmly hand pressed into the wet binder to ensure its adequate embedding to the support wall. The first ply was laid up with the primary fibers aligned horizontally to the bottom of the wall (Fig. 7 *a*). Then, a second layer of mortar was applied by troweling an additional 5 mm thick layer. Finally, the second ply was applied with the primary fibers aligned vertically and covered by a relatively smooth surface, the resulting cement based matrix coated alkali-resistant glass grid system, CMG system, nominal thickness being of about 10 mm (Fig. 7 *b*).

*a* *b*  
Fig. 7 – CMG system: *a* – grid installation; *b* – applying the final mortar layer (Prota *et al.*, 2006).

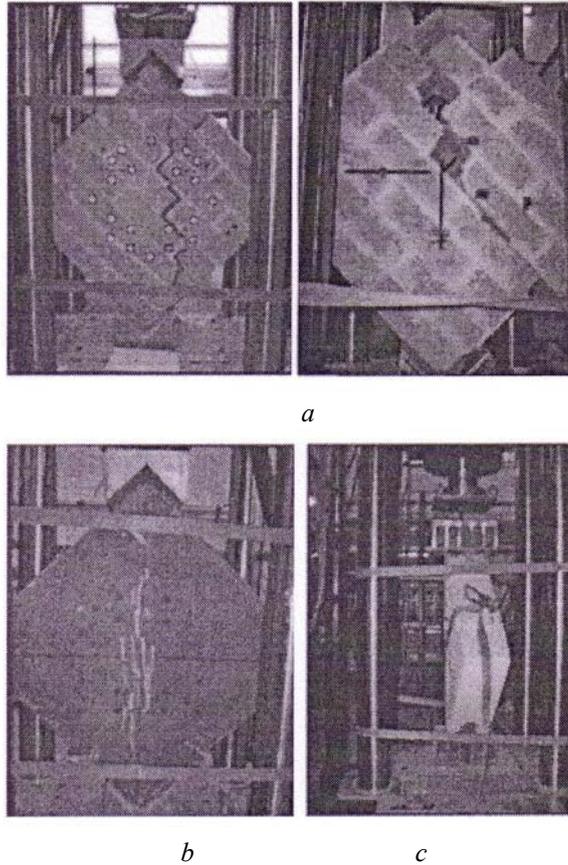
Fig. 8 – CMG system applied on one face of the panels: *a* and *b* – failure patterns on unstrengthened and strengthened side; *c* – out-of-plane deformation (Prota *et al.*, 2006).

and tensile failure of units (Fig. 8 *a*). This is the reason for the higher shear strength obtained. In fact, the failure plane ran through a greater surface compared to the case of sliding along the mortar joints and caused the full splitting of the panel. For the strengthened face, the CMG system provided a distribution of stresses along the loading line (Fig 8 *b*), causing the out-of-plane failure of the panel, as seen in Fig. 8 *c*. Although higher stress concentration was induced by the test setup at the loaded edges, no local failure close to the loading shoes was observed.

For the panels with the CMG system applied only on the face, at the ultimate stage, the stress field in the as-built panels tend to force the fracture

cracks to follow the line of least resistance rather than the line of action of the splitting load. For some panels, the failure resulted in mortar bed and head joint failure. Thus, shear capacity is governed by the weak bond between mortar and units – tuff stones. For some other panels, the failure plane had a marked stepped appearance due to a combination of debonding along the mortar joints

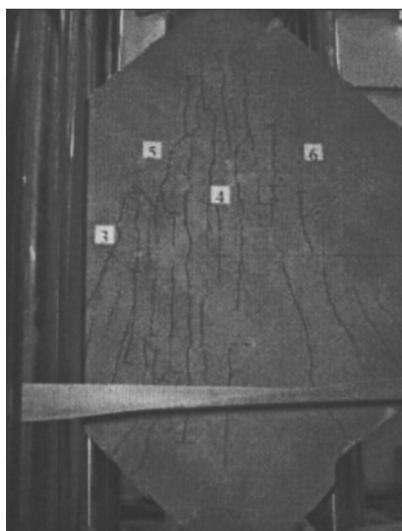
The presence of a double layer of CMG on both sides changed the mode of failure of panels from a shear slip along the mortar joints to a more uniform crack pattern along the splitting line. The elastic modulus of glass fibers led to a better redistribution of the lateral load on the panel, resulting a more uniform stress state and higher energy absorption provided by the reinforcing grid (Fig. 9). The panel kept its structural integrity throughout the entire test and it would have been able to carry a further load if no local failure close to the loading shoes happened. Shear strength response of the walls was governed by masonry cracking at the loaded edges, therefore the ultimate values determined with the tests represent a lower limit of the shear capacity of the specimens.

Fig. 9 – Crack pattern at failure for CMG system applied on both sides of the panels (Prota *et al.*, 2006).

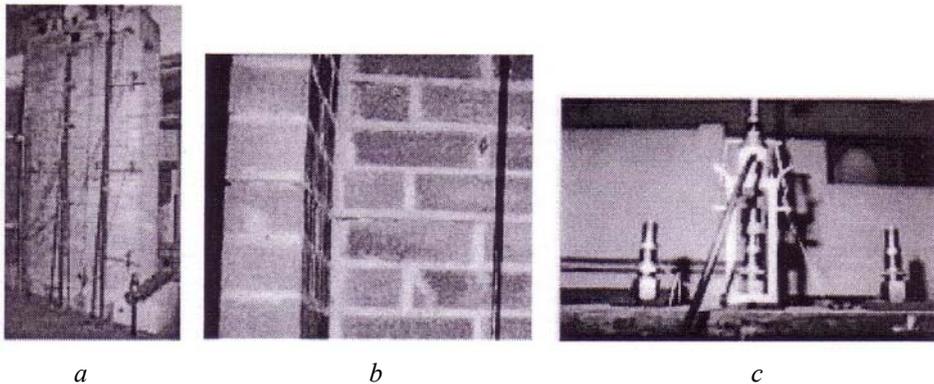
The system consists of placing FRP tendons inside a steel tube (duct) either within holes drilled along the midplane of the wall or along grooves

symmetrically cut on both surfaces of the wall (Reda Taha & Shrive, 2003). Holes are cement grouted and external grooves are filled with shotcrete (Fig. 10).

Fig. 10 – *a* – Post-tensioning using FRP; *b* – flexural crack in post-tension wall; *c* – post-tensioning jacking frame (ISIS) (ElGawady *et al.*, 2004).

Anchorage of post-tensioning in masonry is more complicated than in reinforced concrete, as masonry has a relatively low compressive strength. The self-activating dead end can be encasing to continuous and heavy reinforced concrete foundation beams, constructed on either side of the wall bottom and connected well with it (ElGawady *et al.*, 2004). At the top, post-tensioning is anchored in the existing or new reinforced concrete elements or specially stiffened steel plates. Anchorage devices and plates are usually placed in a recess of the surface and covered later on with shotcrete or cement mortar. The requirement for bottom anchorage penalizes considerably this retrofitting technique. A major problem encountered for this system is the anchorage of the tendons. Standard anchors for steel tendons rupture CFRP tendons very easily.

Post-tensioning increases both the cracking moment of resistance and the ultimate moment of masonry walls, so has some attraction for application in seismic areas. However, there would be a need in design to have some component of the masonry fail in a stable manner at ultimate rather than the prestressing tendon.
