BULETINUL INSTITUTULUI POLITEHNIC DIN IAȘI
Publicat de
Universitatea Tehnică „Gheorghe Asachi” din Iași
Tomul LVIII (LXII), Fasc. 4, 2012
Secția
CONSTRUCȚII. ARHITECTURĂ

CHURCH ACOUSTIC REHABILITATION A CASE STUDY

**DANIELA-ROXANA TĂMAȘ-GAVREA*, RALUCA FERNEA,
CONSTANTIN MUNTEANU, SIMONA STANCA and LIGIA ANDREICA**

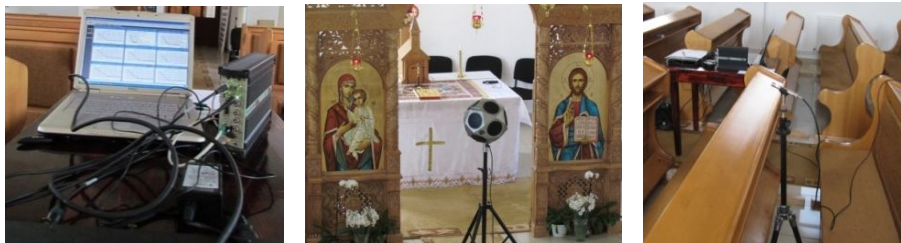
Fig. 3 – Reverberation time (acoustic measurements).

The measurements for reverberation time, set according to the International standard ISO 3382-1 requirements, were made by using a special acoustic equipment (Bruel & Kjaer Sound and Vibration Measurement) composed of

The measurements were taken inside the emptied church. According to International Standards ISO 3382-1, the reverberation time can be computed using two different methods: interrupted noise and integrated response to the impulse. In this case, the preferred method was “interrupted noise”, method comprising an omnidirectional sound source generating white noise which is a random signal (or process) with a flat power spectral density. The omnidirectional sound source is composed of 12 speakers placed in such a way as to allow a spherical distribution of the sound.

Reverberation time measurements, presented in Figs. 3 and 4, were executed in two stages, depending on the position of the omnidirectional source:

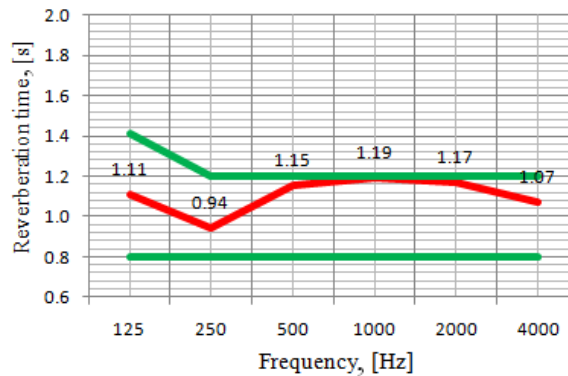
In Fig. 10 the resulting values (T/T_m) fit between the set limits according to STAS 9783/0-84 were represented too.

Fig. 10 – Reverberation time compared with the admissible limits.

A reduction of the registered values was realized through the implementation of a perforated gypsum board system which ensures reverberation time adequate values.
