BULETINUL INSTITUTULUI POLITEHNIC DIN IAȘI  
Publicat de  
Universitatea Tehnică „Gheorghe Asachi” din Iași  
Tomul LIX (LXIII), Fasc. 3, 2013  
Secția  
CONSTRUCȚII. ARHITECTURĂ

## **SOME ASPECTS CONCERNING THE INCREASING THE ENERGY EFFICIENCY FOR BUILDINGS MADE OF BRICKWORK AND AUTOCLAVED AERATED CONCRETE MASONRY**

**IRINA BARAN\* and RADU-AUREL PESCARU**

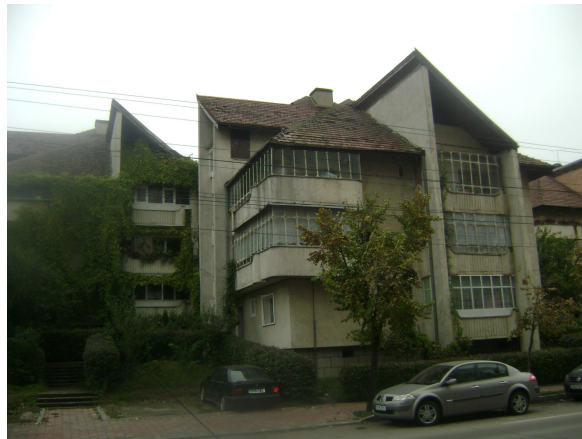
Fig. 1 – The analysed building.

- c) windows of PVC frames and thermopane glass that replaced the old wooden joinery, achieved by occupants effort (Fig. 1).

The collective housing building, which was the subject of study, is a building with groundfloor and 3 floors, located in town of Iași. The building was built in 1987 and has 7 apartments in the analysed section.

- a) exterior walls of brickwork of 25 cm thickness and insulation of BCA of 20 cm;
- b) pitched roof type with unheated attic and insulation made of BCA plates of 20 cm thickness;

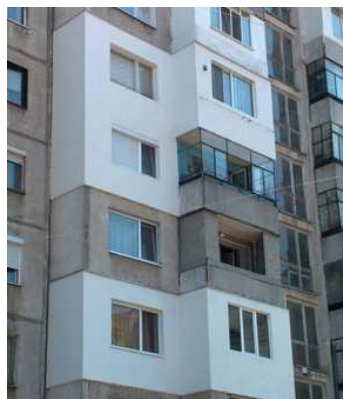
Fig. 6 – Façade partial insulated.

implementation process and because it eliminates the need for a general agreement among all owners of apartments in the building. In the case of the external additional insulation solution, separate decisions of owners affect both the façade appearance and also the general aspect of the area (Fig. 6). The interior thermal insulation method can be made by each individual beneficiary in different periods of the year, with much lower capital expenditure. For studied building, appears also the exaggerated growth of the external wall thickness, associated with difficulties in attaching the insulating material to the structural layer.
