BULETINUL INSTITUTULUI POLITEHNIC DIN IAȘI  
Publicat de  
Universitatea Tehnică „Gheorghe Asachi” din Iași  
Tomul LIX (LXIII), Fasc. 3, 2013  
Secția  
CONSTRUCȚII. ARHITECTURĂ

## THE STRENGTHENING OF THE DAMAGED HISTORIC MASONRIES BY USING SPECIALS MORTARS

DANIEL COVATARIU<sup>1,\*</sup>, RAREȘ-GEORGE ȚARAN and  
IONUȚ-OVIDIU TOMA

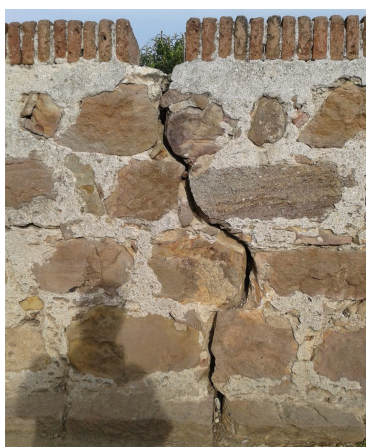
Fig. 1 – Damaged masonry joints caused by water infiltration, XVII<sup>th</sup> century masonry.

(mortar) (Covatariu *et al.*, 2011a). At these types of masonry, cracks will often occurs in the vulnerable areas (in the joints), at the interface mortar–brick from various reasons: premature aging of the materials, water infiltration by capillarity (Fig. 1), exposure to an aggressive environment (Fig. 2.), land movements caused by geological phenomenon or seismic, foundation soil degradation, etc.

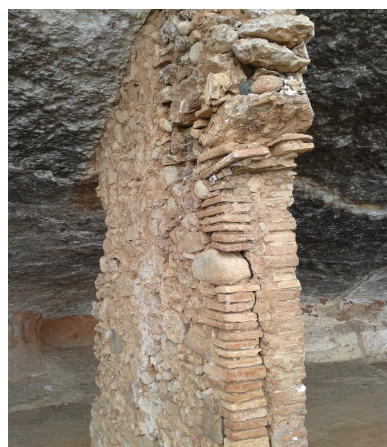
Fig. 2 – Mortar without continuity caused by aggressive environment's agents, XV<sup>th</sup> century masonry.

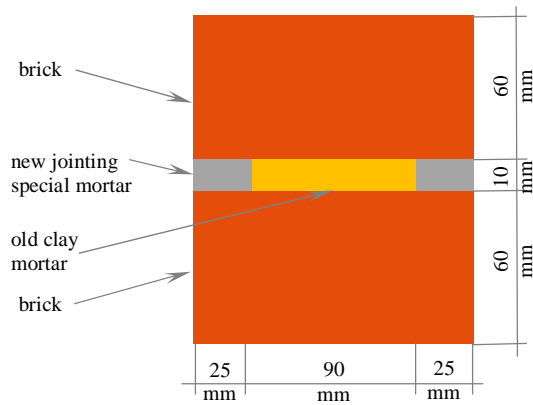
Fig. 3 – Masonry Jointing pattern.

maturing period of the samples, they were consolidated by horizontal grouting and re-filling with special mortars in order to test before the rehabilitation

(Fig. 3) and 3 samples were kept as control samples (Fig. 4) in order to compare with the consolidated samples.

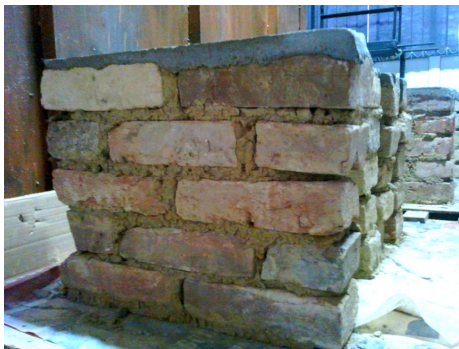
Fig. 4 – Control sample.

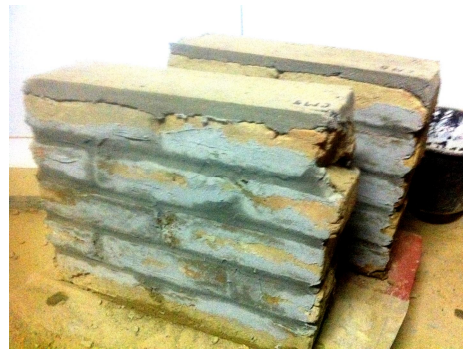
Fig. 5 – Strengthened joints sample.

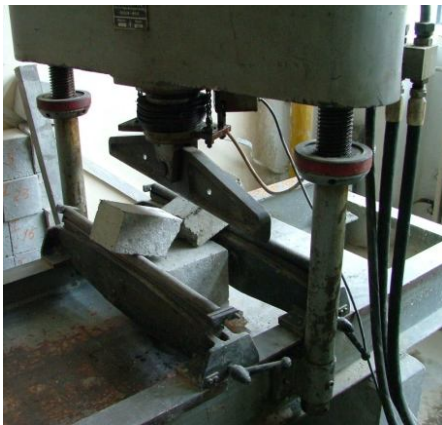
Fig. 6 – Reinforced mortar prism samples tested for tensile strength in bending.

For each type of mortar used to strengthen the joints, in order to determine the tensile strength in bending (on  $40 \times 40 \times 120$  mm prisms) (Fig. 6) and the compressive strength (on  $40 \times 40 \times 40$  mm cubes) (Fig. 7) have been performed tests (ASTM C780-10, 2010; ASTM C270-10, 2010).

The tests revealed a superior strength at cement additioned with EdiFiber 3 samples, while CM11 mortar samples showed a brittle behaviour (a very good adherence, low mechanical characteristics, long setting time for thickness of material above 5 mm).

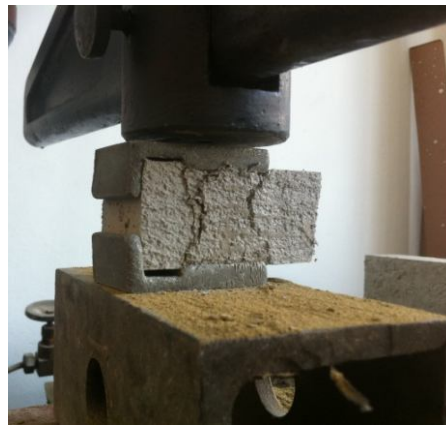
Fig. 7 – Determination of compressive strength of hardened mortar prisms.

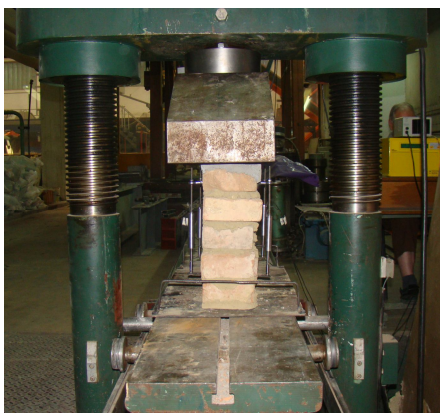
Fig. 8 – Handling of samples for testing at centric compression.

Masonry samples (3 for each group) were tested in the laboratory of the Faculty of Civil Engineering and Building Services of Jassy in order to determine the centric compressive strength, using a Universal Testing Machine having a load capacity of 3,000 kN, supplementary equipped with a 1,000 kN load cell, 4 displacement LVDT traducers and numerical analogical conversion system (Figs. 8 and 9).

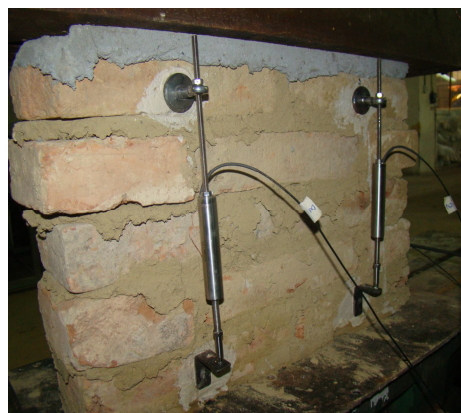
Fig. 9 – Control sample equipped with displacement traducers (on both sides).

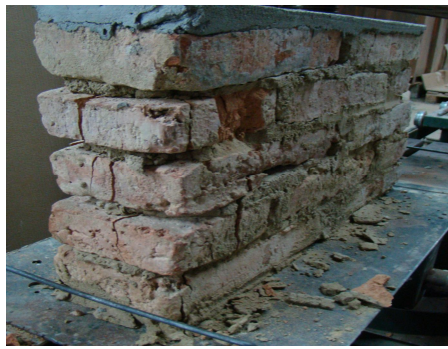
Fig. 10 – Aspects of the failure modes of masonry samples rehabilitated with:  
*a* – control samples (clay mortar); *b* – FlexCement added mortar;  
*c* – cement mortar disperse reinforced with polypropylene fibers EdiFiber3;  
*d* – M10 cement based mortar; *e* – CM11 type adhesive.
