BULETINUL INSTITUTULUI POLITEHNIC DIN IAȘI
Publicat de
Universitatea Tehnică „Gheorghe Asachi” din Iași
Tomul LXI (LXV), Fasc. 1, 2015
Secția
CONSTRUCȚII. ARHITECTURĂ

STRUCTURAL ASSESSMENT AND PROPOSED INTERVENTION WORKS ON A HISTORIC MASONRY TOWER

LUCIAN SOVEJA* and CONSTANTIN GAVRILOAIA

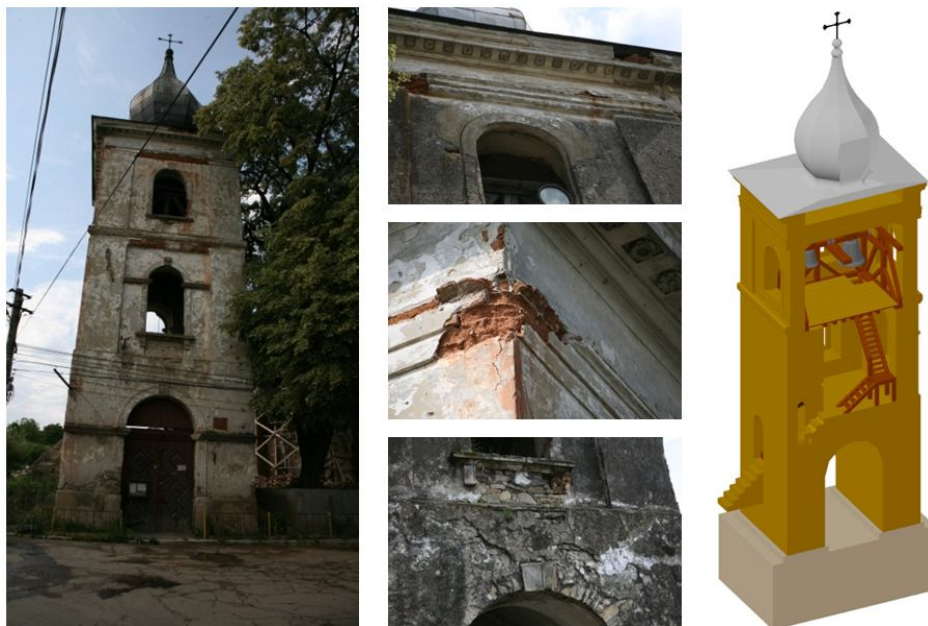
Sf. Simion tower was made around the year 1551, as part of the Armenesti Church complex, having borrowed the name and functioning as a belltower. The tower's height is 15.6 m (22.5 m at the top of the roof) and its dimensions in plain are 6.45×5.66 m. At the base, the tower is crossed (on the W-E direction) by an vaulted entrance, with the width of 2.70 m, therefore the tower's body is supported by two massive masonry piers. The cylindrical entrance vault is limited by two arched timpanyums, having the width of about 1.20 m. The foundations of the tower are composed by a solid block of 2.2 m width, made of stone masonry. The body of the tower is constituted of double walls filled with stone debris in a sand-lime-matrix.

Fig.1 – Sf. Simion's Tower.

The architectural and structural intervention works are due to the following main factors: the advanced degradation state, as a result of repeatedly seismic actions and material ageing, the aggressive vibrations on which the structure was subjected, vibrations caused by intense traffic, the necessity of structural and functional rehabilitation for the use of local community (Fig. 1).

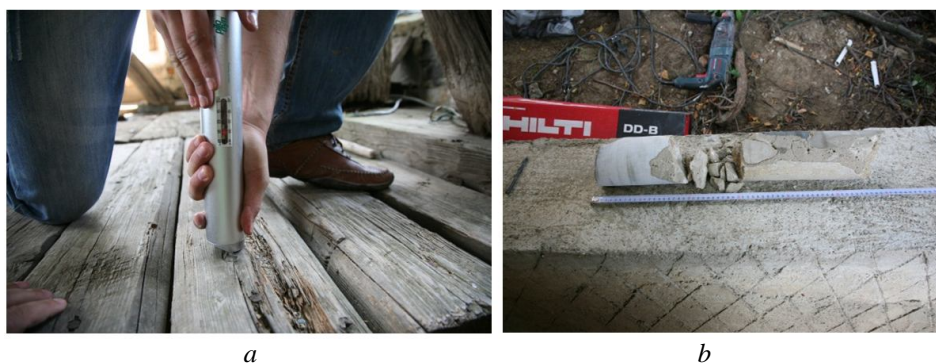
The wooden elements of the scaffolding have been in situ tested by using Pilodyn sclerometer in order to find the wood degradation depth. During testing (Fig. 2 *a*), a constant pin penetration, of about 14..15 mm, in the wood surface has resulted, which shows a superficial material damage depth of about 5 to 6mm. In two different points, a 16..17mm penetration depth was recorded, but due to local damage of the wood.

Fig. 2 – On site investigation on St. Simion Tower: *a* – testing wooden elements with Pilodyn sclerometer; *b* – extracted mortar and stone specimen by core boring.

Core boring was performed at the right side facade wall, at a height of about 1m to ground level. The extracted core had 650 mm in length and 150 mm in diameter. The first 200 mm were stone representing the exterior part of the wall and the next 450 mm were stone debris in a sand-lime-matrix (Fig. 2 *b*).

After laboratory tests carried out on the extracted sample of stone and filling, the density, compressive strength and water absorption have resulted. A compressive of 16.1 N/mm² was obtained for stone specimen, 3 N/mm² for mortar and 10.3 N/mm² for filling material.

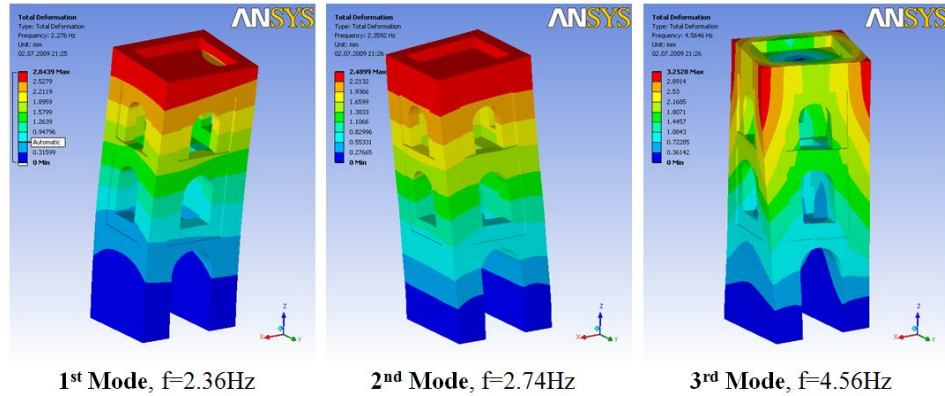
For example it would be unnecessary to use solid elements (Fig. 6) for the out of plane investigation of a masonry wall. Instead of solid elements, it would be enough to use shell elements for such a kind of investigation.

Modelling the tower masonry structure with solid elements had provided results regarding stress values and distribution inside the walls, providing significant informations on the structural response in gravitational and seismic loads.

Fig. 6 – First 3 vibration modes of the structure modeled with solid elements.

Based on the modal analysis on two types of finite element models, using shell and solid elements, vibration modes with similar forms have resulted as following: the first mode is translation along the y axis (direction with a higher

rigidity at the base level), the second mode is translation along x axis and the third mode is a torsional one.
