MOISTURE – THE MAIN CAUSE OF THE DEGRADATION OF HISTORIC BUILDINGS

DIANA-ANDREEA CLIM*, LIVIU GROLL AND LIVIA-INGRID DIACONU

“Gheorghe Asachi” Technical University of Iași
Faculty of Civil Engineering and Building Services

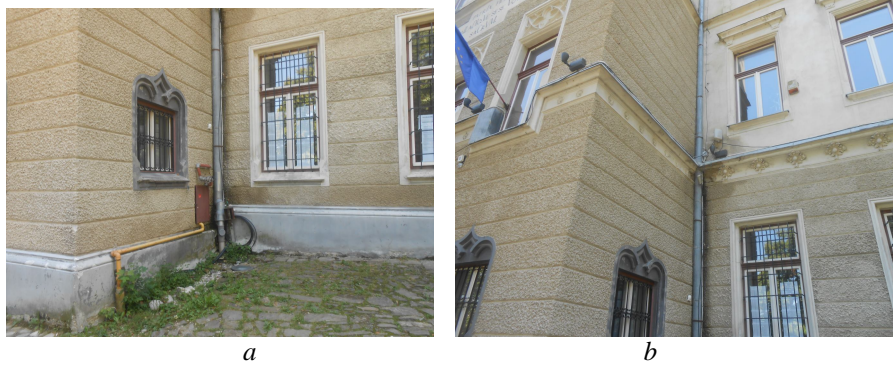
Fig. 1 – *a* – Lack of vertical systematization; *b* – damage to the collecting rainwater elements.

a) Defective collection of rainwater and the lack of an effective vertical systematization (Fig. 1);

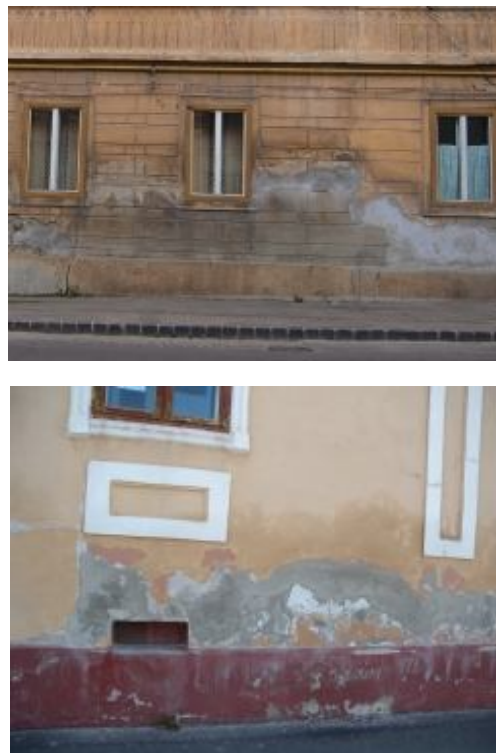
Fig. 2 – Moisture coming from the capillary rise of water in the building elements (Zaharea, 2011).

b) Infiltration of groundwaters, because of the capillary rise and of the forces of electro-osmosis (Fig. 2);

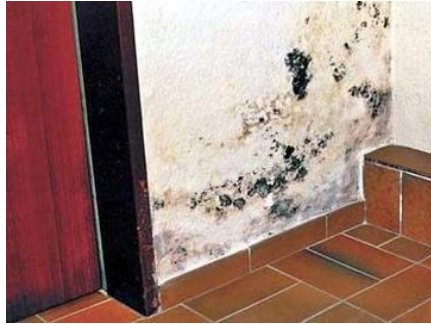
Fig. 3 – Moisture from condensation (Zaharea, 2011).

c) Condensation of water vapors from the air and from the pores of the building materials (Fig. 3);

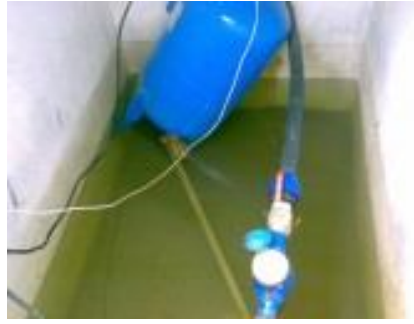
Fig. 4 – Flooding of a basement because of accidental causes (<http://www.hidroizolatii-constructii.eu/category/lucrari/page/3/>).

d) Accidental actions, such as installation system failure or clogged drains (Fig. 4);

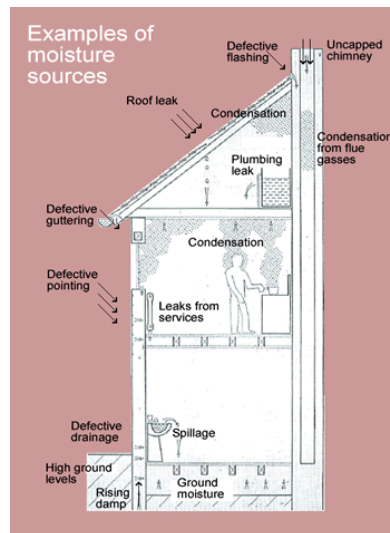
Fig. 5 – Humidity sources (Hutton, www.buildingconservation.com).

In the construction elements of historic buildings, moisture can come from both the raising of the hydrostatic groundwater level and its penetration through the capillaries, from the condensation of the water vapor from the air, and from the infiltration of rainwater (Massari, 1971) (Fig. 5).

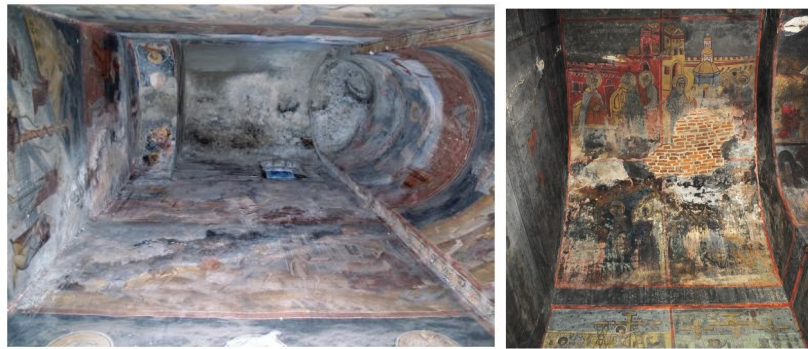
Fig. 6 – Effects of humidity in the case of interior mural paintings (Zaharea, 2011).

A factor that significantly favors water ingress and stagnation in the construction elements is the hygroscopicity of materials. According to the literature, the main cause of the presence of moisture in the masonry of historic buildings is the capillary rise, a phenomenon influenced by the internal structure of the materials through which it passes. The degradations are more severe as the amount of soluble salts transported by water is greater. The salts can come from the building materials, from the soil or from the air, and are driven upwards by moisture, which generates the appearance of efflorescences, because of the crystallization phenomenon (Frattari *et al.*, 2005). In the case of churches, whose walls contain murals, moisture irreversibly damages these works of art (Fig. 6).

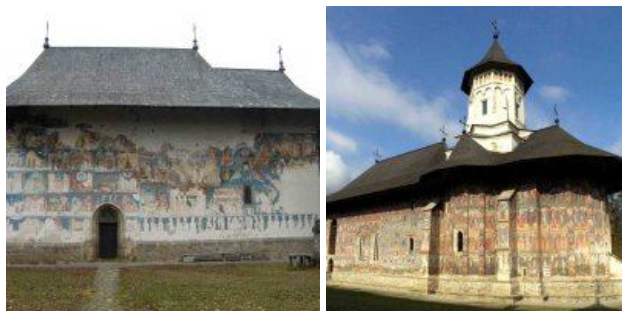
Fig. 7 – Effects of moisture in case of exterior mural paintings (Frattari *et al.*, 2005).

According to the architect responsible for monitoring the “Churches of Moldova” site, on behalf of UNESCO, the main factors contributing to the degradation of monuments are “the poor collection of rainwater and the presence of capillary humidity in the walls, which affects both the interior and the exterior painting” (Filip, 2015) (Fig. 7).

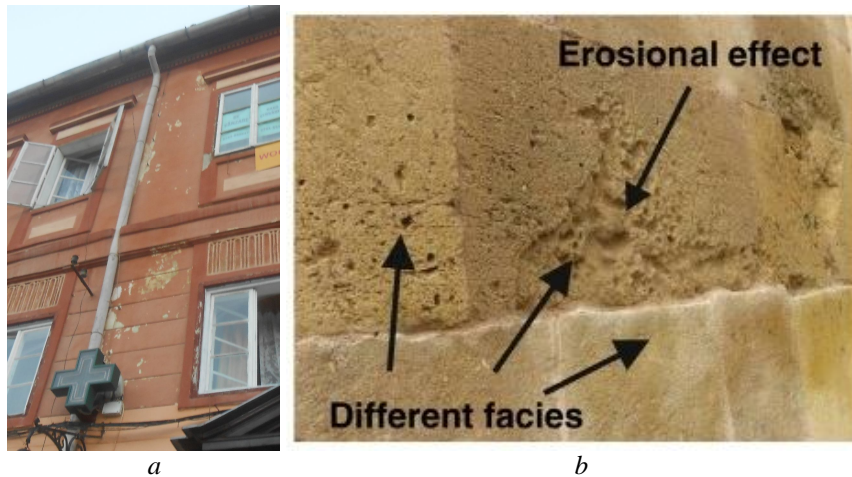
Fig. 8 – *a* – Coating peeling; *b* – erosions caused by wind action (Korkane, 2013).

- a) exfoliations or expulsions of the exterior coatings, because of the inefficiency of the rainwater control and collection systems (Fig. 8 *a*);
- b) erosions caused by wind action, which carries solid micro-particles that grind the surface of the exposed elements (Frattari *et al.*, 2005) (Fig. 8 *b*);
- c) the staining of the exterior coatings or paintings, caused by the precipitation water intrusion (Fig. 9 *a*);
- d) exterior coating expulsions, freeze-thaw products (Fig. 9 *b, c*);
- e) swellings of the paintings, as a result of low vapor permeability;
- f) grindings and expulsions of the exterior layers of the masonry elements, because of water stagnation in the construction elements (Fig. 10).

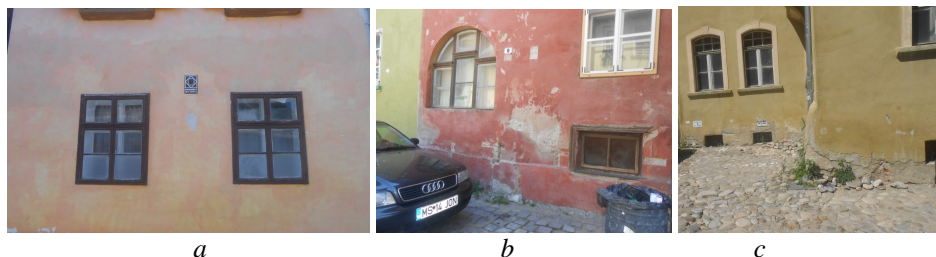
Fig. 9 – *a* – Stained coating; *b, c* – Expulsions of exterior coating

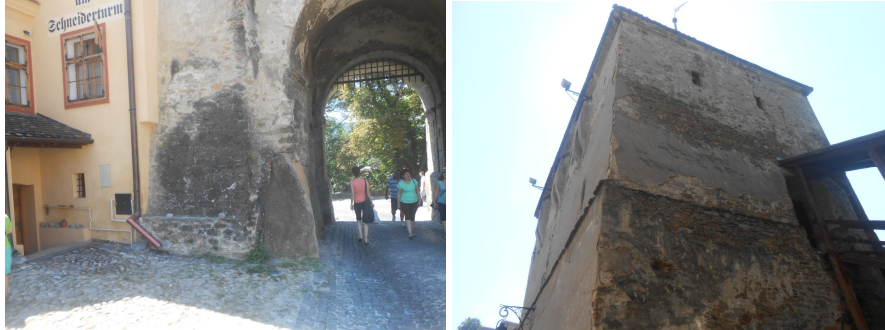
Fig. 11 – Coating degradations

a) The pollution of the urban environment contributes to the deterioration of ancient buildings, by the reactions produced between sulfates and carbonates. The effects of these chemical reactions are the volume variations of the coatings, because of the crystallization of the sulfates which, in time, get broken and allow the ingression of water from the exterior environment (Fig. 11);

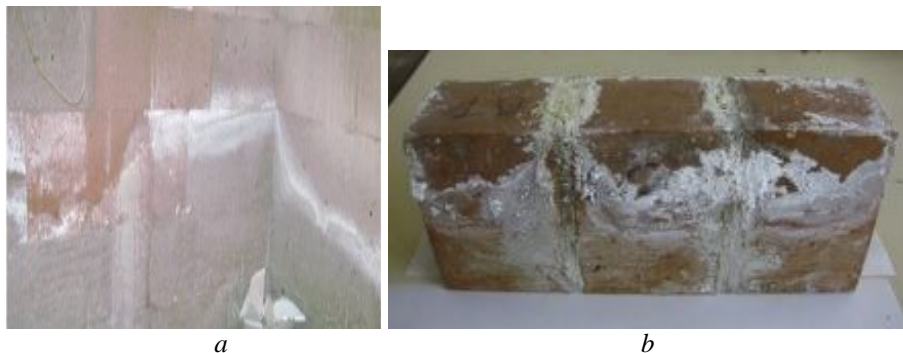
Fig. 12 – *a* – Efflorescences (Korkane, 2013); *b* – Crystallized salts (Gentilini *et al.*, 2012).

b) Efflorescences are powdery deposits, which appear as spots or stripes visible on the surface of the building elements, because of the migration of the salts from their structure, under the influence of water dissolution, transport and evaporation phenomena (INCD URBAN- INCERC București) (Fig. 12). Efflorescences appear because of the upward humidity that carries magnesium sulfates, which are the most soluble in water, calcium or sodium sulfates (<http://www.hidroizolatii-constructii.eu/category/lucrari/page/3/>).

In addition to the unaesthetic appearance produced by the efflorescences on the paraments of old buildings, the soluble salts content has a negative influence on the mechanical performances of the construction elements. These changes occur after numerous salt hydration and dehydration cycles, when spots are no longer that obvious, changing their color from white in colors similar to those of the materials upon which they form (Fragata *et al.*, 2016);

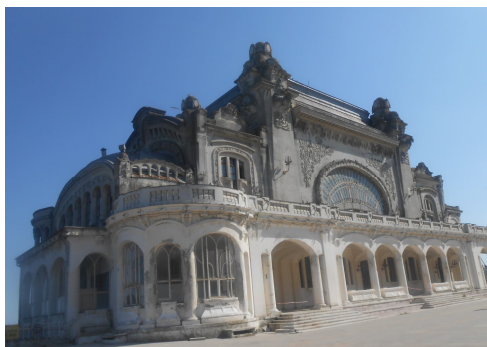
Fig. 13 – Degraded building, located on the seashore.

c) The chlorides affect the historic buildings located in marine environment (Fig. 13), where the sodium chloride precipitates in a saturated

solution, which occupies a bigger volume in the pores of the material and, after several exposure cycles, the detachment of the coating or of the exposed material occurs (Frattari *et al.*, 2005);

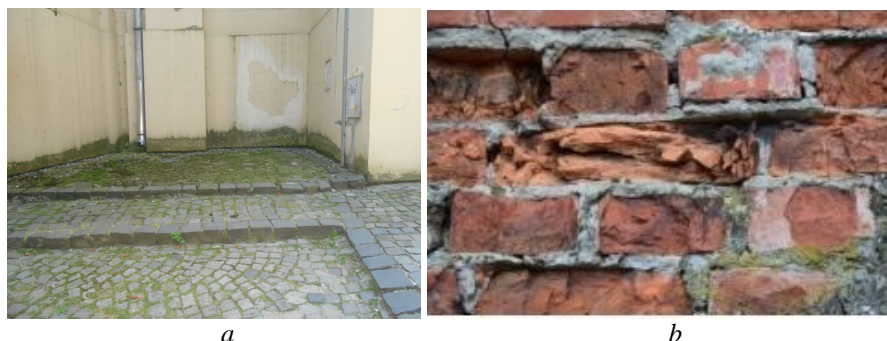
Fig. 14 – *a* – Building exposed to biological attack; *b* – Masonry affected by the presence of microorganisms (Strzysewska *et al.*, 2015).

a) The common manifestations of the biological attack are represented by the appearance of some black crusts on the side of the wall exposed to the outdoor environment. Research has shown that these pellicles appear because of the organic material content in aggregates or cement. This type of degradation is frequently encountered in old buildings, affecting both the aesthetic appearance of the paraments and the structural integrity of the building materials, by the deterioration and the detachment of their outer layers (Fig. 14);

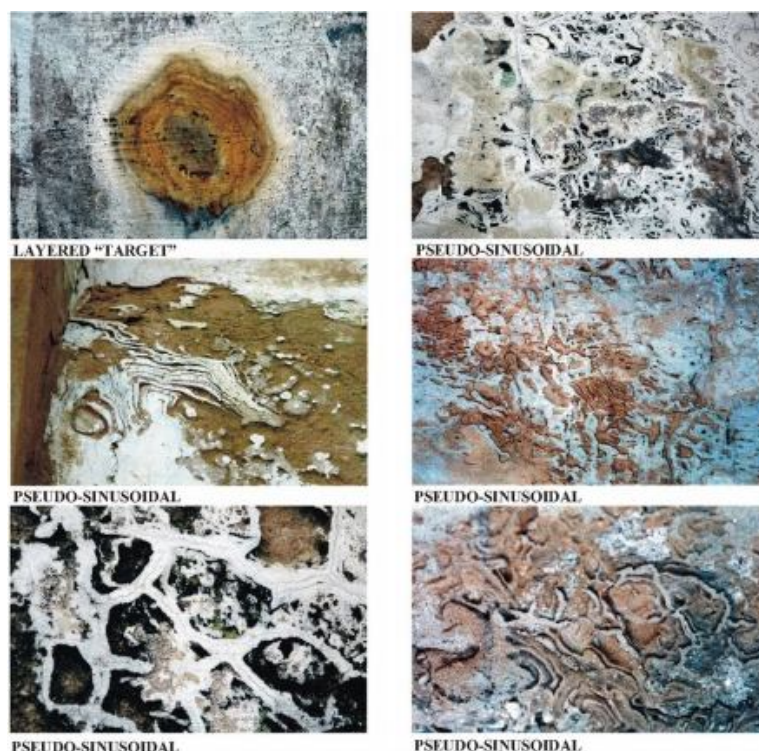
Fig. 15 – Buildings affected by Flos Tectorii.

b) A rare type of degradation is the biological attack on lime mortar based coatings, called “Flos Tectorii” in the specialty literature (Fig. 15). Responsible for this type of degradation is an Actinobacteria, which is usually found in calcareous rocks, having a particular visual aspect, because of the bacteria colonies and of the presence of soluble salts (Randazzo *et al.*, 2015).

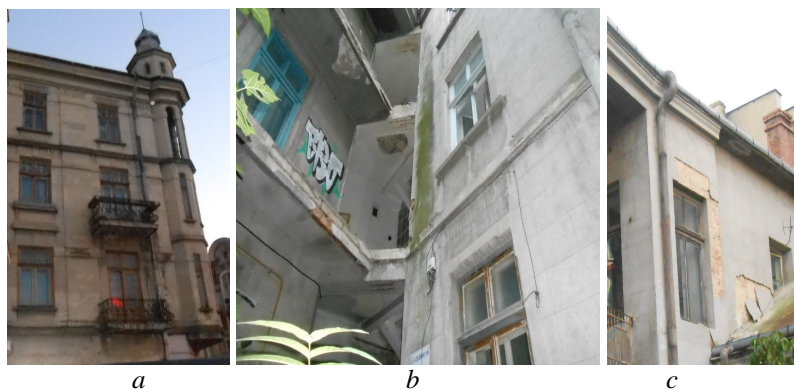
Fig. 16 – *a* – Kieser Building; *b* – areas affected by biological attack; *c* – peeled coating.

In order to understand the degradation phenomena caused by moisture, the state of a historic building from Iași – the Kieser House (Fig. 16 *a*) has been investigated in-situ. This building was built in the early 1880s, by F.M. Kieser, and it is currently included in the Historic Monuments List of Iași county (Păunescu, 2016). According to the archives, the building has not suffered any structural or architectural interventions, the original style of the early nineteenth century being maintained.

The aesthetic aspect of the building is stark, because of the multiple degradations caused by humidity and the action of the aggressive factors. The outer coating shows signs of biological and chemical degradation (Fig. 16 *b*), being expelled in numerous places (Fig. 16 *c*), because of the great number of freeze-thaw cycles to which it has been subjected.

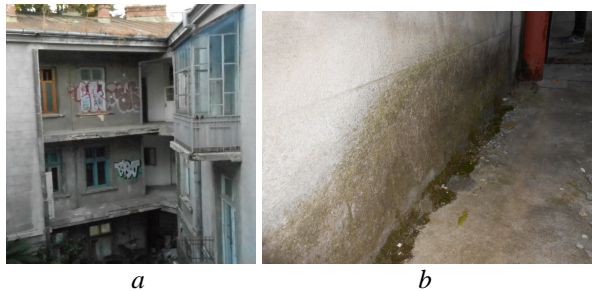
Fig. 17 – *a* – Defective rainwater collection systems; *b* – base area affected by the presence of microorganisms.

The rainwater collection elements are defective, allowing it to flow directly on the facades, fact which produces severe degradations (Fig. 17 *a*). The deterioration of the marginal sidewalks allows water intrusion and stagnation in the base area, favoring the appearance of mosses and lichens (Fig. 17 *b*).

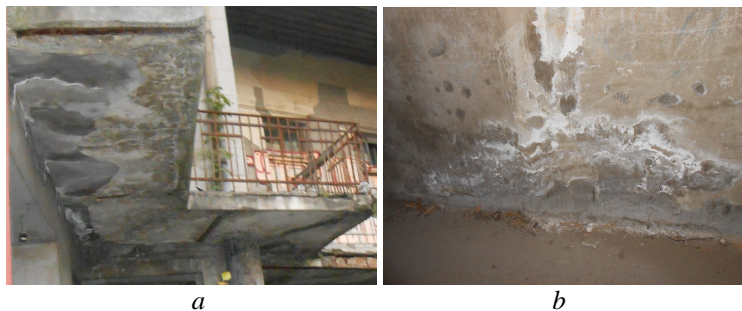
Fig. 18 – *a* – Efflorescences at the soffit of the exterior slab; *b* – base area affected by the presence of efflorescences.

Efflorescences can be seen at the soffit of the exterior slabs (Fig. 18 *a*) and on the exterior walls, in the lower third (Fig. 18 *b*).
