BULETINUL INSTITUTULUI POLITEHNIC DIN IAȘI
Publicat de
Universitatea Tehnică „Gheorghe Asachi” din Iași
Volumul 63 (67), Numărul 4, 2017
Secția
CONSTRUCȚII. ARHITECTURĂ

ON SITE MISTAKES

DANIEL-IONEL DINU, IOANA OLTEANU* and LUCIAN SOVEJA

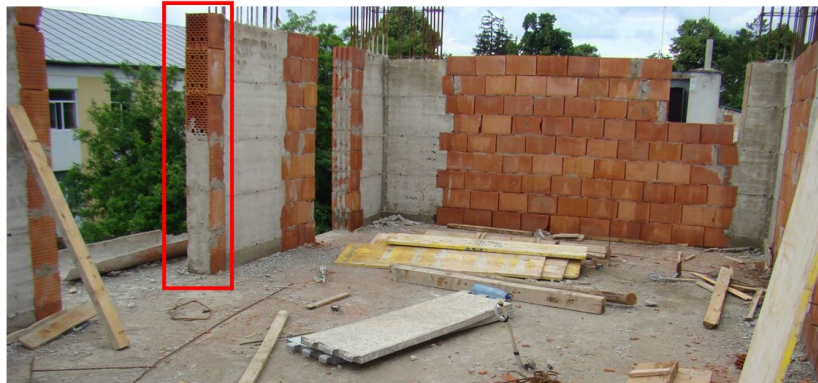
Using the unqualified labour force may lead to big errors as you can see in Fig. 1. What anyone should notice first is the mess on the construction site. Frameworks, wood pieces and nails are left randomly representing a real danger for anyone entering the location. Another huge mistake refers to the way some of the hollow bricks had been positioned – in order to obtain the required openings, the workers placed some of the bricks on horizontal direction, when they should have been put vertically. The main question should be: Who is to blame? Maybe the person in charge with the construction site, but also the one who made the brick walls. There will be some who might say that the mistakes are not that important and even though the structural system is represented by masonry system, the structure is not significantly affected. With all this a similar construction site might hide more mistakes which can seriously damage the structural safety of the construction.

Fig. 1 – On site error due to unqualified workforce.

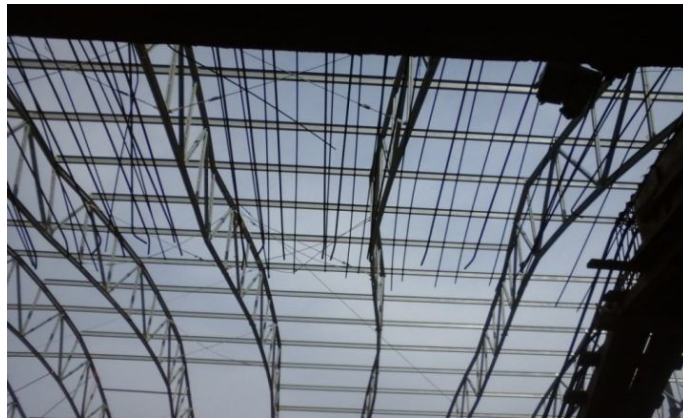
There are many other more dangerous and expensive mistakes, as is the case of the gym construction from Fig. 2. The builder started to install the

arches without considering their large openings and the necessity to introduce coupling braces between the truss arches during the execution process. The general collapse, Fig. 3, was the result of this approach, obtaining a giant steak of elements impossible to reuse. Maybe some will wonder where was the designer and the technological sheets?! It is true that the designer has his fault also because he did not give complete information, but any builder should not have started such a construction without taking the necessary measures in order to be able to correctly assemble the structural system of the roof.

Fig. 2 – Truss arches roof system assembly without assuring lateral stability of the elements.

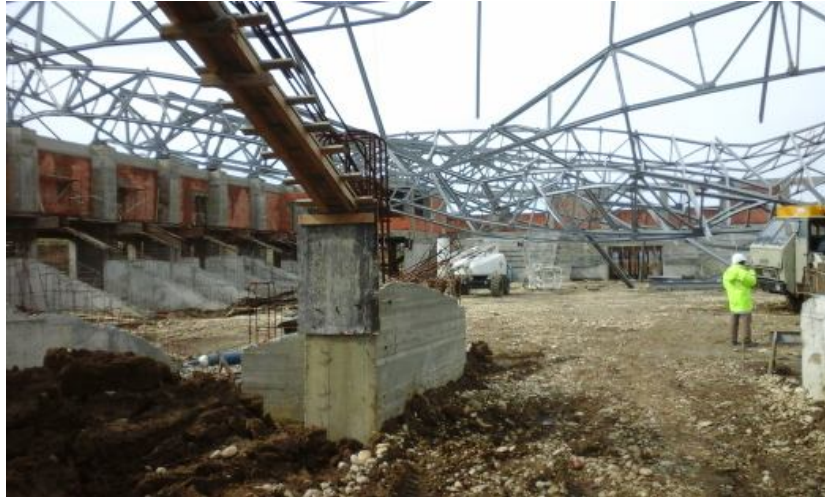
Fig. 3 – General collapse of the roof system.

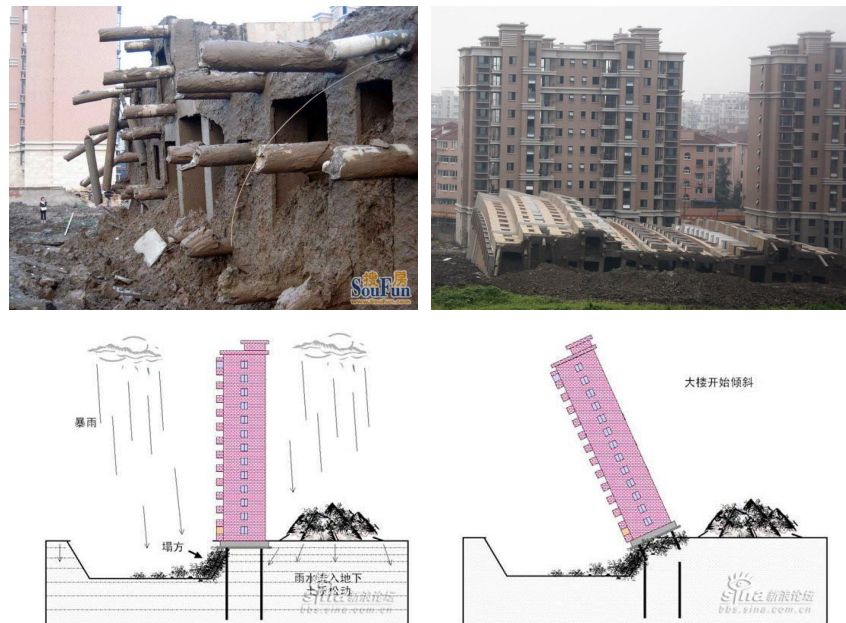
A case which led to major damages happened in Shanghai, China, in June 2009. The collapse of a 13-story apartment building occurred due to major construction errors which led to the death of a worker. As it can be seen from Fig. 4 on the south side an underground garage was being dug to a depth of 4.6 m. The excavated dirt was put on the north side, to a height of 10 m. In this case, the building experienced an uneven lateral pressure from south and north to which heavy rain contributed with water seeping into the ground. The final result was that the building tilted and the hollow pillars with no rebars were snapped (http://hoax-slayer.com/13-story-building-collapse-china.shtml). The big distance from the closest building prevented a domino effect collapse. This error is common mainly due to insufficient reinforcing measures from the ground in case of excavations close to existing buildings.

Fig. 4 – Collapse building due to construction error (http://hoax-slayer.com/13-story-building-collapse-china.shtml).

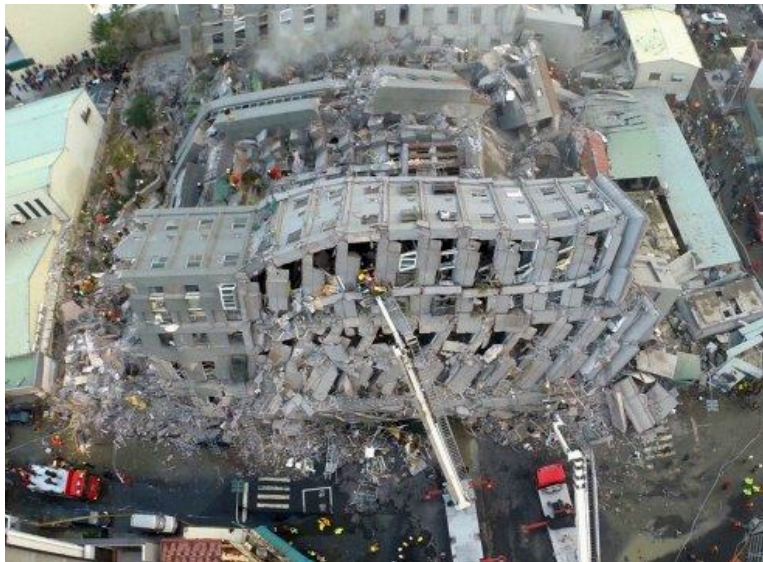
each year. The majority of victims occurred in Yongkang neighbourhood due to the collapse of Weiguan Jinlong residential building, Fig. 5 (<http://www.deccanchronicle.com/world/asia/090216/developer-quizzed-over-taiwan-quake-collapse.html>). The 16-storey building was a relative new one. After the collapse, large cans and foam appear to complete the complex concrete framework in post disaster photos, Fig. 6 (<http://kuow.org/post/photos-cans-inside-taiwan-buildings-pillars-help-spur-call-safety-reviews>). A structural engineer stated that prior to September 1999 it was not illegal to use cooking oil cans in order to fill out pillars/walls and make them look larger, but after they were replaced by styrofoam and formwork boards. The collapsed building (also called Golden Dragon) was completed in 1994. Currently the Court of Tainan are looking into this case in order to establish who is to blame.

Fig. 5 – Collapse building in Taiwan, 2016.

The building collapse raises questions regarding the construction quality in the area.

Beside the facts, some statements were given which suggest a more complex collapse cause. Firstly, the height of the structure does not follow the characteristics of the area (the majority of the surrounding buildings have only 3 floors). Secondly a team of experts noticed that the building collapsed to the east, where the ground floor had shops, which by their particularities damaged the building stiffness in elevation, leading to a weak ground floor. Thirdly, the execution firm went bankrupt which can significantly influence the quality of

used materials. Fourthly, experts consider that the ground shape, U shape, contributed to the general collapse of the building. Fifthly, the liquefaction of the foundation soil contributed to the disaster, as it is considered an irregular shape. Finally, these points of view were confirmed by an international expert team which investigated the site. Until a final verdict is given, it can be assumed from the photos that is the case of a huge error occurred during the execution process.

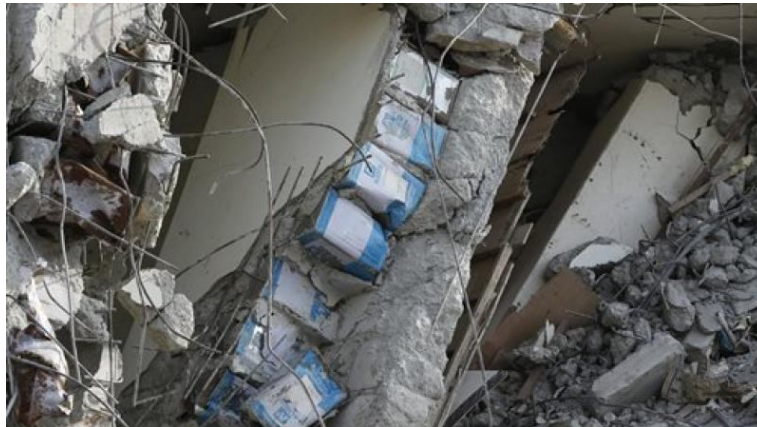
Fig. 6 – Cans in the structural walls of the collapse building in Taiwan, 2016.

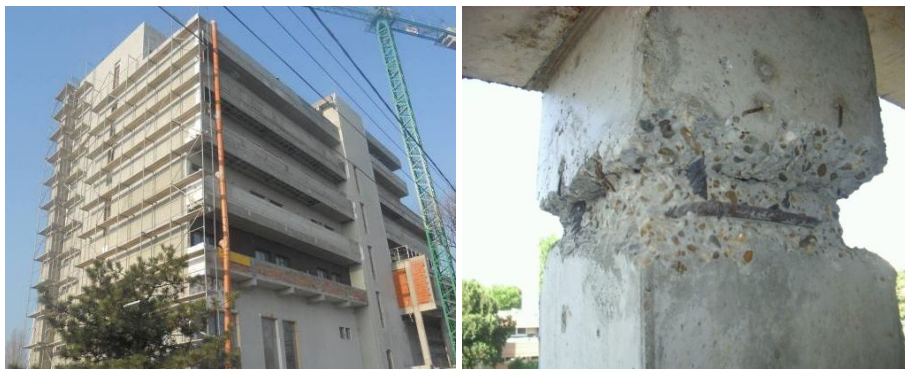
Another case which lead to cost increase has to blame the constructor, the owner and the code. If the first two can easily be found, one can wonder who is paying for the code? During the execution process, after removing the framework of the columns from the ground floor, it was noticed that sawdust was inserted in the upper part, Fig 7. It can be stated that in this case, the structure was constructed with initial plastic hinges.

Fig. 7 – Damage structure due to sawdust in the ground floor columns.

The construction work stopped in order to find an appropriate solution. In this period, the owner decided to add a supplementary level and a smaller one. During the redesign work process, the seismic code changed from P100-2004 to P100-2006. The changes in the norm moved the importance class of the building from III to II, which increased the seismic force by a 20%. In order to increase the building safety and to include the changes it was recommended to introduce structural walls. The supplementary costs were divided between the constructor and the owner.
