BULETINUL INSTITUTULUI POLITEHNIC DIN IAȘI
Publicat de
Universitatea Tehnică „Gheorghe Asachi” din Iași
Volumul 64 (68), Numărul 1, 2018
Secția
CONSTRUCȚII. ARHITECTURĂ

CASE STUDY ON HEROES' CROSS FROM CARAIMAN

Abstract. This article presents information on the structural assessments of the historic monument called the Heroes' Cross and the data on the proposed rehabilitation measures. After a brief introduction and a description of the analysed structure, the tests on the materials used are shown as well as the structural analysis and its particularities. Finally, the intervention measures and their effects on the degree of insurance are presented.

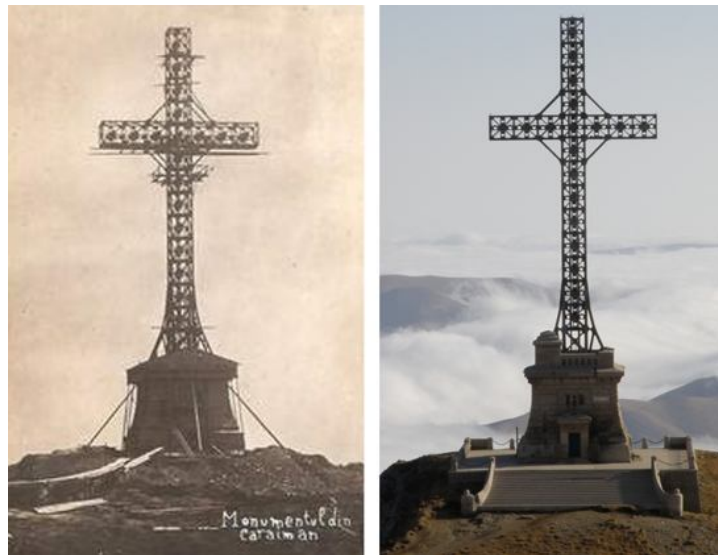
The structural system of the cross consists of a truss spatial system with flared base (Fig. 1).

Fig. 1 – Heroes Cross during building and today.

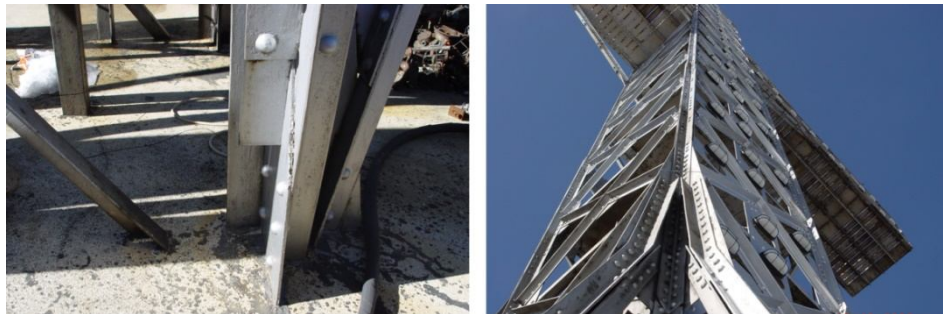
All the bars from the structure are made from equal-angle steel cross section with the following dimensions $70 \times 70 \times 7$ mm. The bars can be grouped into elements with one equal angle section (diagonals, struts), elements with two equal angle sections (bottom and top chord, the column edges and the cross arms) and elements with four equal angle sections forming the flares at the base of the monument. The bar connections are made with 17 mm diameter rivets and 10 mm thick sheet gussets. Cross metallic strips are placed in the spaces formed by the struts, with circular hollows in which light bulbs are introduced (Fig. 2).

Fig. 2 – Technical details.

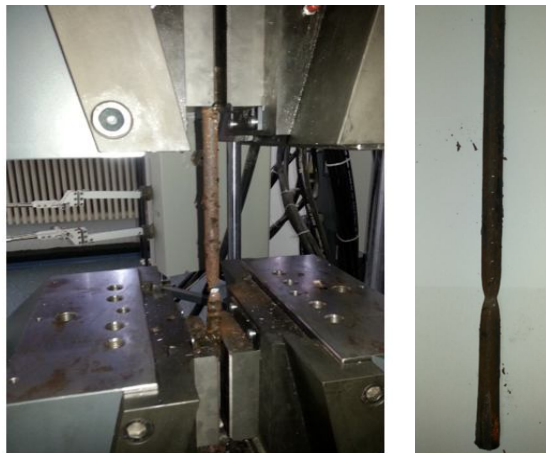
The metal bar has been tested to tension loads (Fig. 3). The resulting characteristics, such are the breaking stress, flow tension, elongation, cracking, ductility, places the material in the OL37 grade steel category. According to STAS 438-54 for the hot-rolled OL38 steel, the breaking strength should be between $38 \dots 47$ daN/mm² and the yield strength of 22 daN/mm².

Fig. 3 – Tension test.

For the tested steel, the breaking strength was slightly inferior to OL38 steel (36 daN/mm² instead of 38 daN/mm²), meanwhile the yield strength was higher (24 daN/mm² instead of 22 daN/mm²). Fig. 4 presents the characteristic stress-strain curve for the used material in the analysed monument. According to STAS 200-52 steel tension test, the obtained value for the tension test place the material in the OL34 quality steel class.

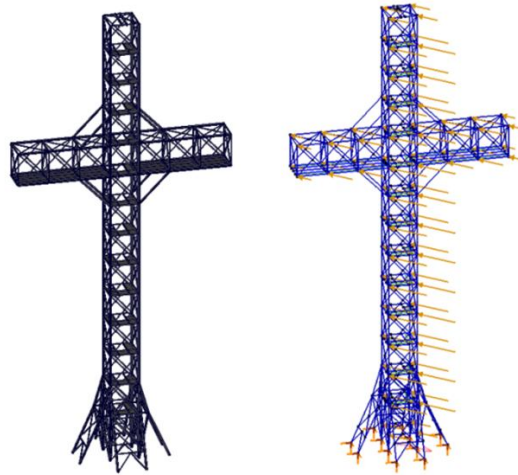
The load combination in which maximum internal forces were obtained are those that contain the wind and the ice coating effect. The elements of the 3D truss beam were calculated for tension, compression and buckling. The considered structural model and the wind case are shown in Fig. 6.

Fig. 6 – Considered numerical model and wind load action.
