BULETINUL INSTITUTULUI POLITEHNIC DIN IAȘI  
Publicat de  
Universitatea Tehnică „Gheorghe Asachi” din Iași  
Volumul 64 (68), Numărul 3, 2018  
Secția  
CONSTRUCȚII. ARHITECTURĂ

**A HOLISTIC APPROACH TO STRUCTURAL  
REHABILITATION  
A STUDY OF THE METROPOLITAN CATHEDRAL SECTIONS C1 &  
C2 IN IAȘI, ROMANIA**

**TUDOR-CRISTIAN PETRESCU\*, MIHAI BUDESCU, PETRU MIHAI  
and IONUȚ-OVIDIU TOMA**

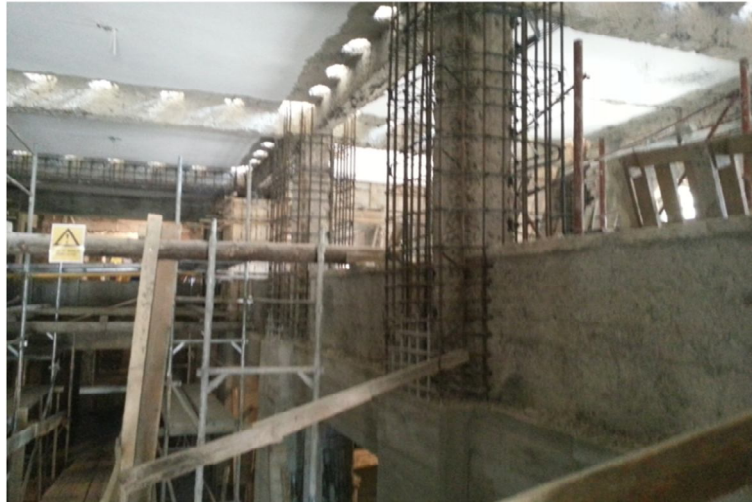
Fig. 3 – Concrete jacketing of columns, plates and walls.

Sections C1 & C2 of the Metropolitan Ensemble in Iași underwent rehabilitation works as part of a project that encompassed the whole Ensemble, works being completed in 2015. Structural works included masonry injections in order to fill up existing cracks and the concrete jacketing of columns, plates and walls in concrete (Fig. 3), for the purpose of restoring the bearing capacity to current building standards. (Alexander, 2006; Pumarada-O'Neill *et al.*, 1998).

Also of note is that the concrete jacketing of columns, plates and walls was done by concrete casting and pouring, rather than by shotcreting. (Branco & Guerreiro, 2011; Vidivelli, 2009).

All this information was gathered by the structural engineer. As it was subsequently proven, this had a major influence on selection the proper rehabilitation method. As previously stated, the concrete jacketing of columns, plates and walls in concrete was done in the “classic” way of using formwork and concrete pouring (Fig. 4) (Costa *et al.*, 2014). This was deemed necessary, as the existing reinforcement was of OB37 type and also because extra adherence and strength was needed, which the shotcrete could only provide to a limited extent.

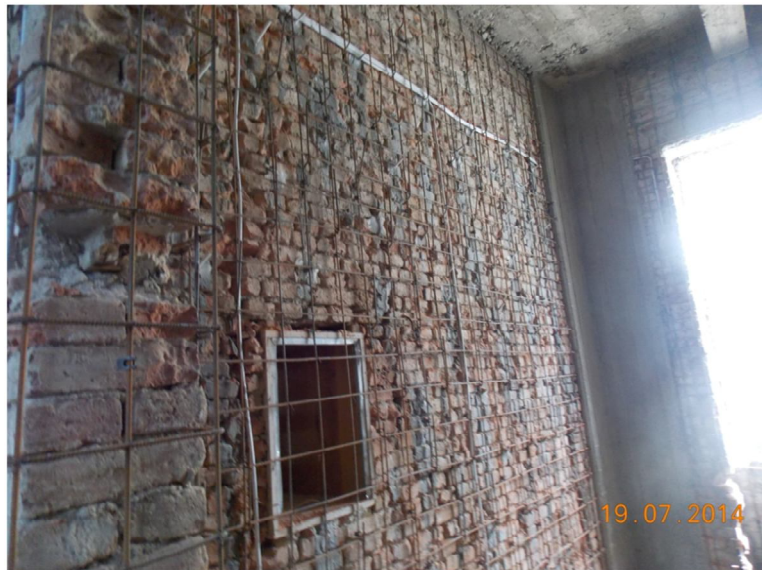
Fig. 4 – “New” wall reinforcing, ready for formwork and casting.

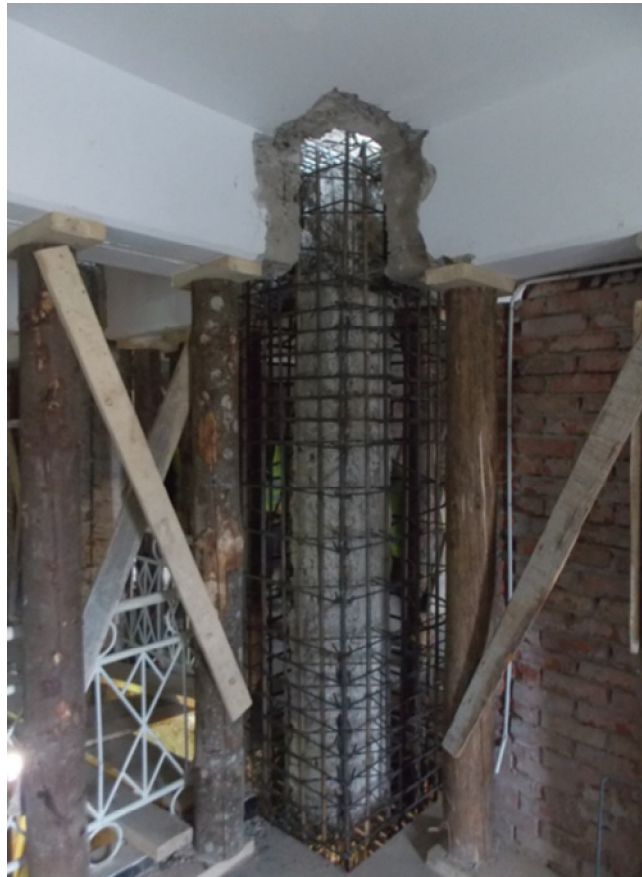
Fig. 5 – Reinforced column. Note the damage done to the paintwork.

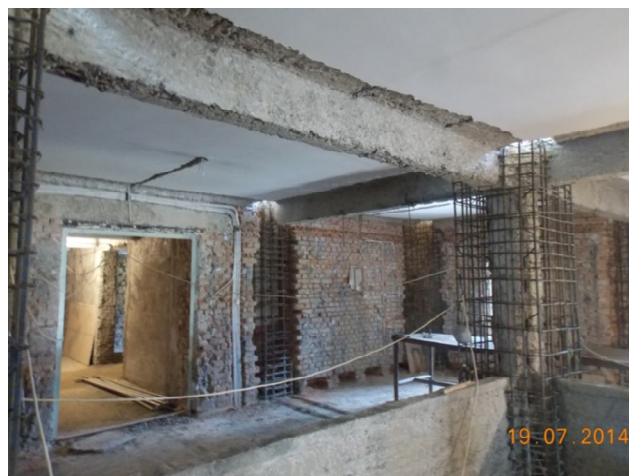
However, there were a few negative points of view to this project, from a building rehabilitation point of view. Although the historically important parts of Sections C1 & C2 were restored to bring back their initial beauty and value, it can be argued that the rehabilitation solution itself “watered down” the historical aspect of these structures (Fig. 5). Furthermore, as there was also the desire for some (technical) upgrades (such as top – performance windows to minimize heat losses, modern installations, modern heating etc.), these can also be considered less – than – stellar approaches to the rehabilitation of these buildings (Figs. 6,...,9).

Fig. 6 – New electrical installations layout.

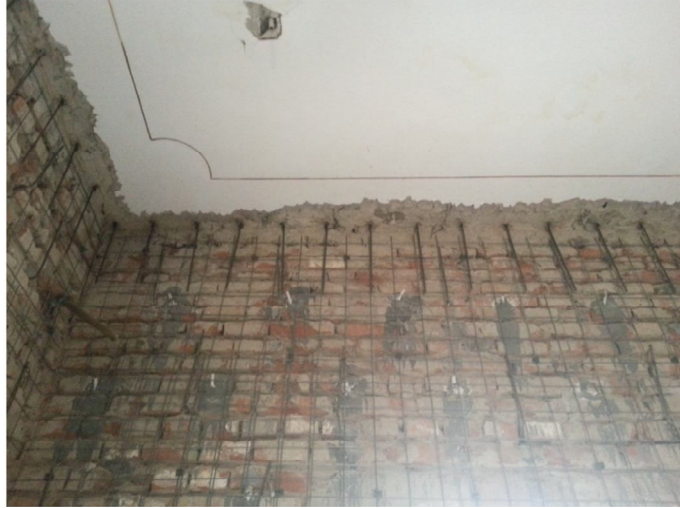
Fig. 8 – Hole in the finished plate for lighting installations.

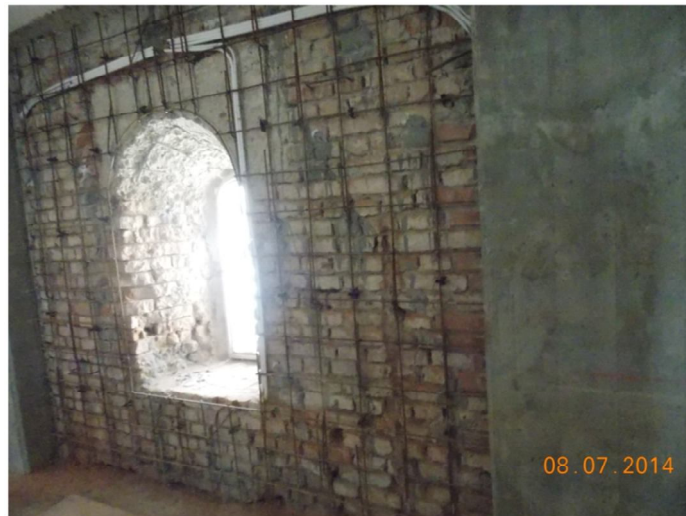
Fig. 9 – New electrical installations and window space.
