BULETINUL INSTITUTULUI POLITEHNIC DIN IAȘI
Publicat de
Universitatea Tehnică „Gheorghe Asachi” din Iași
Volumul 65 (69), Numărul 1, 2019
Secția
CONSTRUCȚII. ARHITECTURĂ

STRUCTURAL BEHAVIOR OF A HYBRID STEEL-CONCRETE BRIDGE EXPERIMENTAL SET-UP

The main objective of this paper is to present the preparatory stages of the experimental program regarding the implementation of an automated, efficient system for monitoring a mixed steel-concrete structure and determining its viability.

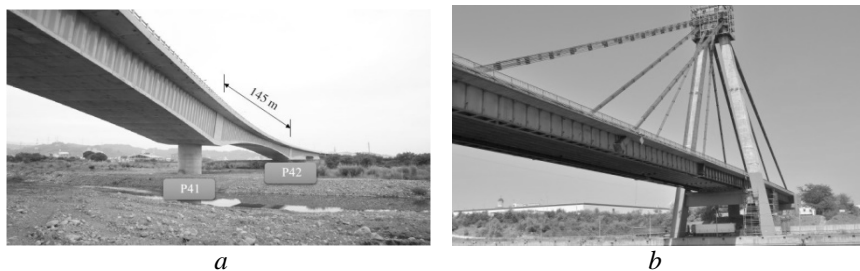
The first example could be the Taiwan-made steel-concrete composite bridge that ensures the continuity of the road to the Caohu River. The bridge has a total length of 476 m, with four openings of different lengths (93 m + 145 m + 145 m + 93 m), the width of the bridge being 25.8 m (Fig. 1 *a*). The superstructure underwent an extensive rehabilitation process at the end of which it was decided it needed monitoring. Therefore, various in-situ tests were conducted before the assessment of the non-degraded structure stage of the bridge. The implemented SHM system includes 4 types of sensors (strain gauge, LVDTs, inclinometers and temperature strains) mounted in the most important points of the third opening. In this way, the structure manager knows the technical state of the structure at any time (Sung *et al.*, 2016).

Fig. 1 – *a* – Caohu Bridge (Taiwan) (Sung *et al.*, 2016); *b* – Agigea Bridge (Romania).

In our country, one of the most representative examples of structure that benefited from the implementation of a SHM system is the Agigea Bridge, which connects Constanța city and Vama Veche (Fig. 1 *b*). This bridge is the first cable structure in Romania, with a total length of 267 m, spread over four spans (40.5 m + 40.5 m + 162.5 m + 23.5 m). The monitoring system consists of eight pairs of voltage sensors in four characteristic sections. The sensors were located at the bottom of the metal beams, in contact with the lower sole, to monitor the technical state of the structure (Mihalache *et al.*, 2017; Romanescu, 2014).

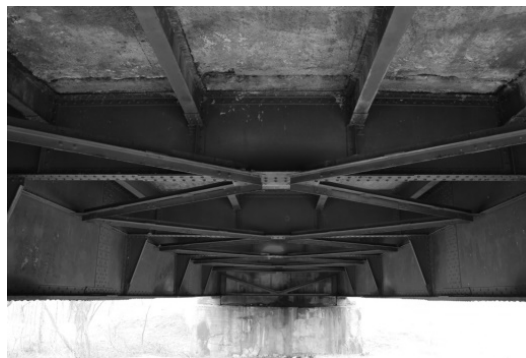
The superstructure of the bridge is made of two solid steel girders, continuously adjacent to the supports, and a reinforced concrete slab on top. Between the two girders there are four balks. The distribution of loads between the girders, balks and maintaining of these elements in the correct position are achieved by the struts. One of the interesting features of this structure is the lack of connectors between the flanges of the girders and the concrete slab. The main girders have a constant height of 2.40 m, being arranged at an interax distance of 7.00 m. At the bottom of the steel structure, there are horizontal bracings (Fig. 4).

Fig. 4 – View of the bracing system.

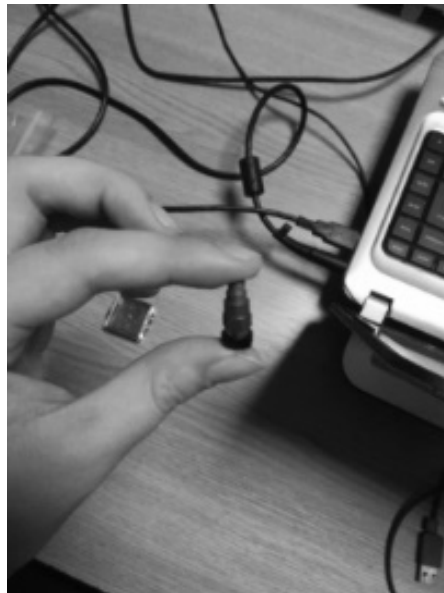
The uniaxial accelerometer shown (Fig. 6) requires a DC power source to operate, the current being provided by the Controller Module. This sensor has a mounting surface disposed at the bottom of the unit, attaching it to the monitored element by means of a wax film. At the top, the data transmission cable is attached, thus linking to the Controller Module.

Fig. 6 – Uniaxial accelerometer of PCB Piezotronics 628F01 type.

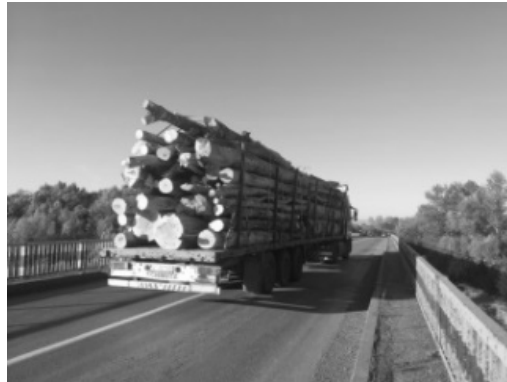
Recordings under traffic highlight the passing of heavy vehicles (Fig. 11) that produce excessive vibration of the structure in operation. These vibrations reveal the degradation state, in the case of the Șcheia Bridge,

resulting in the first analysed of the data a rather advanced state of degradation. At the same time, it is pointed out the degradations caused primarily by the lack of cooperation between the steel girders and the concrete slab, the most important defect of the structure, the lack of the maintenance works execution or their faulty execution.

Fig. 11 – Heavy vehicles crossing the bridge.
