THE INFLUENCES OF THE DURABILITY FACTORS OVER A SPECIAL REINFORCED CONCRETE STRUCTURE'S IN-TIME BEHAVIOUR

ALEXANDRU FILIP^{1,*} and DANIEL COVATARIU²

Keywords: water tank; level of degradation; durability; experimental program; rehabilitation solutions.

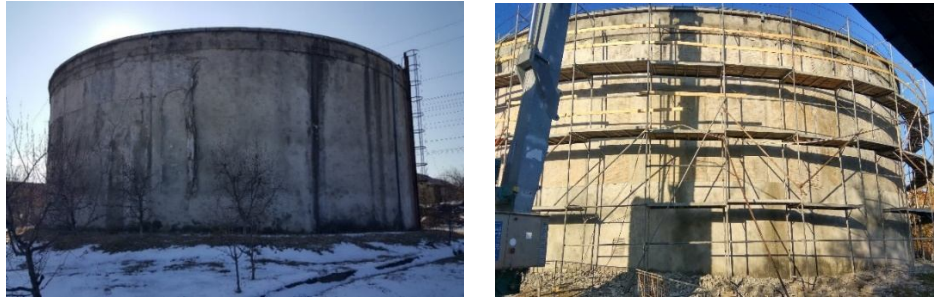
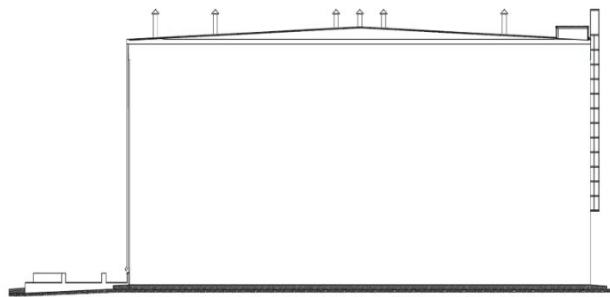
The analysed construction is a ground water tank (Fig. 2) made of reinforced concrete having a capacity of 5,000 m³. It was built in the 1980s and it is still in exploitation, providing the necessary water for the Miroslava village and the Nicolina neighbourhood in Iași, Iași county.

Fig. 2 – Water tank – Miroslava village, Iași county.

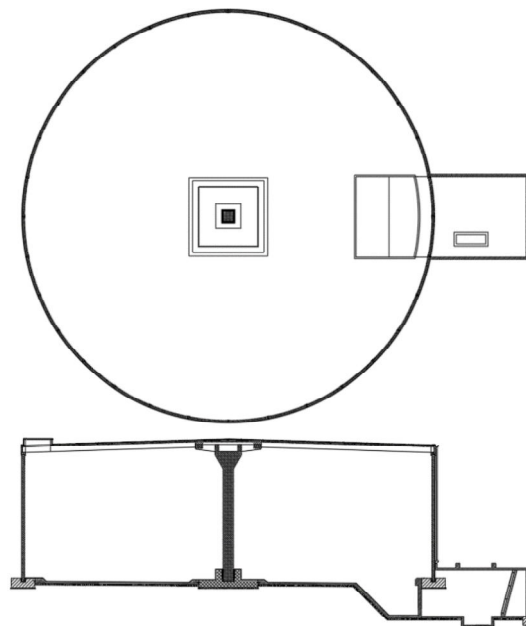
The water tank has a circular shape in the horizontal plane (Fig. 3) with an inner radius of 13.85 m and a useful height of the tank of 8.05 m. Inside, there is a central reinforced concrete column with the dimensions of 70 × 70 cm supported by a continuous foundation (C18/22.5), provided at the top with a circular cap.

The wall of the tank is made of prefabricated elements (C25/30) of 17 cm thick. At the top of the wall was made a reinforced concrete belt with the dimensions of 28 × 20 cm.

At the top, the tank was closed with pre-fabricated T-shaped roof elements (C25/30), radially disposed, supporting one end on the top of the wall and the other on the central pillar cap.

Fig. 3 – Miroslava water tank:
a) longitudinal section; b) transversal section.

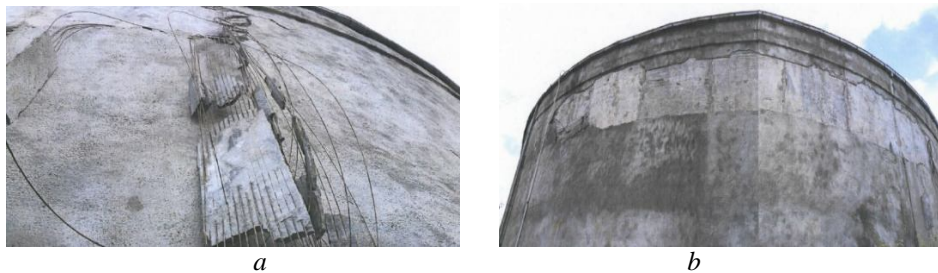
At the exterior, at the superior part of the perimeter wall of the tank there have been observed corrosion of reinforcement and in some cases, breaking of the post-tensioned reinforcement (Fig. 4 *a*) and the detachment of the shotcrete on very large surfaces (Fig. 4 *b*).

Fig. 4 – Degradations at the top of the water tank wall.

At the exterior, significant degradations were identified following visual analysis (breakage of winding springs, peeling of the shotcrete) and the results obtained using non-destructive testing methods (carbonation, water absorption).

Strengthening the circular wall of the water tank will be achieved by post-tensioning by means of an annular winding and a shotcrete layer will be applied. Then the circular wall and roof will be thermally insulated. Subsequently, special waterproofing mortars will be applied.

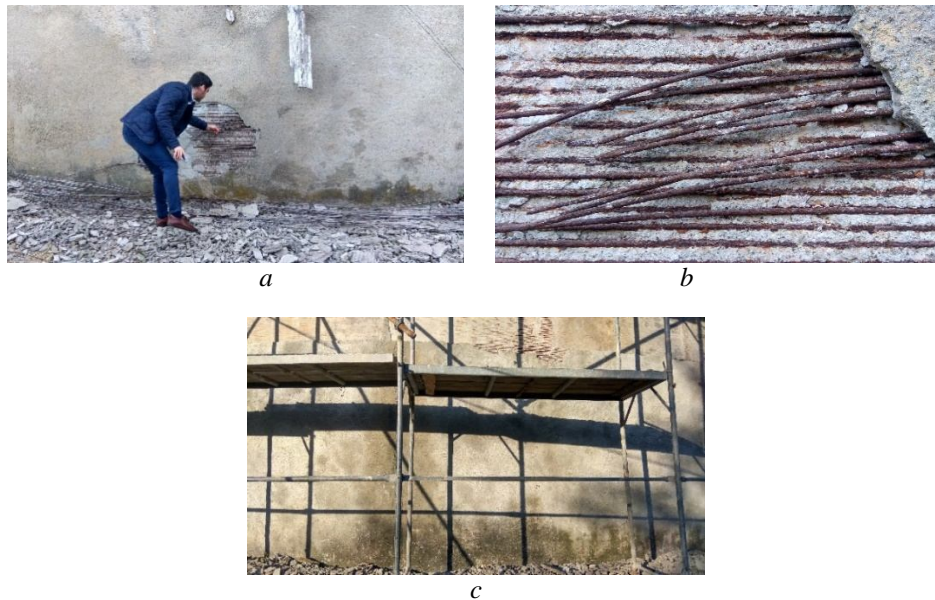
At the inferior part of the wall, an accelerated corrosion process of the post-tensioned reinforcement (Fig. 5 *a*, 5 *b*) has been caused by continuous water infiltration resulting from precipitation and the detachment of the shotcrete due to the excessive humidity at the base due to open capillarity (Fig. 5 *c*), as well as the succession of freeze-thaw cycles.

In the case of the post-tension reinforcement, it was not necessary to carry out further tests in order to determine the mechanical characteristics since it was found during the visual inspection phase that its were significantly affected by the corrosion process, being needed the full replacement of the post-tensioned reinforcement.

Fig. 5 – Degradation at the base of the water tank wall.

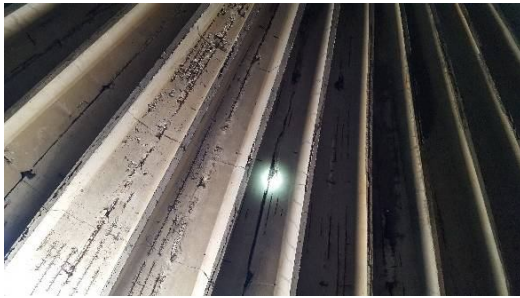
At the interior, in the inlet of the prefabricated roof elements (Fig. 6) were identified portions where the structural elements present severe degradation (segregated concrete areas, concrete expulsion), due to high humidity values maintained over long periods, mainly due to the inefficiency of the ventilation system. These have been manifested by reducing the cross-section of the reinforcement and detaching the concrete cover layer.

Fig. 6 – Degraded roof elements of the water tank.

As a result of destructive and non-destructive tests performed in the laboratory, the strengthening of prefabricated roof elements in the first phase will be achieved by the application of special mortars for repair to the underside of the elements, then by applying the strips and woven fabrics of carbon fibres.

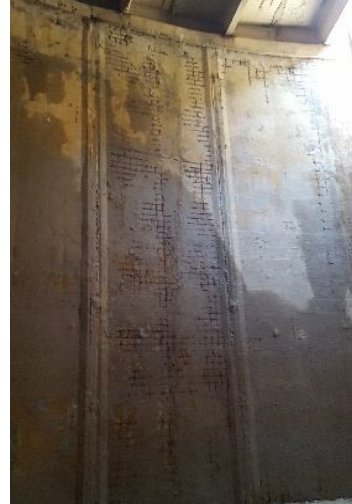
At the level of the wall elements (Fig. 7), major degradations were found on the inner face of the circular wall which led to the expulsion of the concrete layer and the corrosion of the reinforcements. The main cause is represented by large surfaces of wet reinforced concrete elements / temporarily covered with water.

Complementary secondary causes, with a role in amplifying the development of the corrosion phenomenon of steel, were local concentrations of effort from static and / or dynamic loads during the exploitation history.

Fig. 7 – Degraded wall element.

Special waterproofing mortars are used at the level of the water tank wall to stop possible water infiltrations.

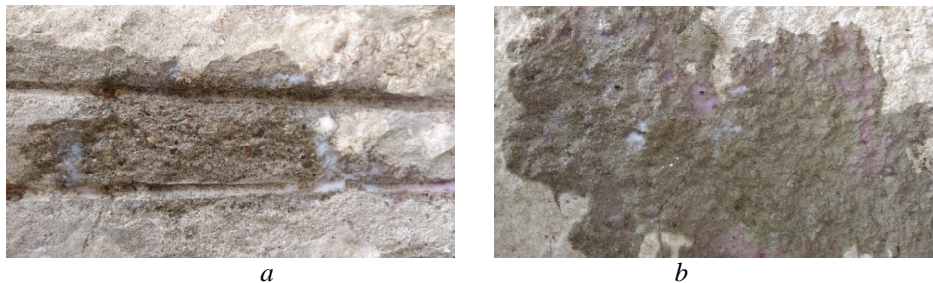
An effective in-situ non-destructive testing method is represented by the alkalinity test (performed by applying phenolphthalein) on shotcrete (Fig. 8 *a*) and concrete (Fig. 8 *b*).

Fig. 8 – Alkalinity test performed in-situ.

The alkalinity test is performed with sprinkled on concrete surfaces. Depending on the coloring of the concrete, the alkalinity decreases (Somridhivej *et al.*, 2016).

From the tests carried out, spraying with indicator substances (phenolphthalein) revealed low pH areas due to the strong penetration of chlorine ions. Spray test is a quick way to determine areas and the depth of affected material.

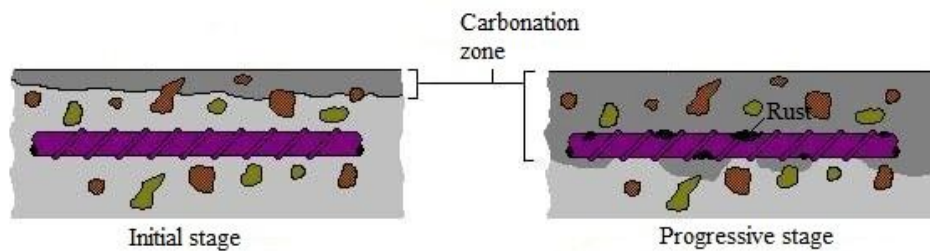
Another important feature for estimating the level of degradation of buildings, regarding the durability of reinforced concrete elements, is the carbonation process (Fig. 9) of the concrete protection layer of the reinforcements. The depth of carbonation of the covering layer can be determined quite simply using the alcoholic solution of phenolphthalein (Hann, 2011).

Fig. 9 – Carbonation process.

Determination of the carbonation depth of the concrete consists of pulverizing the phenolphthalein on freshly stripped successive layers and observation of the obtained coloration: the non-carbonated concrete is coloured in pink, the depth of the layer where the staining appears, marking the limit to which the concrete is carbonated (carbonate concrete does not change colour to phenolphthalein) (Pack *et al.*, 2018).

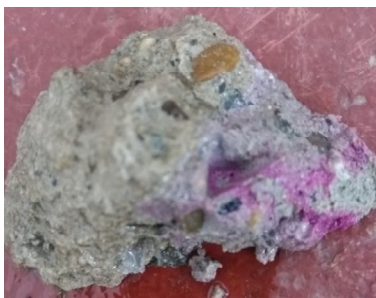
The tests performed on the concrete samples (Fig. 10) revealed that the concrete is carbonated due to the long exposure of the water vapor to the intimate structure of the concrete and the aggressive environmental agents, leading subsequently to the corrosion of the reinforcement and the expulsion of the concretes.

Fig. 10 – Concrete's carbonation test.

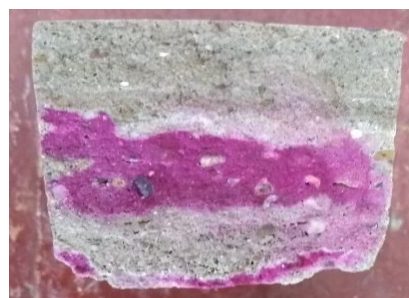
In tests carried out on the sample of shotcrete (Fig. 11) it has been found that at the reinforcements level the shotcrete has been little affected by the carbonation process. Instead, due to the interaction with aggressive environmental agents (high humidity, freeze-thaw cycles, etc.), the carbonation process has amplified from the outside to the inside.

Fig. 11 – Shotcrete's carbonation test.

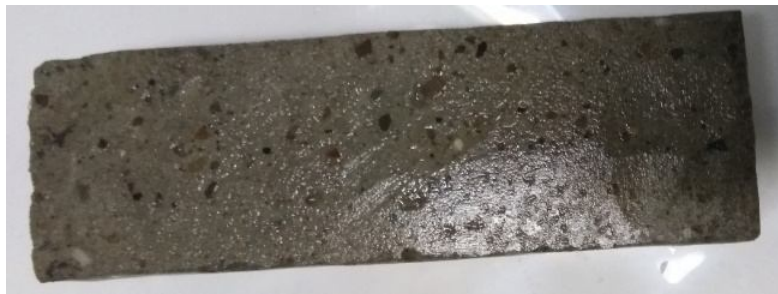
In the case of shotcrete specimen, it was performed the water absorption test (Fig. 12). Water absorption is the amount of water absorbed by the voids accessible from the outside of a test specimen, at the maintaining in water under vacuum and expressed as a percentage of the initial mass or volume of the specimen.

Fig. 12 – Water absorption

Dimensions of the specimen ($L \times l \times h$): $149 \times 47.5 \times 40$ mm; $m = 0.555$ g; $m_u = 0.560$ g; $m_s = 0.595$ g; $A_{m1} = [(0.595 - 0.560)/0.560] \cdot 100 = 6.25\%$; $A_{m2} = [(0.595 - 0.55)/0.55] \cdot 100 = 7.20\%$.

In the case of the tested sample, the resulting values are 6.25% in the case of initial specimen and 7.20% in the case of specimen after being dried. This fact concludes that the material used (shotcrete) due to the action of precipitation water has a high absorption capacity and it is recommended to use special waterproofing mortars.

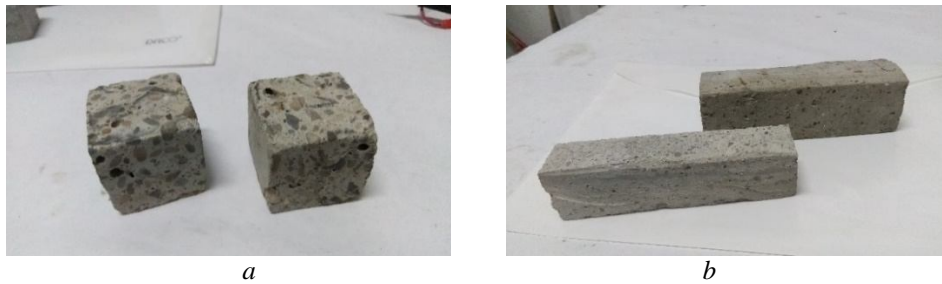
In order to estimate the level of degradation of structural elements, concrete (Fig. 13 *a*), shotcrete (Fig. 13 *b*) and reinforcement samples were tested.

Fig. 13 – Test specimens: *a* – concrete samples; *b* – shotcrete samples.

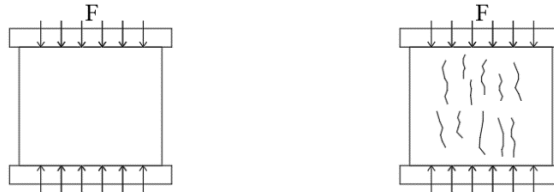
For concrete samples the determination of the compressive strength on cube ($f_{ck,cube}$) was made. The concrete test using specimens are used to obtain information on the concrete quality of the work, including the compressive strength of the concrete (Fig. 14) (SR EN 12504-1).

Fig. 14 – Compressive strength test – schematic representation.

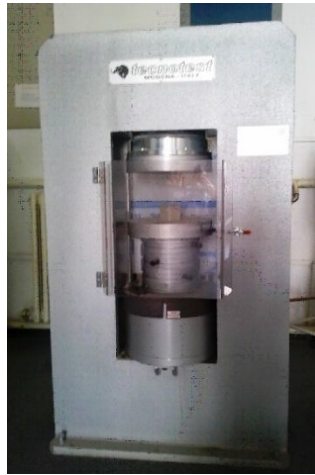
Test specimens were tested until compression failure at the test machine, the maximum load at which the test specimen resisted and the compressive strength of the concrete is calculated. Cubic specimens are positioned so that the load is applied perpendicular to the casting direction (Fig. 15).

Fig. 15 – Compressive strength test – concrete.

For the concrete specimens tested in the laboratory by using destructive methods, the characteristic compressive strength is $f_{ck,cube,m} = 15$ N/mm² corresponding to the concrete class C12/15.

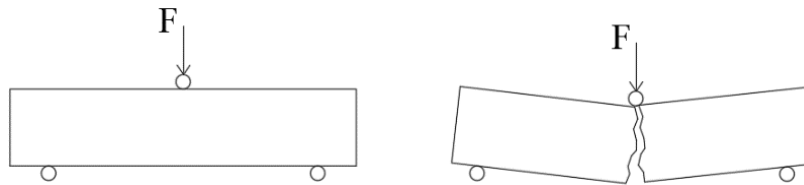
To determine the tensile strength by bending (Fig. 16), the prismatic specimens are subjected to a bending moment by applying a load through the upper and lower rollers. Then the maximum loaded load is recorded and the tensile strength by bending is calculated.

Fig. 16 – Tensile strength test – schematic representation.

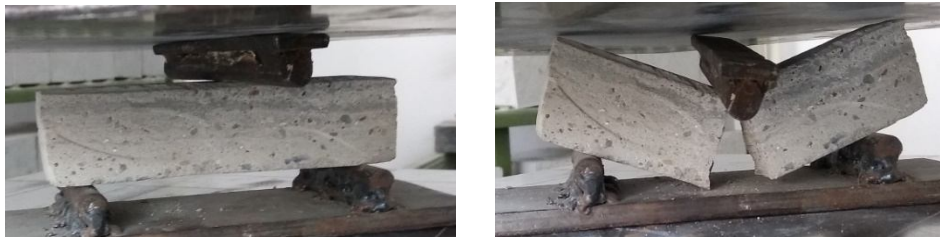
The test piece is placed on the machine, it is centred correctly with the longitudinal axis of the specimen at right angles to the longitudinal axis of the upper and lower rollers (Fig. 17). It is ensuring that the reference direction of the test is perpendicular to the direction of casting of the specimen. The loading does not apply until all loading rollers and support rollers are placed on the specimen.

Fig. 17 – Tensile strength test – shotcrete

For the shotcrete samples tested in the laboratory, using destructive methods for determining the characteristic value, the tensile strength is $f_{cf,m} = 6.05$ N/mm².

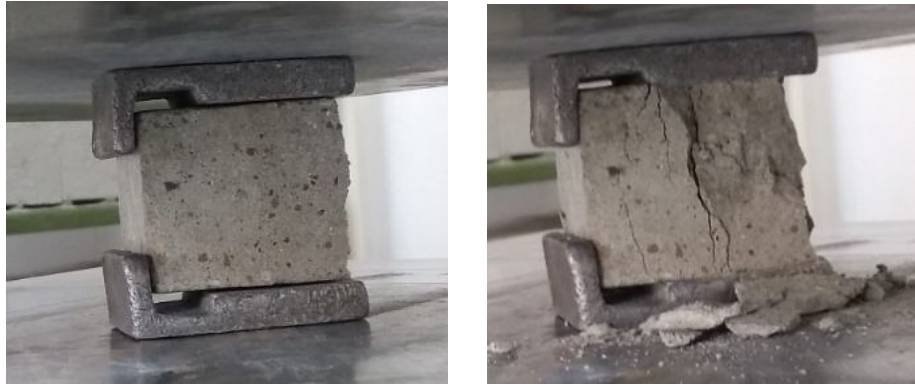
The evaluation of the compressive strength of the shotcrete samples (Fig. 18) was carried out similarly following the steps as in the case of concrete specimen.

Fig. 19 – Compressive strength test – shotcrete

For the shotcrete specimens tested in the laboratory using destructive methods, the characteristic compressive strength value is $f_{ck,cube,m} = 19.50$ N/mm².
