BULETINUL INSTITUTULUI POLITEHNIC DIN IAȘI Publicat de Universitatea Tehnică "Gheorghe Asachi" din Iași Volumul 66 (70), Numărul 3, 2020 Secția CONSTRUCȚII. ARHITECTURĂ

# INTERVENTIONS UPON BRICK MASONRY WALLS – CONSTRUCTIVE SOLUTIONS

# 3. Case Study

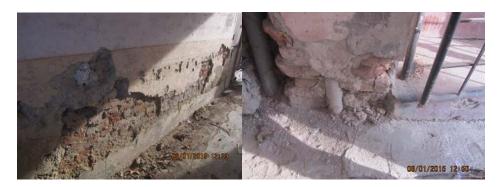
b) The repeated freezing-thawing phenomenon and the poor maintenance led to the destruction of the masonry, at various extents, and sometimes up to half of the wall thickness (Fig. 9).

Fig. 9 – Damaged masonry.

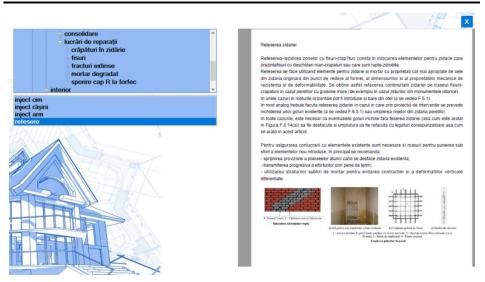
It is recommended to reweave/rebuild cracked and fissured areas and it consists in replacing masonry elements with wide openings or cracks as well as those which are broken. Reweaving consists in using masonry elements and mortars of features as near as possible to the original materials, in so far shape, size and mechanical strength and deformability are concerned. In this way the masonry is rebuilt along the fissure/crack route. Reweaving of elements means to use connections both in the wall plane and perpendicularly to it when walls are very thick (Fig. 10).

Fig. 10 – Reweaving masonry.

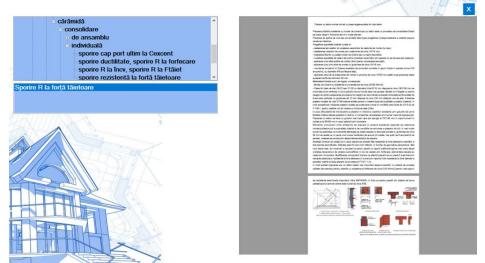
Plating is applied on one or both sides after the masonry to be intervened upon is properly prepared. Obviously, plating has a relatively more important effect upon the poor quality masonry walls (for instance, for masonry with a shear strength of about  $0.05 \text{ N/mm}^2$ ) where increasing the strength is

very important reaching between 300÷400%, while for good quality masonry walls, the increase in strength is of only 30%, (Fig. 14).

Fig. 14 – Plating masonry walls with cement mortars or concrete.

Plating existing masonry with cement mortar or concrete is a consolidation procedure used on a wide scale in Romania as well as in other countries.
