## CRITERIA FOR THE ASSESSMENT OF EXISTING HIGHWAY BRIDGES

EDWARD PETZEK and RADU BÂNCILĂ

### 4. Case Study – the Bridge in Săvârșin

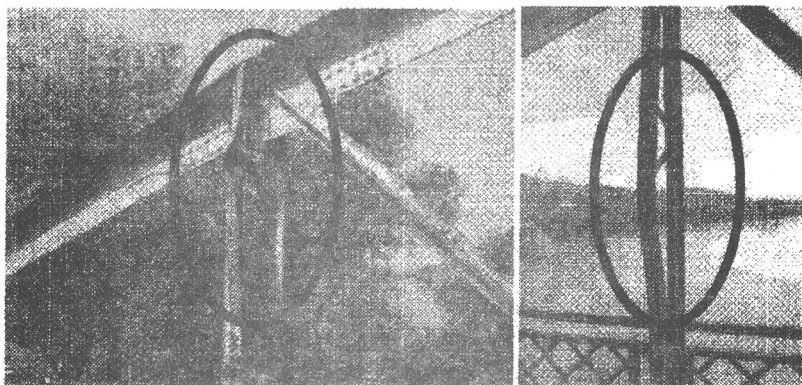
a) *Insufficient clearance*: (the width,  $B = 5.0...6.0$  m, (Fig.1) and therefore vertical members of the main truss girders damaged by the impact with vehicles (Fig.2).

Fig. 2.- Degradations of the structural elements due to the impact with vehicles.

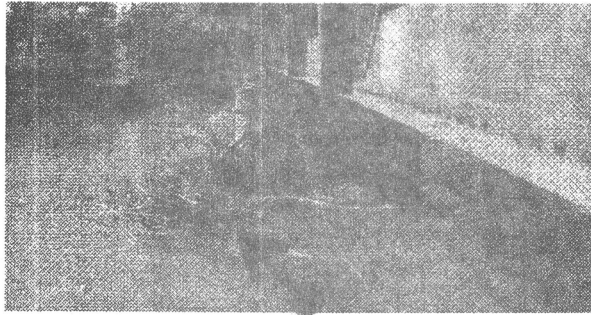
b) The *maintenance* of these structures is not continue (Fig.3), the owners have changed during history (different administrations), the *corrosion* is important (Fig.4).

Fig. 3.- The problem of maintenance work.

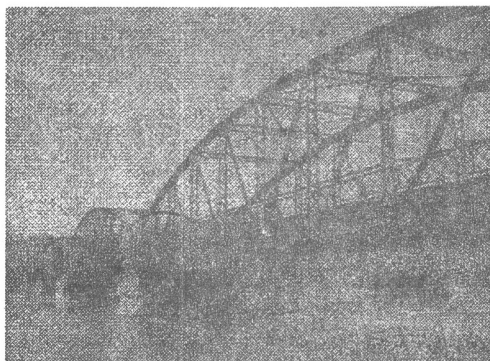
The bridge in Săvârșin over the Mureș River (Fig. 15) on the local highway DJ 707 A (km 1+271 m) is a remarkable structure with four spans (Fig. 16) erected in 1897. The steel superstructure has a typical composition for the time period in

which it was built, that is: steel deck, main parabolic truss girder with descending diagonals and posts, with trough deck slab laid on profiles of the Zorres type.

Fig. 15.- The bridge in Săvârșin (1987).

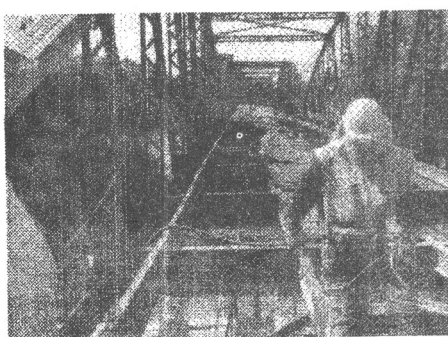
2. Sand blasting of the structure and after that cutting the new consolidation elements and their positioning (Figs.26 and 27).

Fig. 26.- Sand blasting of the structure.

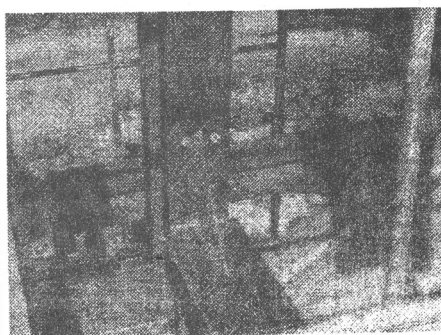
Fig. 27.- New consolidation elements.
