BULETINUL INSTITUTULUI POLITEHNIC DIN IAȘI Publicat de Universitatea Tehnică "Gheorghe Asachi" din Iași Tomul LIX (LXIII), Fasc. 2, 2013 Secția CONSTRUCȚII. ARHITECTURĂ

## RETROFIT OF STONE MASONRY BUILDINGS IN GREECE I. DAMAGE PATTERNS AND PREVENTIVE RETROFIT/REPAIR MEASURES

## MARIA BOŞTENARU-DAN<sup>1,\*</sup>, GREGORY G. PENELIS<sup>2</sup> and GREGOR BOURLOTOS<sup>3</sup>

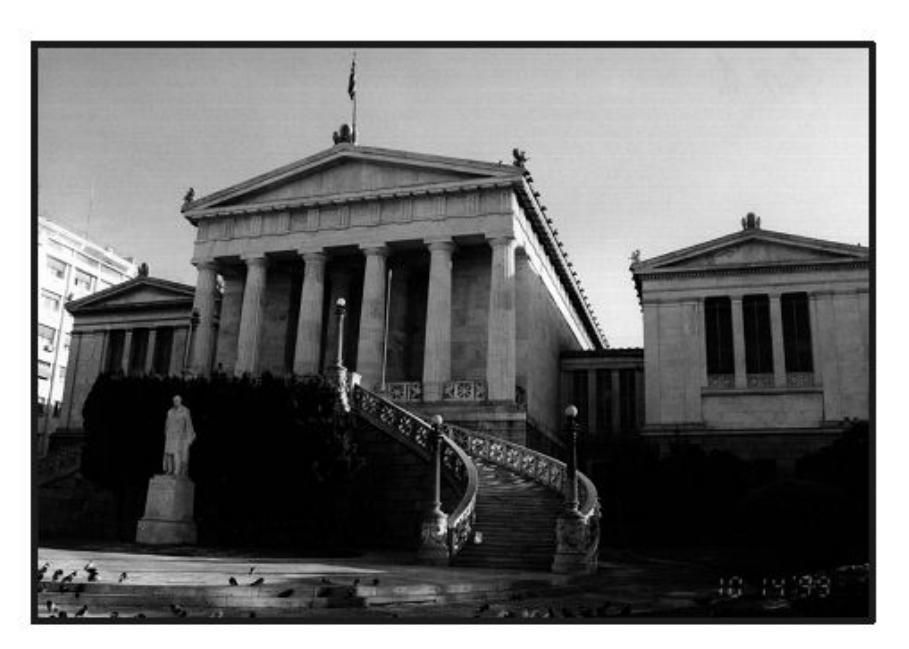
Fig. 1 – National Library of Greece (Εθνική Βιβλιοθήκη) buildings, Athens, architects Theofil von Hansen (1813-1891) and Ernst Ziller (Ερνέστος Τσίλλερ, 1837-1923), 1888-1903.

In case of the National Library of Greece (Fig. 1) the buildings are built from Unreinforced Masonry (URM) constructed externally with smoothened marble megastones combined with marble kions while the floors are composed of steel beams filled with brick vaults in between. The buildings had three different type of damage (Penelis & Penelis, 2001)

In all three wings the type (I) damage consisted mainly of water leakage and oxidation of the steel beams, while the damages of types (II) and (III) are different for each wing.

More specifically the two side wings presented inclined cracks at the edges of the transverse walls typical of independent out of plane behavior of these walls due to the lack of diaphragm constraint at the floor and roof levels. Furthermore horizontal cracks were presented at the foot of the piers of the longitudinal walls due to in plane flexure. The spandrels of the longitudinal walls suffered small vertical cracks indicative of tensile stresses. One of the side wings had an additional R/C mezzanine level, which during the 1999 earthquake pounded on the URM back transverse wall and caused significant damages. The main wing had significantly less damages that can mainly be

As has been aforementioned the intervention mainly concentrated on the side wings except for type I damages (time dependent) which also existed in the main wing. Furthermore all the intervention has been directed towards being light and reversible. So, in that context, for the two side wings, the structural restoration consisted in the implementation of a perimetrical, internal zone consisting of beams on the roof level, in order to restore the diaphragm constraint, either using concrete with stainless steel as reinforcement or uniformly stainless steel profile in order to avoid future corrosion. Furthermore four titanium stitches per corner per wall were suggested in order to secure the uniform behaviour of the longitudinal and transverse walls (Fig. 6). The cracks on URM were filled with enema with specially selected composition in order to

conform chemically, mechanically and aesthetically with the existing mortar using the sophisticated laboratory tests that had been performed and the existing database at the Reinforced Concrete Lab of AUTH. Finally the mezzanine level was demolished and reconstructed with a composite steel-lightweight concrete structure providing a suitable seismic joint with the surrounding URM walls, to avoid pounding damage in the future.

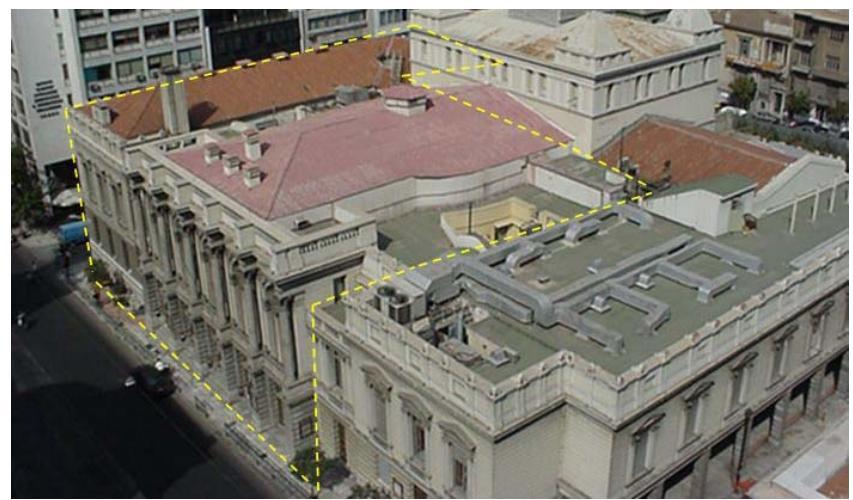
Fig. 2 – Preserved part of the National Theatre (Εθνικό Θέατρο) buildings (Schiller phase), Athens, architect Ernst Ziller, 1895-1901.

- The building had the following type of damage:
- (I) Time related.
- (II) Damage in the perimeter walls from the balcony cantilever.
- (III) Damage from the 1999 earthquake.

From the analysis results as well as the observed crack patterns which confirmed the analysis results, it was decided that an intervention would be <u>26</u>

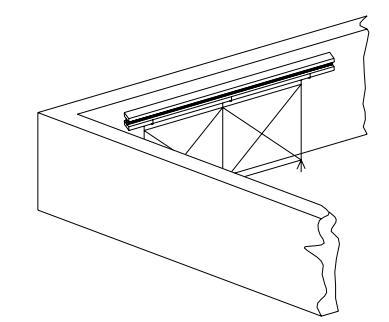
Fig. 11 – Unloading of the wall in order to add confinement (from Boştenaru & Bourlotos, 2008).

In both cases the loads are caught with a support (ex. Fig. 11) and lead into the load bearing foundation. Then the old wall or part of wall is demolished and a new wall is built. Finally the wall is loaded again (the support is unmounted).

As in the previous case the loads from the roof and the floors are caught with a scaffold construction (Fig. 11). It is bolted in two directions on the inner side of the wall. The corner masonry is demolished on a length of ca. 2 m and disposed (Fig. 12 *a*). The corner is reinforced with a column: forming, concreting and stripping of the corner column (Fig. 12 *b*). In the zone of the column reinforced masonry is created (Fig. 12 *c*).

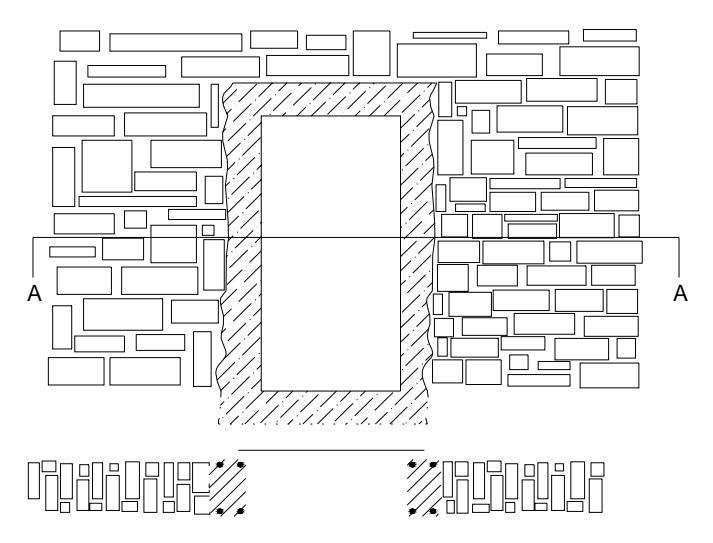
Sometimes the lintels consist of stone arches, wood or metal joists. These do not always correspond to the sizes and surfaces of the wall openings. This is also a seismic deficiency. The steps in taking the measure are described on the example of a door opening (Fig. 13). First the old door and the door frame are demolished and disposed. If there is a lintel, this is also demolished and disposed. Then the masonry adjacent to the door opening is demolished and disposed on a 15 cm width (Fig. 13 a). The reinforcement of the reinforced concrete frame is anchored in the floor slab. Other reinforcement works are done, then the reinforced concrete door frame: formed, concreted, stripped (Fig. 13 b). Finally the new door is introduced (Fig. 13 c). The confinement of window frames is similar (Fig. 14).

Fig. 14 - Confinement of window frames (from Boştenaru & Bourlotos, 2008).
