VERIFYING THE OPERATIONAL SAFETY OF SOME EARTH DAMS USING OWN CODED COMPUTER PROGRAMS

DORIN COTIUȘCĂ ZAUCĂ*, **RALUCA-CATRINEL GIURMA-HANDLEY**,
AMEDEO MITROI and **PAULA COJOCARU**

An analysis of this type has been carried out on the Varsolt Hydrotechnical System, located on the Crasna River in Romania. The results of the test have contributed to the rehabilitation and modernization of the earthen dam (Expertiza tehnică..., 1997).

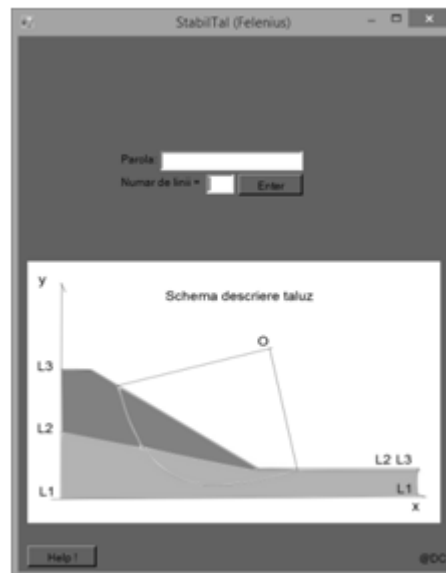
Fig. 3 – Screenshot of the self conceived stability program.

The stability calculus, carried out for several hypothesis also using a self conceived a computer program written in Turbo Basic (Fig. 3.), has emphasized relatively small and critical values for the stability coefficient (values of 1.121,...,1.129). The minimum value of 1.121, in the hypothesis of the blocked drain, indicated the risk of losing the stability of the downstream slope of the dam when the level of water in storage basin increases. In the drain functions, accordingly it results an increase of the coefficient up to the value of 1.151 (Expertiza tehnică..., 1997).
