BULETINUL INSTITUTULUI POLITEHNIC DIN IAȘI
Publicat de
Universitatea Tehnică „Gheorghe Asachi” din Iași
Tomul LXI (LXV), Fasc. 1, 2015
Secția
CONSTRUCȚII. ARHITECTURĂ

STRUCTURAL AND DAMAGE ASSESSMENT OF AN HISTORICAL MASONRY CHURCH

LUCIAN SOVEJA* and MIHAI BUDESCU

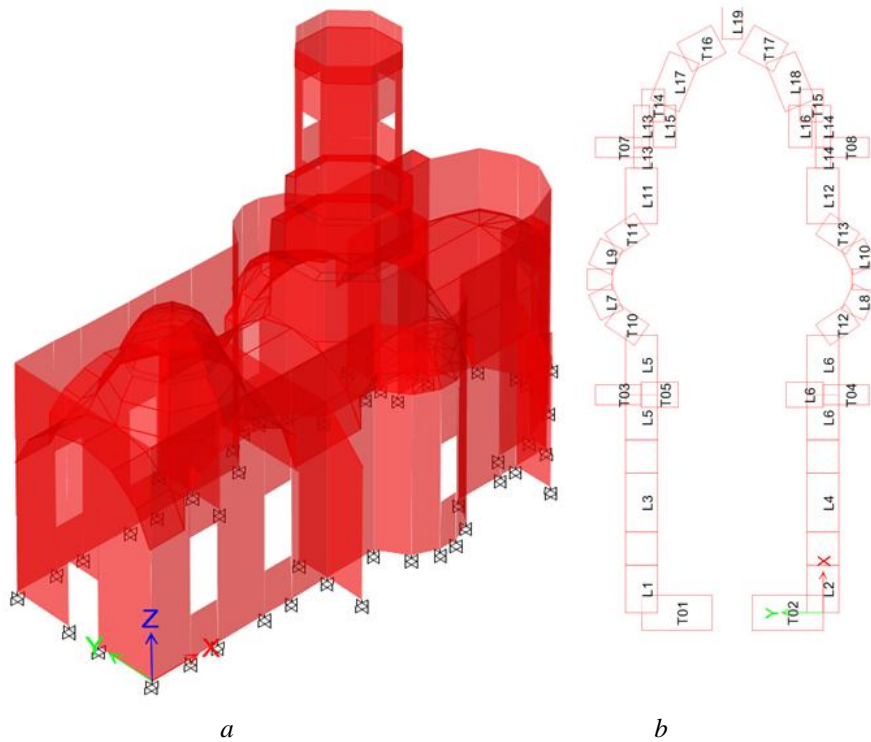
Fig. 10 – *a* – Three dimensional model using shell elements and *b* – walls numbering in linear static analysis.

The model used to simulate the church structural behavior was built in Etabs program using 11,400 shell elements with the maximum dimension of 500 mm (Fig. 10 a).

Before performing linear static analysis, in order to analyze and compare the shear strength and shear demand in each wall, the macroelements were identified and labeled with letter L for longitudinal walls and with letter T for transversal walls (Fig. 10 b).
