BULETINUL INSTITUTULUI POLITEHNIC DIN IAȘI Publicat de Universitatea Tehnică "Gheorghe Asachi" din Iași Tomul LXI (LXV), Fasc. 2, 2015 Secția CONSTRUCȚII. ARHITECTURĂ

STRUCTURAL REHABILITATION OF OLD MASONRY CHURCHES. A COST-ORIENTED CASE STUDY

RADU LUPĂȘTEANU, LUCIAN SOVEJA and VLAD LUPĂȘTEANU^{*}

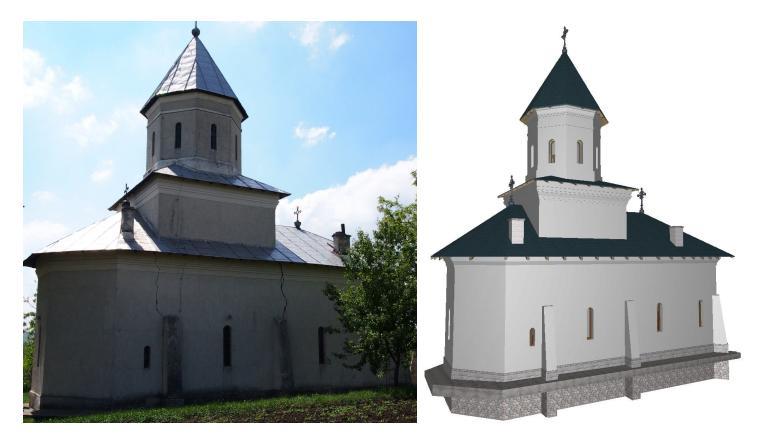
Fig. 2 - "St. Dimitrie" Church - Photo and CAD Model.

"St. Dimitrie" Church is located in Vicoleni village, Botoşani county, and it was erected in 1942. The church (Fig. 2) has dimensions about $18 \times 8 \text{ m}^2$ in plan, with a maximum height of the tower about 21 m. The nave has a simple, rectangular shape, with buttresses at the corners of the west façade and

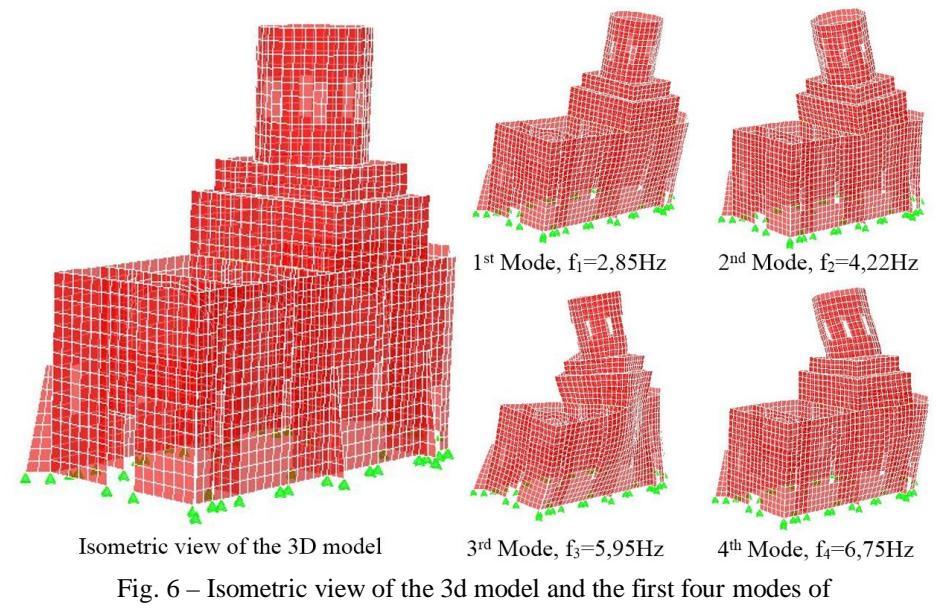
vibration.

been obtained by running linear elastic and dynamic analysis of the 3-D model in the specific loads combinations mentioned before. The modal analysis comprised twenty modes of vibration such that the mass participation factor was greater than 90%. Fig. 6 presents the 3-D model of the church and the first four modes of vibration with their corresponding frequencies. It can be seen that the natural frequency of the structure is 2.89 Hz.
