BULETINUL INSTITUTULUI POLITEHNIC DIN IAȘI  
Publicat de  
Universitatea Tehnică „Gheorghe Asachi” din Iași  
Volumul 65 (69), Numărul 1, 2019  
Secția  
CONSTRUCȚII. ARHITECTURĂ

## **SPECIAL MONITORING OF THE SERVICE BEHAVIOUR OF A HERITAGE BUILDING IN ORDER TO REHABILITATE AND URBAN REINTEGRATION**

**DANIEL COVATARIU<sup>1,\*</sup> and VALERIA ENACHE (COSTEA)<sup>2</sup>**

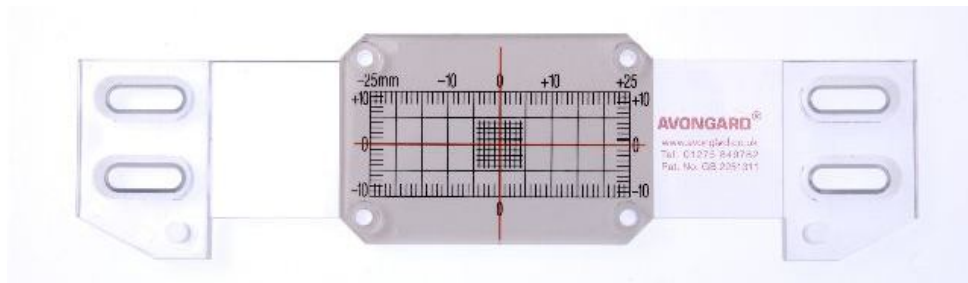
Fig. 8 – Cracks monitoring devices (ruler) “Tell-tale” type

Cracks monitoring devices (Fig. 8) mounted in June 2014 were checked and photographed in order to identify the evolutionary character of fissures / cracks. The devices were mounted in position 0 both vertically and horizontally (the intersection of the two systems of orthogonal axes), fixed by four dowels and hallway screws of 100 mm.

By interpretation of the variations recorded by the mounted devices, it can be concluded that the cracks were of an evolutionary nature (from 3 to 11 mm), this being possible due to the advanced state of degradation, the vibration induced on infrastructure and, obviously, onto the walls of the structure due to road traffic from proximity and the decrease in the characteristics of the foundation ground (water infiltrations).
