BULETINUL INSTITUTULUI POLITEHNIC DIN IAȘI
Publicat de
Universitatea Tehnică „Gheorghe Asachi” din Iași
Tomul LXI (LXV), Fasc. 1, 2015
Secția
CONSTRUCȚII. ARHITECTURĂ

ACCELERATION PROCESS OF CONCRETE'S DISSOLVING – LEVIGATION CORROSION

Abstract. This paper presents a method for accelerate the dissolving-levigation corrosion of the concrete. Test steps and the device used for this purpose are described. The presented method simulates the behavior of the concrete in exploitation subjected to of this type of corrosion to assess the behavior in time of the concrete.

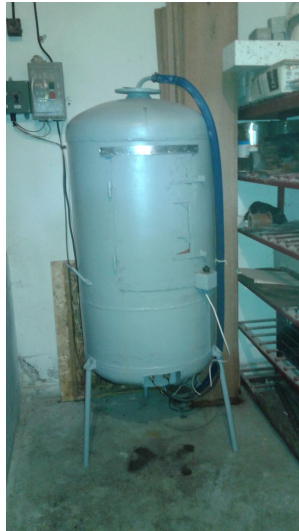
Fig. 1 – Device.

The device is made of a cylindrical chamber realised from steel sheet treated in the interior by priming and painting the device's dimensions (1.8 m heights and 0.9 m diameter) allow the samples placing on three grills made of welded mesh (Fig. 1).

On the lateral wall at a half of the heights it is provided a door that allows a easy access to the three grills were the concrete samples are placed. In this case cubic samples having a 14.2 cm side were realised. To realise an uniform steaming/pulverisation on the samples surfaces on each grill were placed a number of 8 samples having an enough space between them.

The device is realising a continuous pulverisation on the samples surface of a water or steam spirt function on the selected temperature. The water is continuously recycled being taken from the inferior part of the chamber added by an aspiration pump and transmitted by an exterior circuit (rubber hose) at the superior part of the device. From there, by a extremely fine pulverisation system it is dispersed in the interior, all the samples coming into contact with the water and steam. The water's heating is realised with a resistance placed in the water

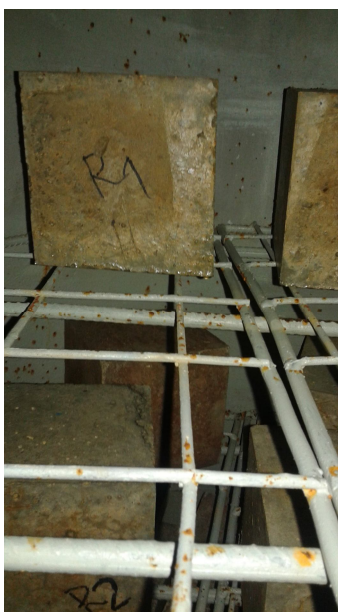
Fig. 2 – Concrete samples position in device.

collecting tank. The device is provided with a thermostat that allows the desired temperature setting, in this case 65°C. In the water tank zone there is a temperature sensor that is actioning the thermostat, so the resistance comes into operation automatically to permanent maintain the water to the desired temperature (Fig. 2).
